MELBOURNE AIRPORT AUTHORITY BOARD MEETING
AGENDA

May 27, 2020 at 8:30 AM
Orlando Melbourne International Airport Terminal

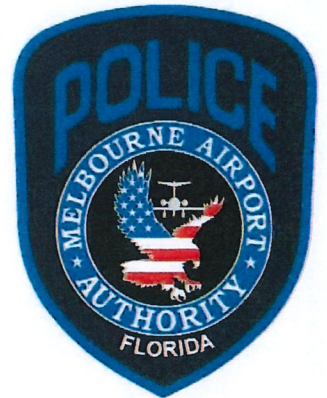
Police Activity	
TSA Required Checks	
Response to Door & Gate Alarms	188
TSA Assists	1
Perimeter	204
Door inspections	8
SIDA & Secure Area Inspections	405
Gate Inspections	5
Customs Assists / Weapons Check	0
Security Violations	2
Assist to Other Agencies	12
Aircraft Alerts	2
Arrests	1
*Other Incident Reports	507
Traffic / Parking Citations/Warnings	0
K9 training & patrols	1
Total	1336
Administrative Action	
Security Badges Issued	77
Parking Permits Issued	1
Total	78

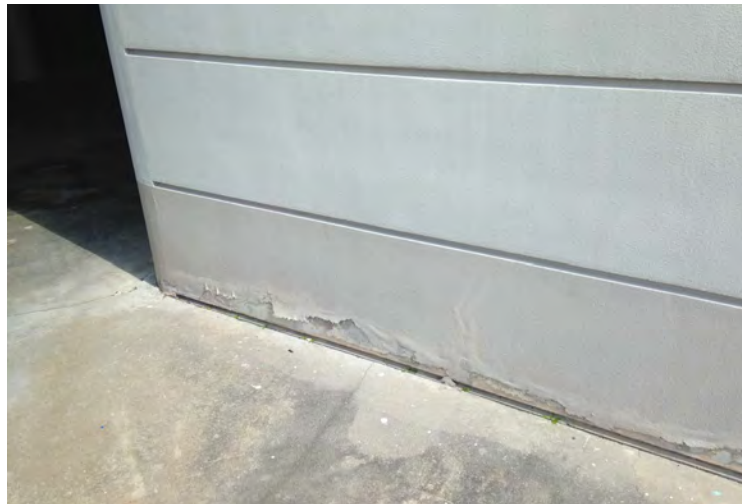
There also appears to be mold on the surface. This assessment only performed a visual inspection. This mold only appeared to be on the surface but an internal testing of the wall would be recommend assuring there is not any mold damage to the wall.

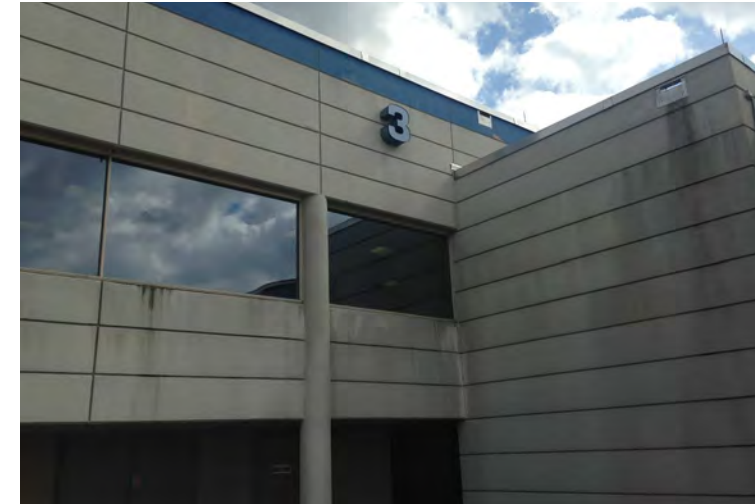
Exterior Doors on the Flight Line side

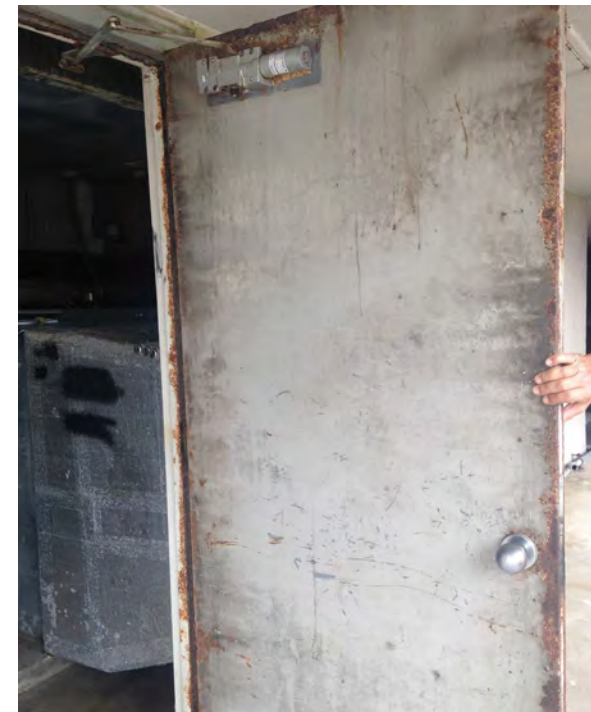
The hollow metal doors, frames and door hardware either need to be replaced or refinished. A number of doors had severe rusting at the joint between the door panel and the frame indicating that the weather-stripping was not working. Most of the doors need to be replaced with new hardware. The door frames could be replaced but the life of them might require them to be replaced in time.

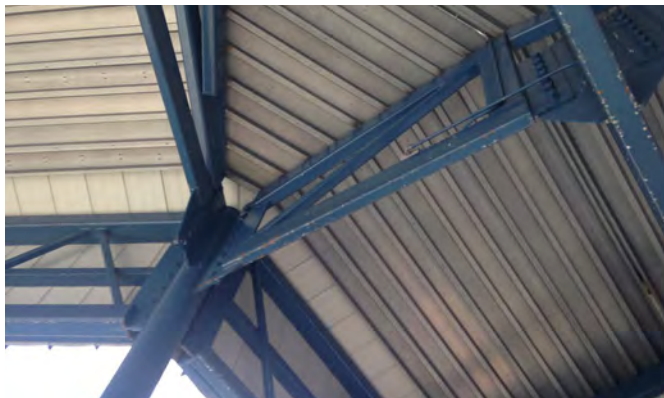
Ticketing Backrooms:

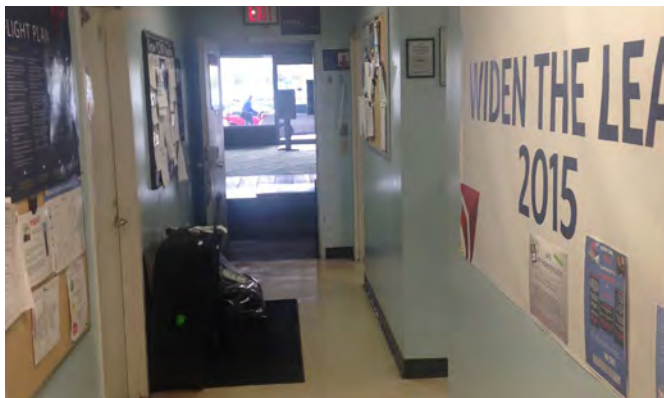
Exterior Baggage Make-up Area

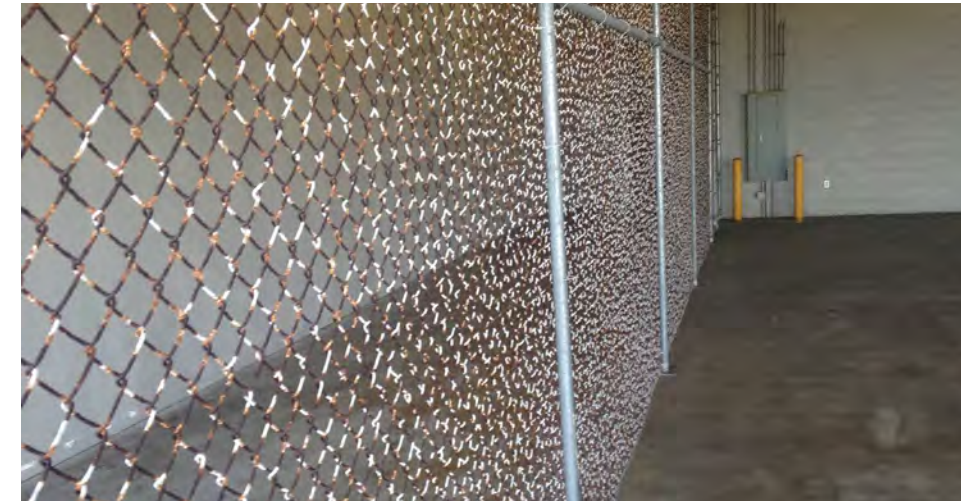
The baggage handling areas that are being maintained by their respective airlines are in good condition. The areas that are not used are in fair condition. General maintenance, painting and cleanup would be required to maintain these areas.

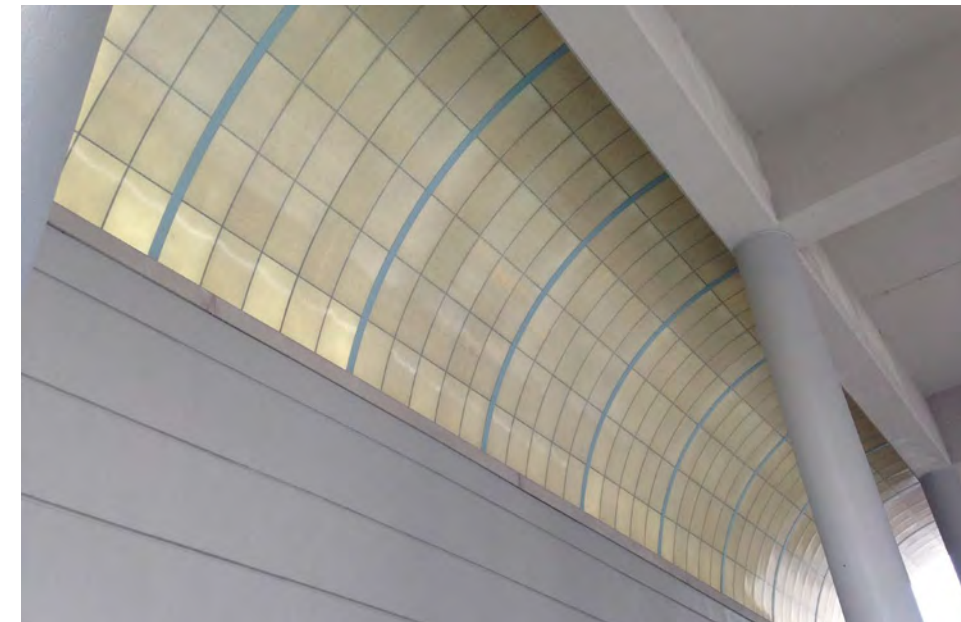
3. Baggage Claim / Rental Area:

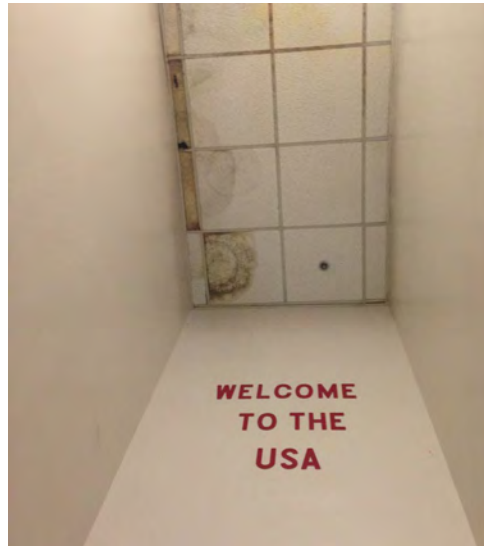
The escalators and elevators are in good working conditions. There is a roof leak above the escalators in the customs area.

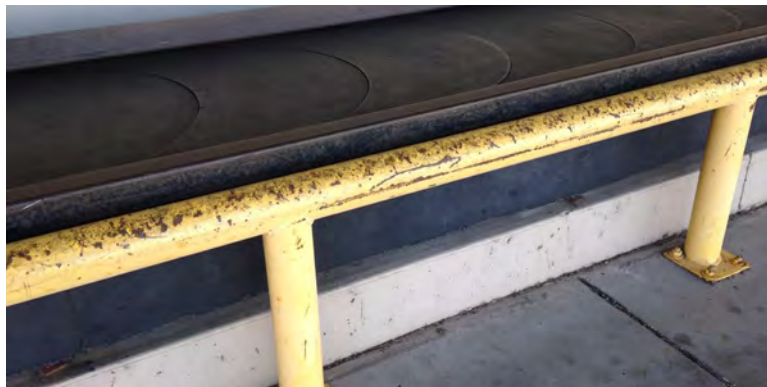
4. Concourse (Terminal) Area:

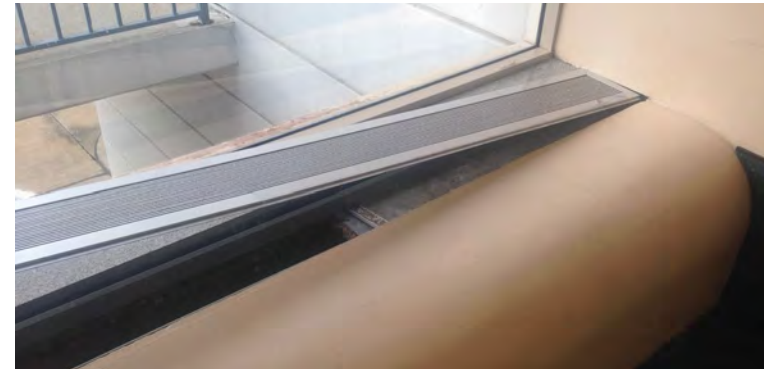
The storefronts in this area appear to be in fair condition. The mechanical diffusers along the windows need repair and replacement.

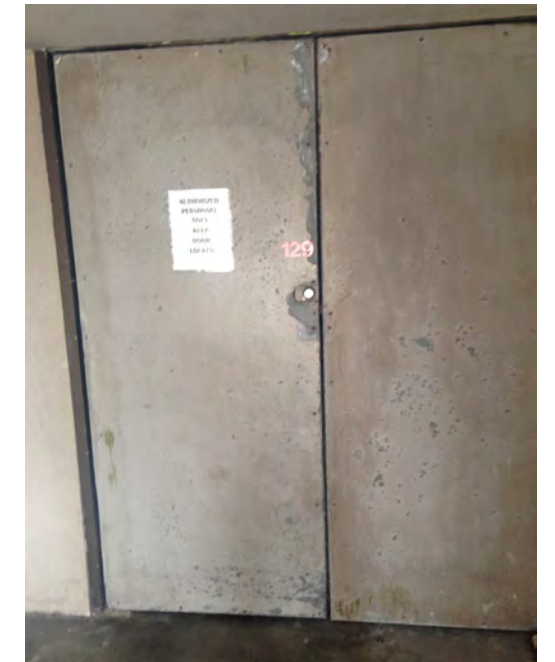
Exterior Stairs & Railings on the Flight Line side

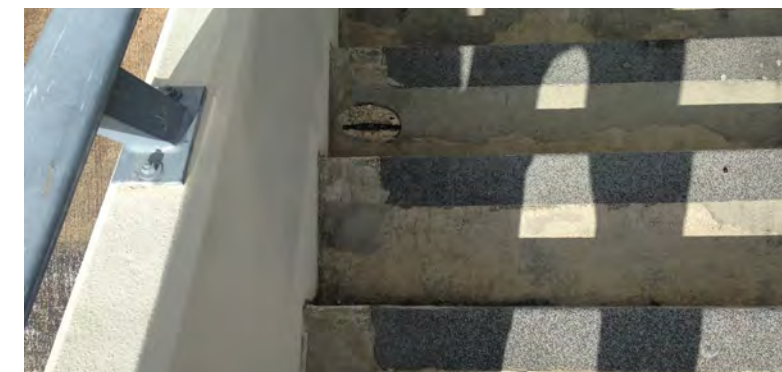
BRPH Project No. C07071.001.00

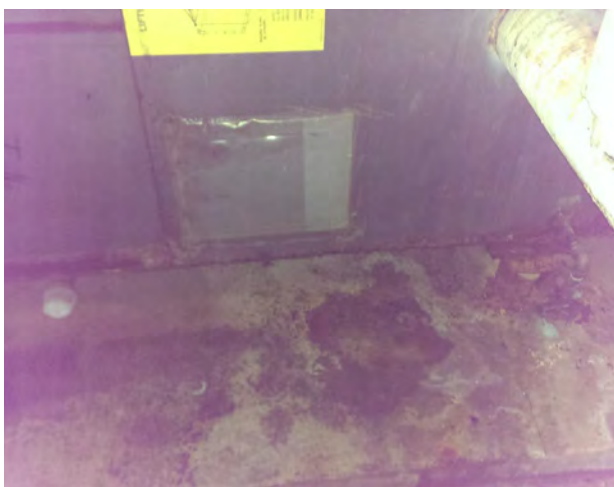
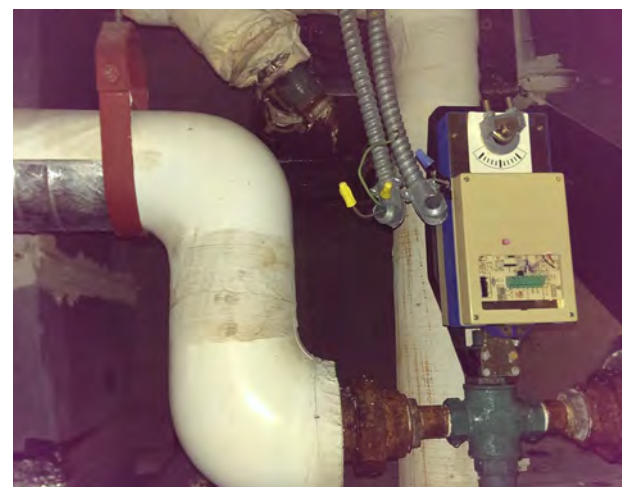
AHU-25 through AHU-30

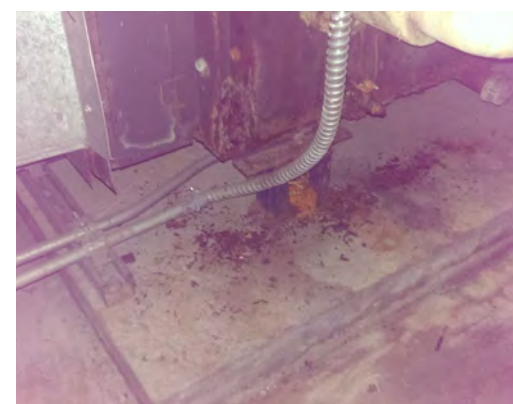
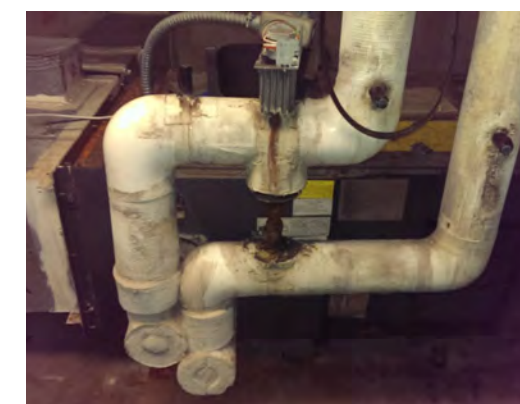
AHU-25 through AHU-30 appear to be in bad shape with large amounts oxidation on the cabinet producing holes leaking air to the mechanical room. The chilled water coils appear to be in bad shape with a lot of dirt and debris present. Where the insulation is compromised, the chilled water piping is sweating and piping is deteriorating. Outside Air (OA) is supplied to these units by Class 2 or 3 air since it is first used to ventilate the mezzanine level equipment room. This is a Code violation. OA and RA are filtered by 30% efficient filters. It is likely that the amount of OA supplied is insufficient to meet present Code requirements. Refer to pictures M-003 & -004 below.

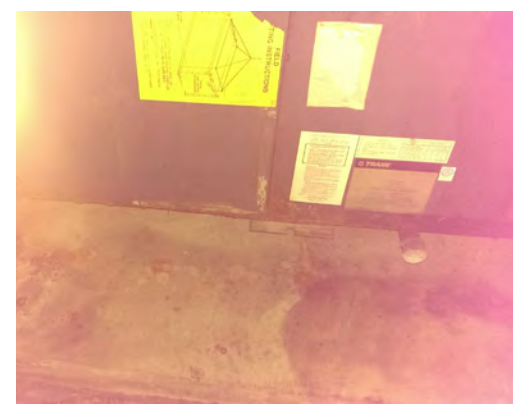
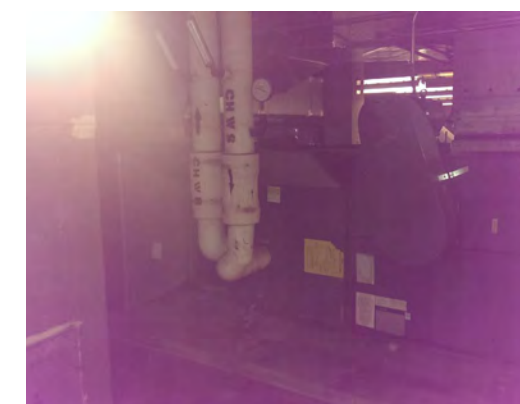
AHU-5 appears to be in poor condition with large amounts oxidation on the cabinet. The chilled water coils appear to be in bad shape with a lot of dirt and debris present. Where the insulation is compromised, the chilled water piping is sweating and piping is deteriorating. Outside Air (OA) is directly ducted to this unit by insulated ductwork. OA and RA are filtered by 30% efficient pre-filters and 85% efficient final filters. It is likely that the amount of OA supplied is insufficient to meet present Code requirements. Refer to pictures M-005 & -006 below.

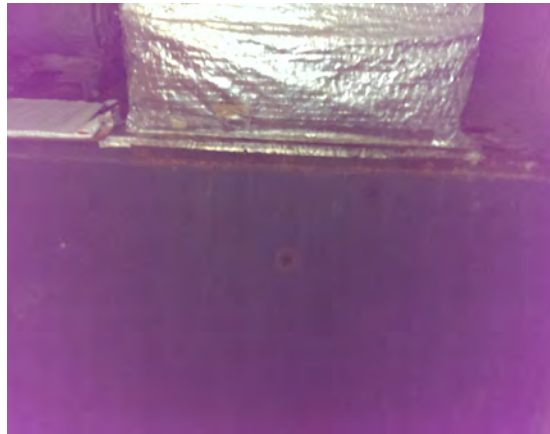
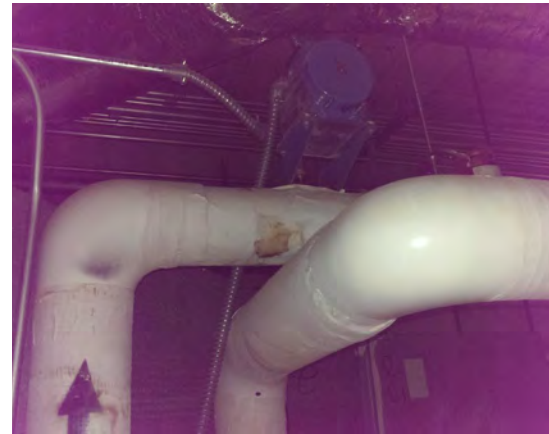
AHU-6 appears to be in poor condition with large amounts oxidation on the cabinet. The chilled water coils appear to be in bad shape with a lot of dirt and debris present. Where the insulation is compromised, the chilled water piping is sweating and piping is deteriorating. Outside Air (OA) is directly ducted to this unit by insulated ductwork. OA and RA are filtered by 30% efficient filters. It is likely that the amount of OA supplied is insufficient to meet present Code requirements. Refer to pictures M-007 & -008 below.

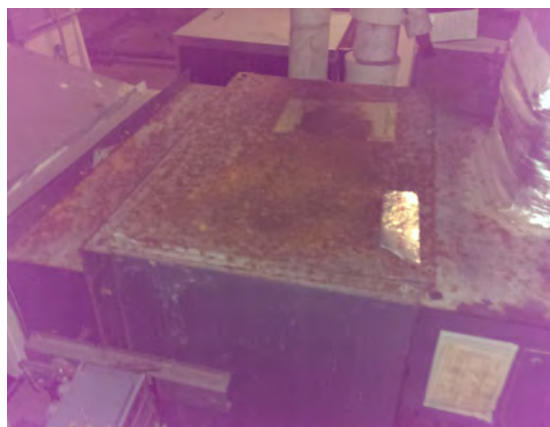
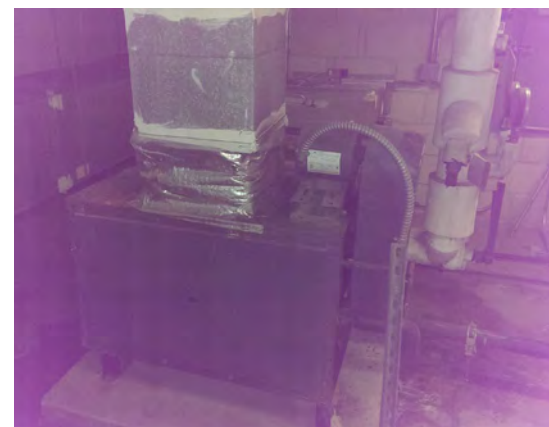
AHU-7 appears to be in poor condition with large amounts oxidation on the cabinet. The chilled water coils appear to be in poor condition with a lot of dirt and debris present. Where the insulation is compromised, the chilled water piping is sweating and piping is deteriorating. No Outside Air (OA) is provided to this unit. RA is filtered by 30% efficient filters. OA is not supplied as required to meet present Code requirements. Refer to pictures M-009 & -010 below.

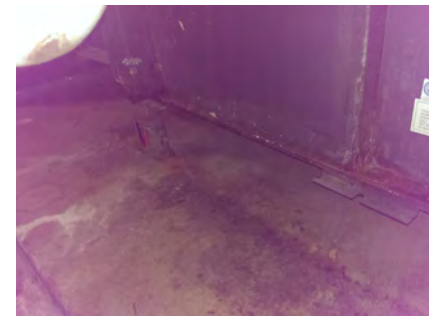
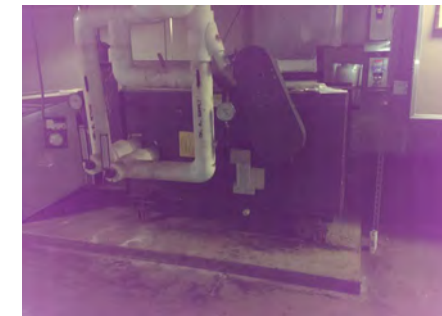
AHU-18 and AHU-19 appear to be in poor condition with large amounts oxidation on the cabinet. They are in a little better shape than most, but need to be replaced. The chilled water coils appear to be in bad shape with a lot of dirt and debris present. Where the insulation is compromised, the chilled water piping is sweating and piping is deteriorating. Outside Air (OA) is supplied to these units by insulated ductwork to roof intake hoods. OA and RA are filtered by 30% efficient pre-filters and 85% efficient final filters. It is likely that the amount of OA supplied is insufficient to meet present Code requirements. Refer to pictures M-011 & -012 below.

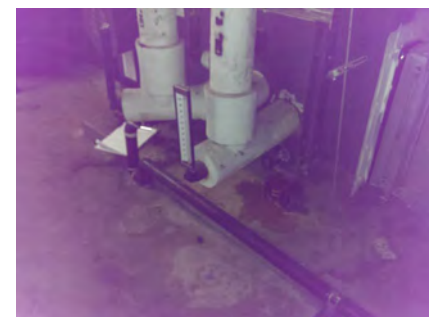
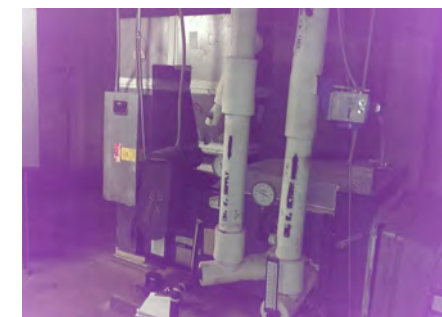
3. Baggage Claim / Rental Area:

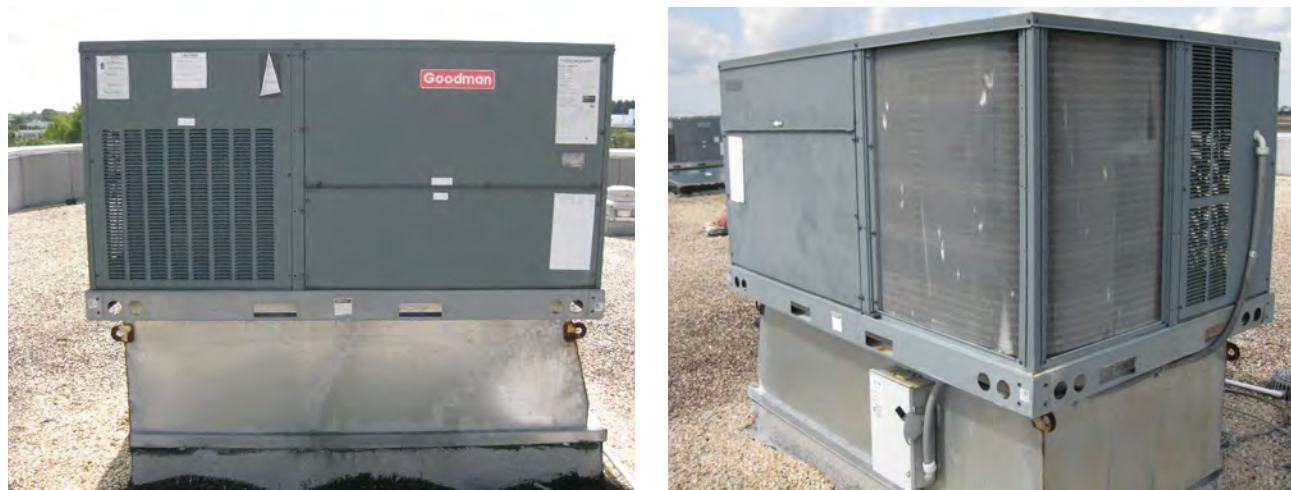
ACU-2
ACU-2 is a 7-1/2 ton unit above the MAA Offices. It appears to be in poor condition at about the end of its service life. Refer to pictures M-017 & -018 below.

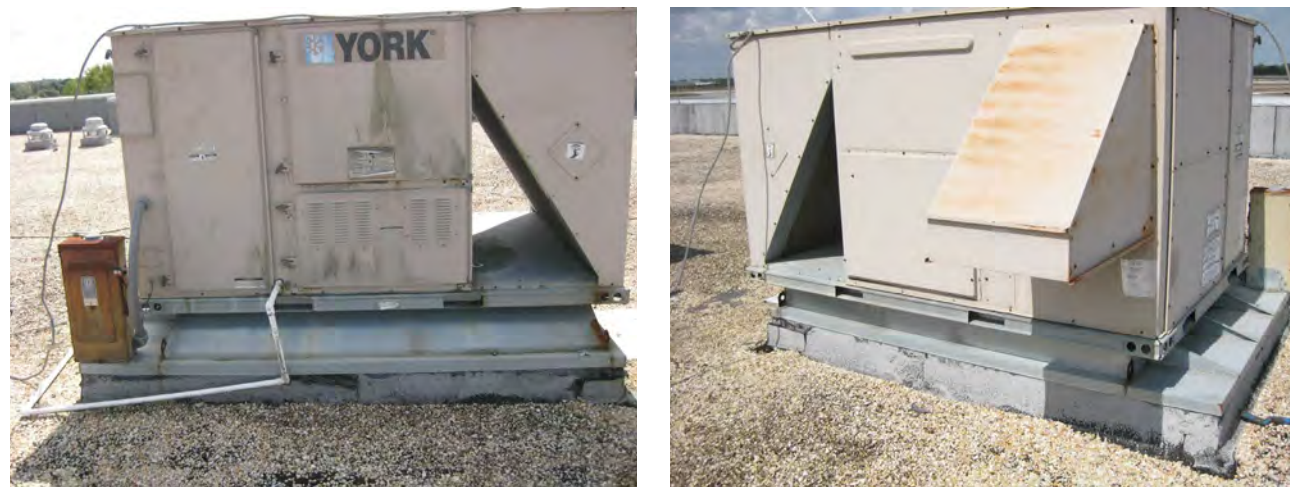
ACU-3
ACU-3 is a 4 ton unit above the MAA Offices. Records show it is about 4 years old and it appears to be in average condition at about midlife of its 10 year service life. Refer to pictures M-019 & -020 below.

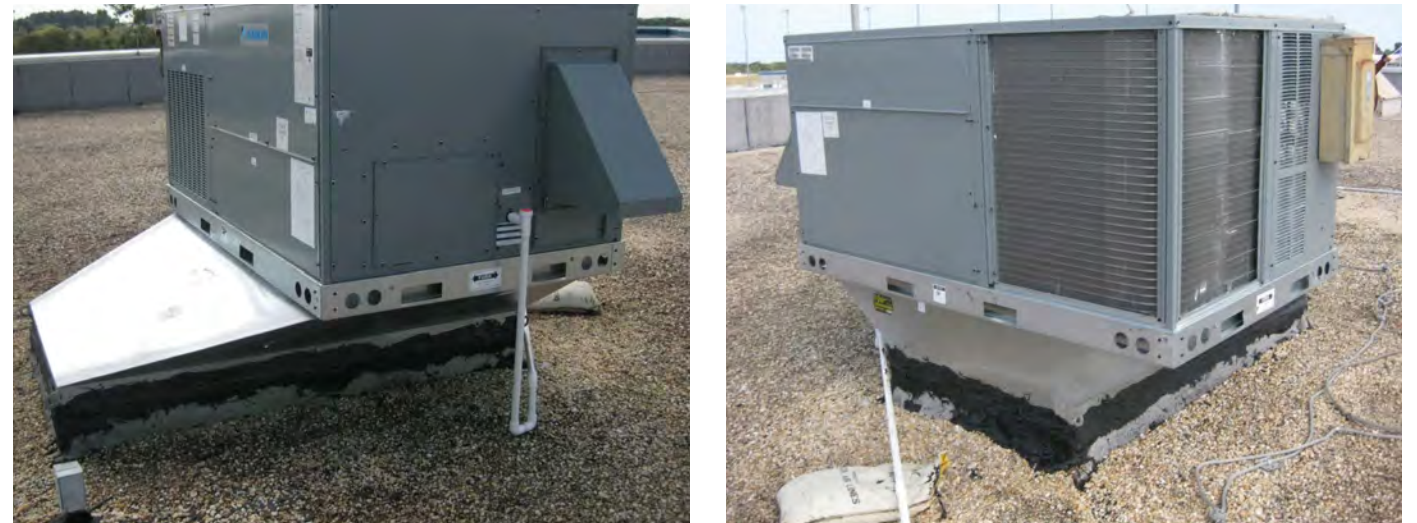
ACU-4
ACU-4 is a 7-1/2 ton unit above the MAA Offices. It appears to be in good condition at the beginning of its 10 year service life. Refer to pictures M-021 & -022 below.

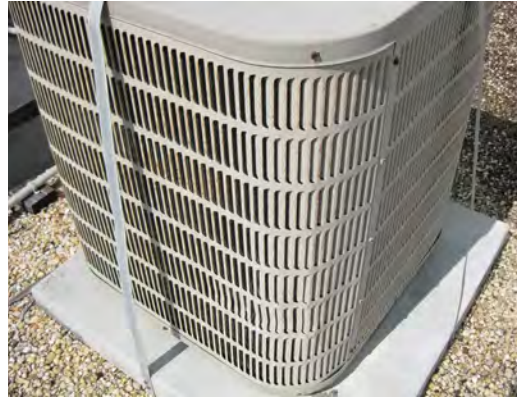
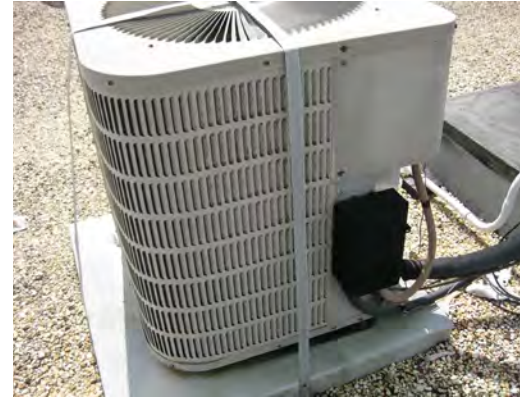
CU-5 is a 3 ton split system condensing unit above the MAA Offices. It appears to be in poor condition at about the end of its service life. Refer to pictures M-023 & -024 below.

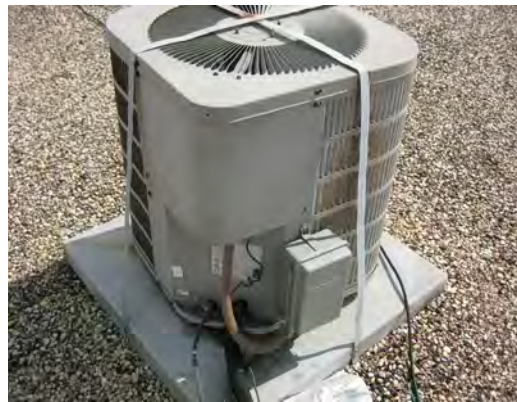
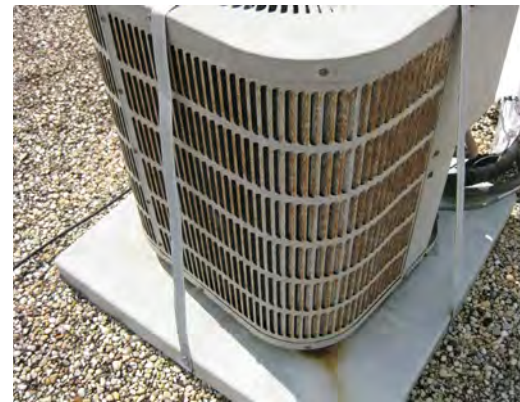
CU-6 is a 1-1/2 ton split system condensing unit above the MAA Offices. It appears to be in poor condition at about the end of its service life. Refer to pictures M-025 & -026 below.

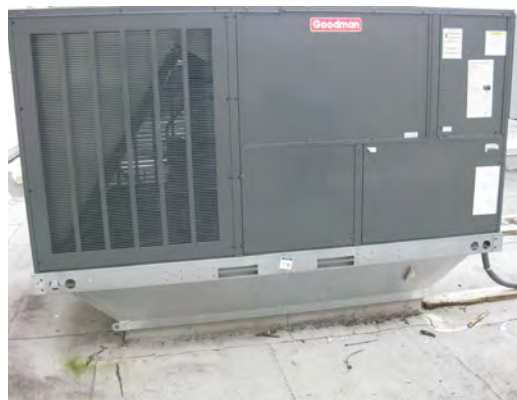
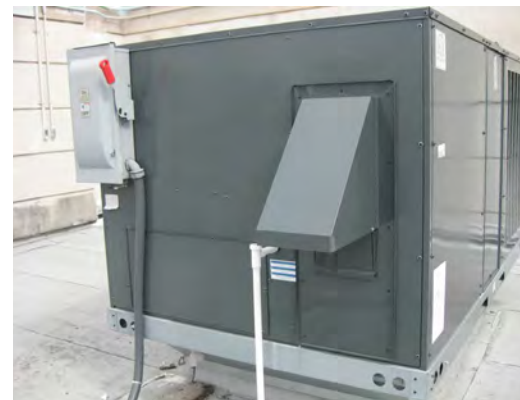
ACU-7 is a 10 ton unit above Rental Cars. It appears to be in good condition at the beginning of its 10 year service life. Refer to pictures M-027 & -028 below.

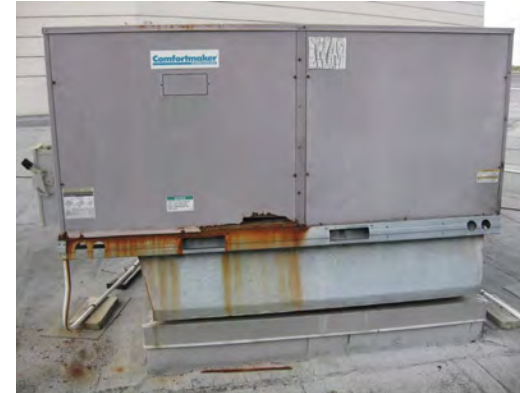
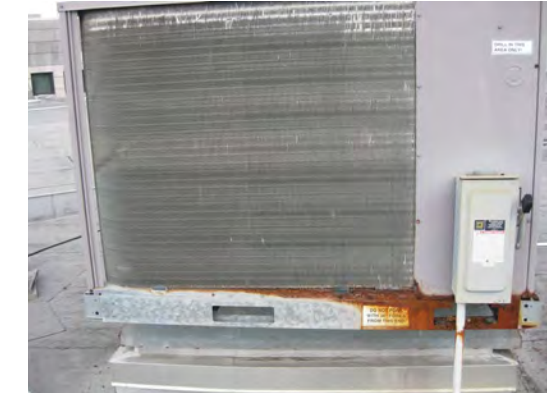
ACU-8 is a 7-1/2 ton unit above Rental Cars. It was installed in 2004 and appears to be in bad condition at the end of its service life. Code required Outside Air does not appear to be provided (no OA intake hood observed). Refer to pictures M-029 & -030 below.

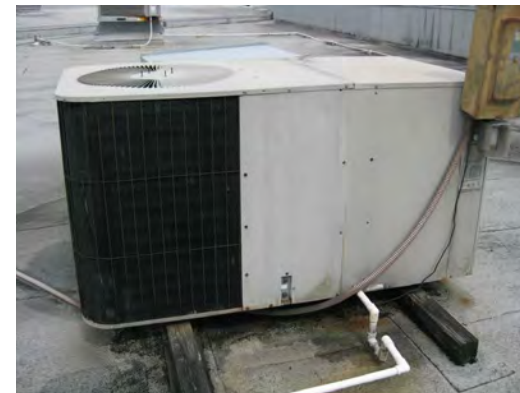
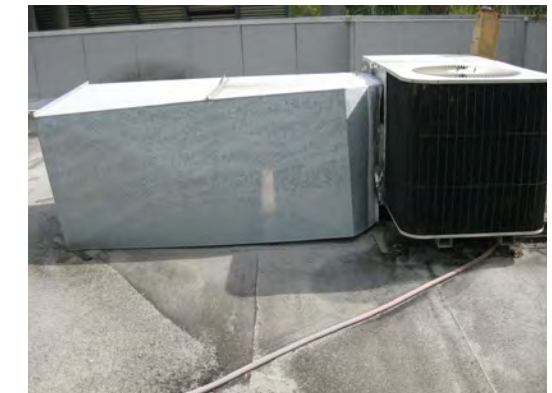
ACU-9 is a 5 ton unit above Rental Cars / Shuttles. It appears to be in poor condition at the end of its service life. Code required Outside Air does not appear to be provided (no OA intake hood observed). Refer to pictures M-031 & -032 below.

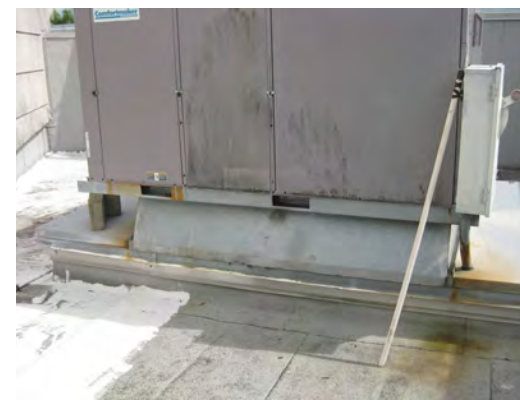
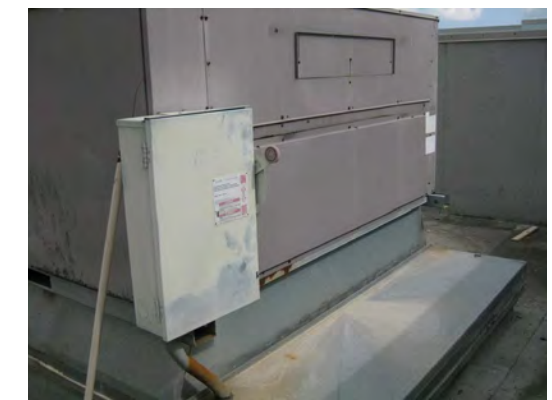
ACU-10 is a 20 ton unit outside MAA Offices. It was installed in 2004 and appears to be in poor condition at the end of its service life. Code required Outside Air does not appear to be provided (no OA intake hood observed). Refer to pictures M-033 & -034 below.

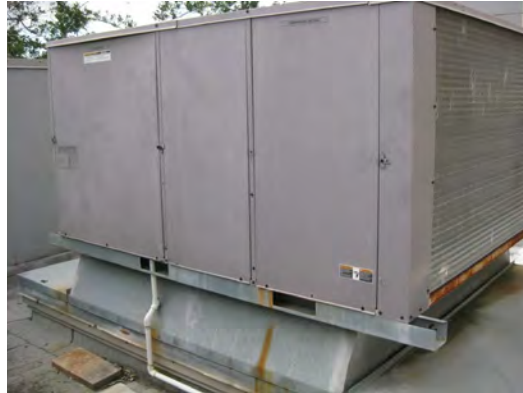
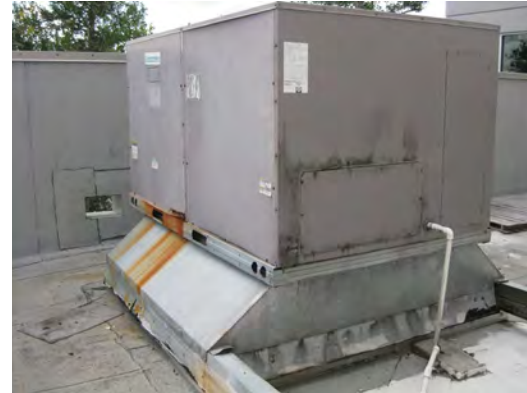
ACU-11 is a 12-1/2 ton unit outside MAA Offices. It was installed in 2004 and appears to be in poor condition at the end of its service life. Code required Outside Air does not appear to be provided (no OA intake hood observed). Refer to pictures M-035 & -036 below.

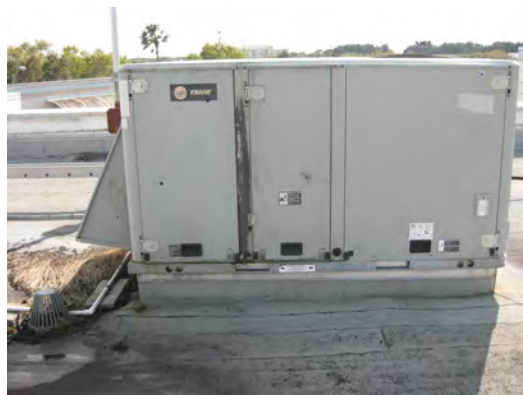
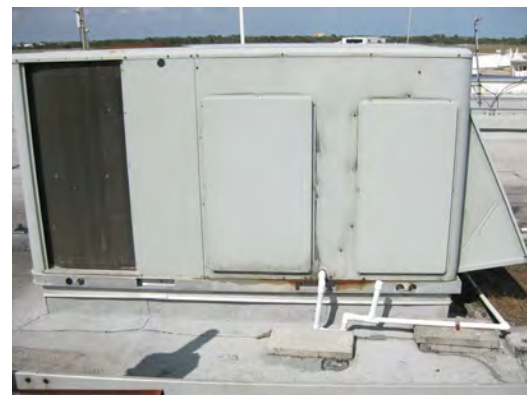
ACU-12 is a 7-1/2 ton unit above the TSA / Polices Offices. It appears to be in poor condition at about the end of its service life. Refer to pictures M-037 & -038 below.

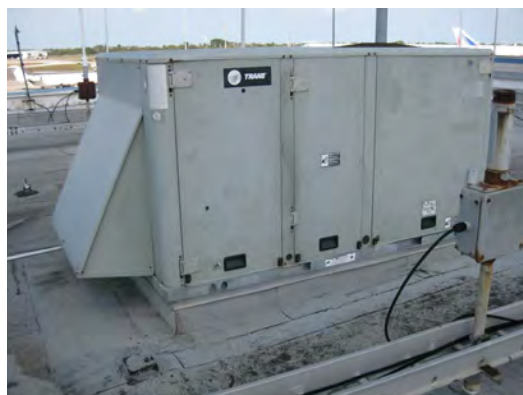
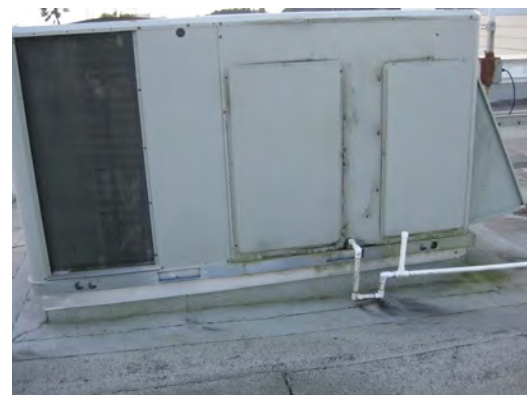
ACU-13 is a 7-1/2 ton unit above the TSA / Polices Offices. It appears to be in poor condition at about the end of its service life. Refer to pictures M-039 & -040 below.

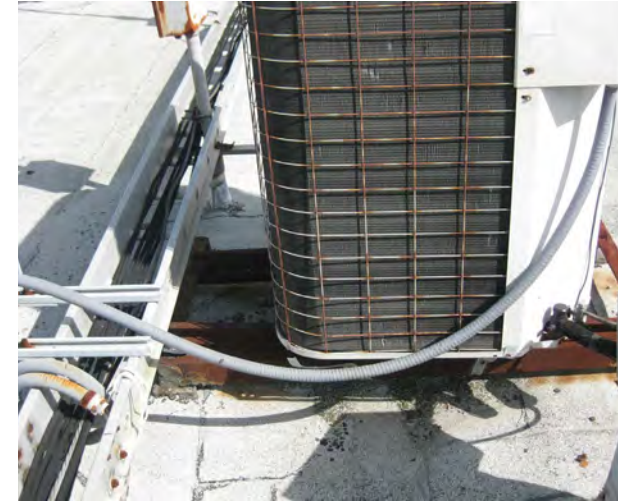
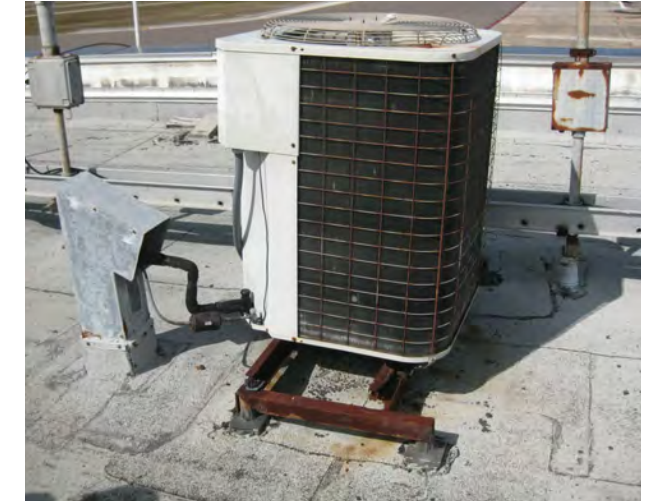
CU-14 is a 5 ton split system condensing unit above the TSA / Polices Offices. It appears to be in poor condition at about the end of its service life. Refer to pictures M-041 & -042 below.

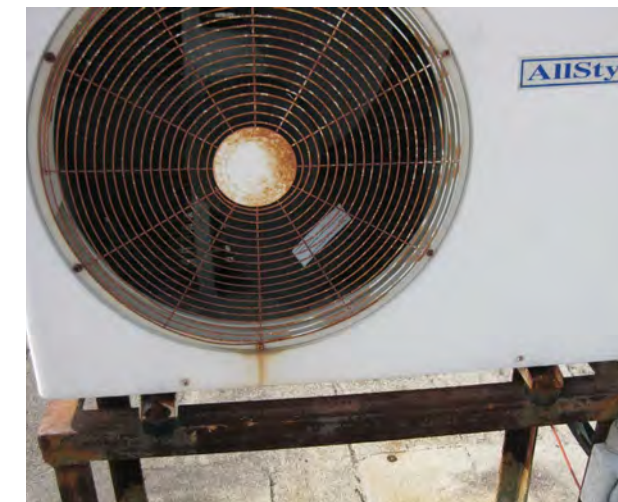
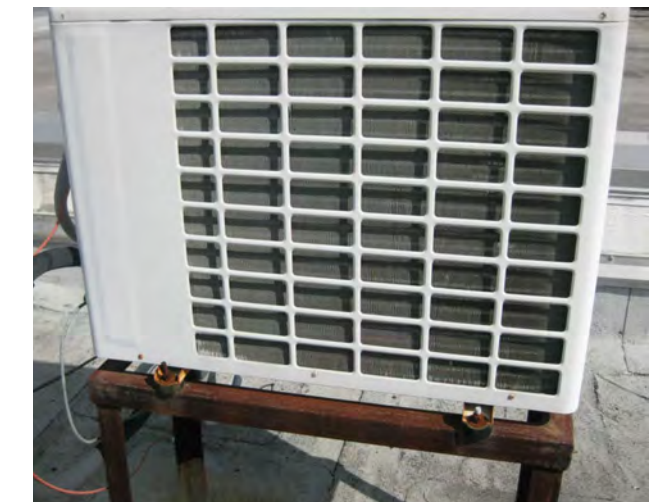
4. Concourse (Terminal) Area:

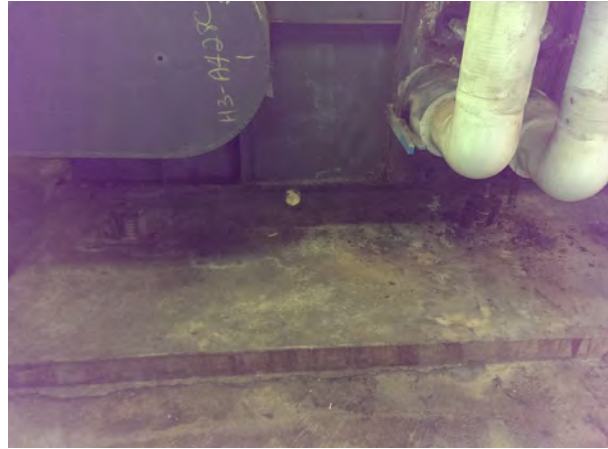
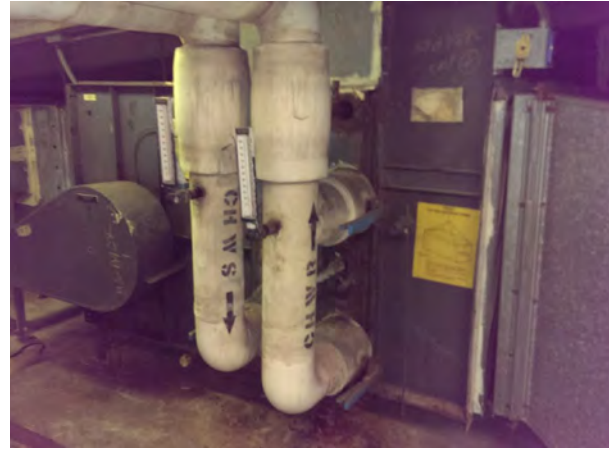
AHU-8 appears to be in poor condition with large amounts oxidation on the cabinet producing holes leaking air to the mechanical rom. The chilled water coils appear to be in poor condition with a lot of dirt and debris present. Where the insulation is compromised, the chilled water piping is sweating and piping is deteriorating. Outside Air (OA) is supplied to these units by insulated ductwork to an intake louver. OA and RA are filtered by 30% efficient pre-filters and 85% efficient final filters. It is likely that the amount of OA supplied is insufficient to meet present Code requirements. Refer to pictures M-045 & -046 below.

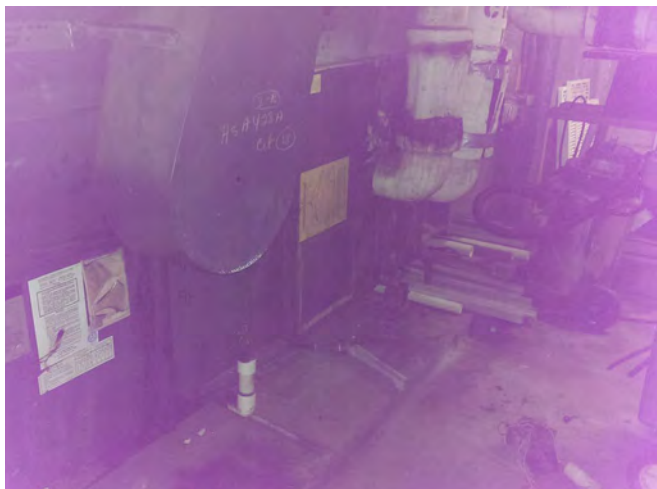
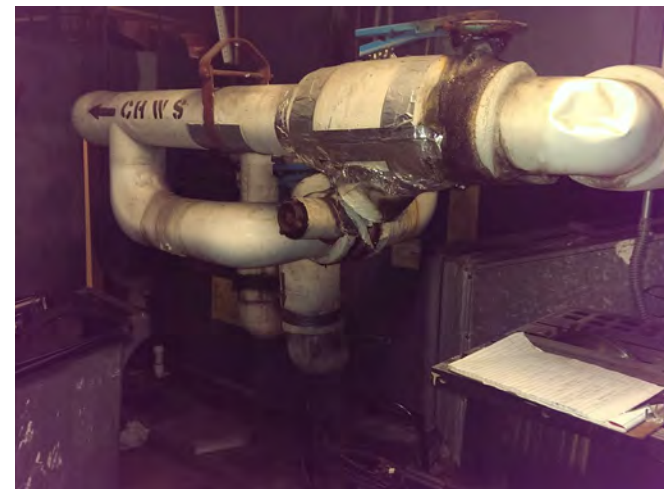
AHU-9 appears to be in poor condition with large amounts oxidation on the cabinet producing holes leaking air to the mechanical rom. The chilled water coils appear to be in bad shape with a lot of dirt and debris present. Where the insulation is compromised, the chilled water piping is sweating and piping is deteriorating. Outside Air (OA) is supplied to these units by insulated ductwork to an intake louver. OA and RA are filtered by 30% efficient pre-filters and 85% efficient final filters. It is likely that the amount of OA supplied is insufficient to meet present Code requirements. Refer to pictures M-047 & -048 below.

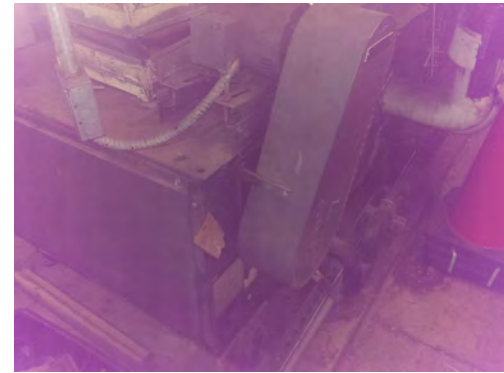
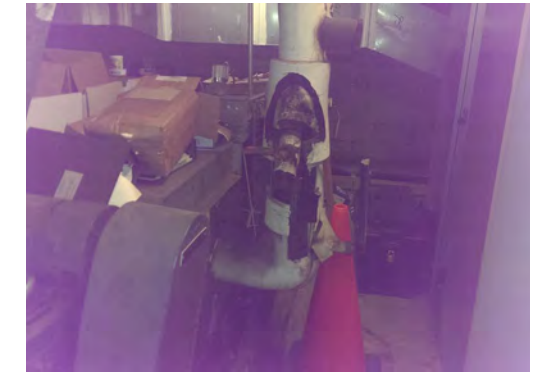
AHU-23 appears to be in bad shape with large amounts oxidation on the cabinet producing holes leaking air to the mechanical rom. The chilled water coils appear to be in poor condition with a lot of dirt and debris present. Where the insulation is compromised, the chilled water piping is sweating and piping is deteriorating. Outside Air (OA) is supplied to these units by insulated ductwork to an intake louver. OA and RA are filtered by 30% efficient pre-filters and 85% efficient final filters. It is likely that the amount of OA supplied is insufficient to meet present Code requirements. Refer to pictures M-049 & -050 below.

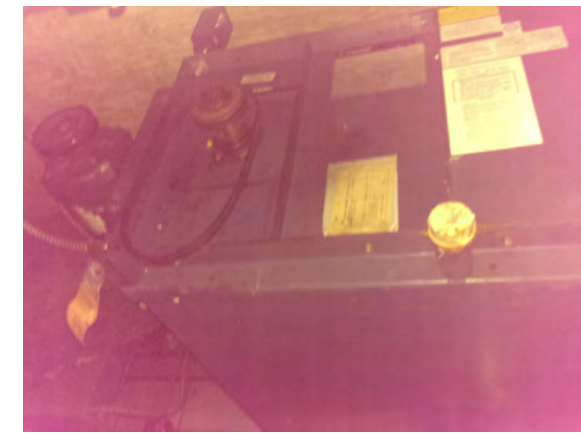
Terminal Area – AHU-10 through 17

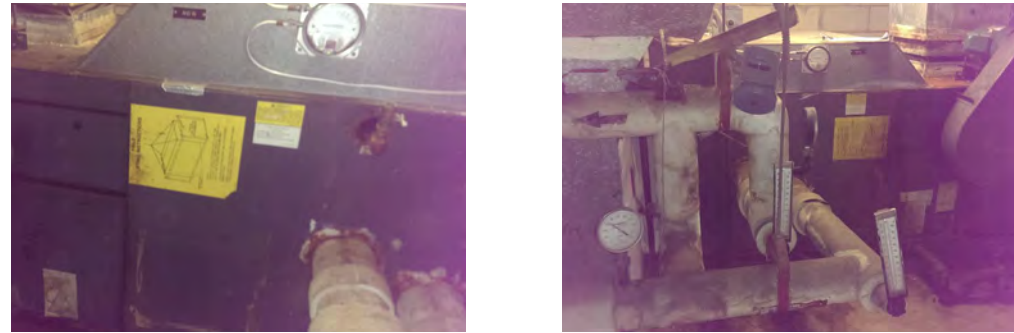
Central Energy Plant (CEP)

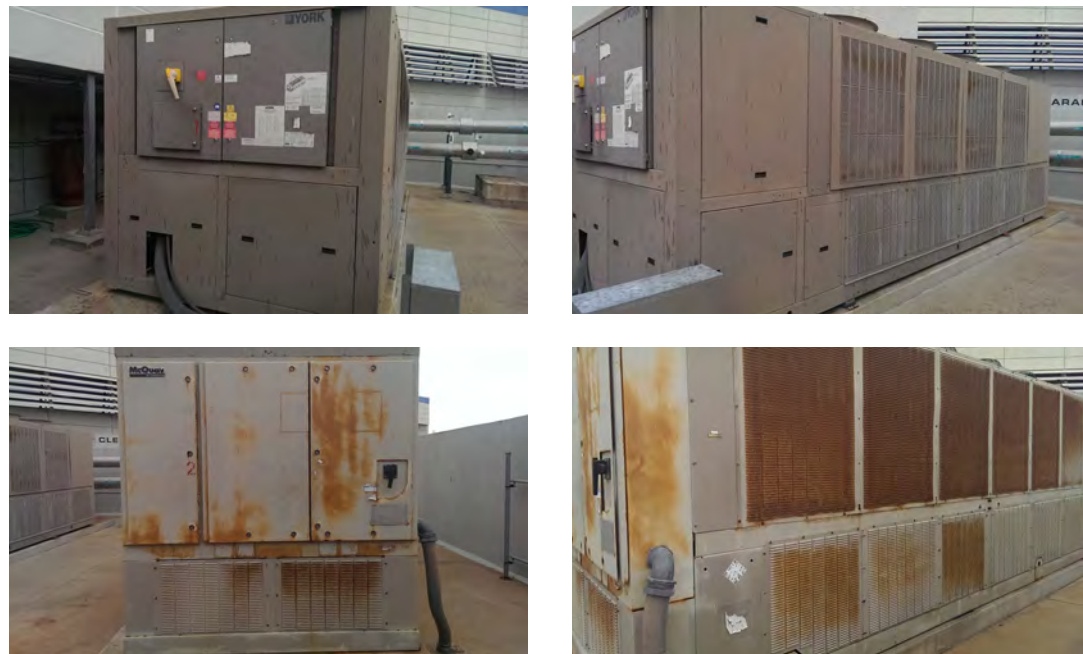
The chilled water pumps each serve a chiller. Chilled water pump one serves the McQuay chiller, chilled water pump two serves the York chiller. There is no redundant pump should one of the first two pumps fail. Chilled water pumps Bases are rusting. The housing for the impeller and insulation are in fair condition. Chilled water pump one appears to be original equipment that should be replaced. Chilled water pump two's motor has been replaced fairly recently, but its base is in poor condition and should be replaced. Base mounted pumps have an expected service life of 20 years, but these are exposed to weather and should be replaced. The pumps' valves and specialties are in poor condition also. Refer to pictures M-058 thru -061 below.

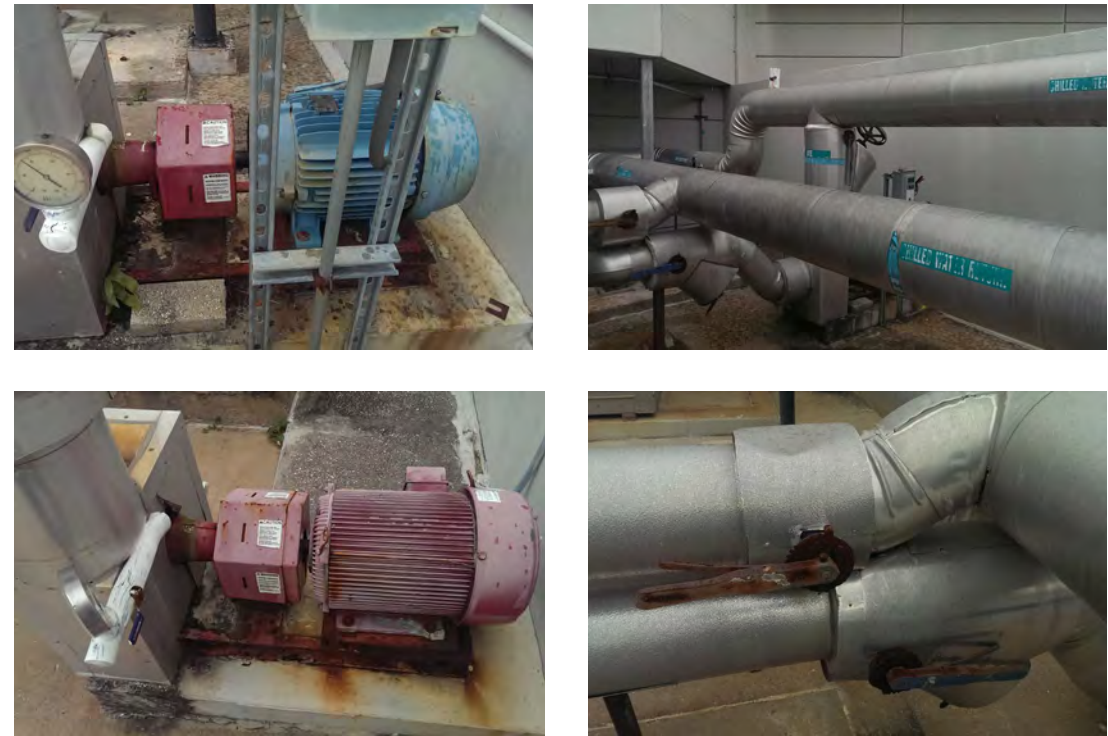
All of the equipment within the CEP including the chilled water piping, chemical treatment pot, expansion tank, and air separator are in poor condition and should be replaced. The pumps should be replaced in kind but the new pumps should be installed with Variable Frequency Drives (VFD) so that they can be modulated based on the load of the campus and would then be compliant with the current design standards. The pumps and CEP piping should be configured to run in a variable primary arrangement. Refer to pictures M-062 & -063 below.

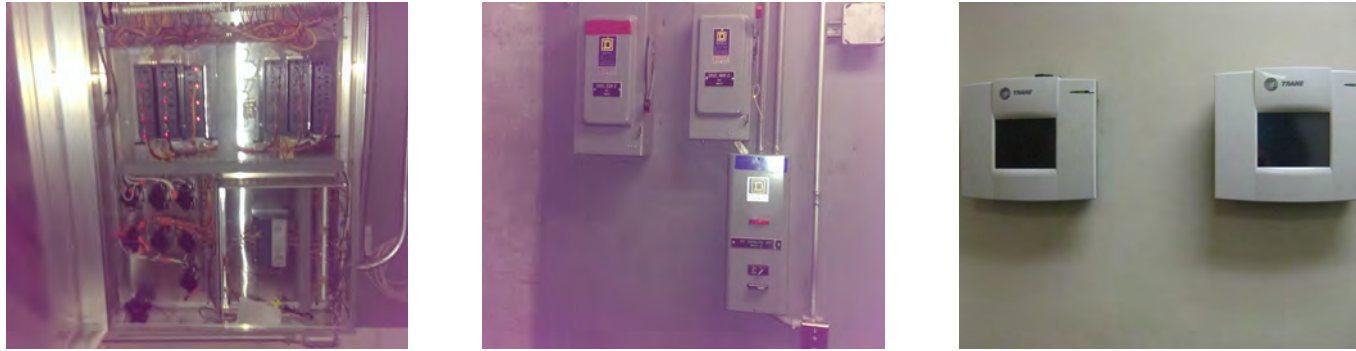
All new controls, equipment interlocks, and existing chilled water devices should be replaced to provide a completely new and fully integrated system. Replacing pieces of an existing system is likely to create problems with integration and control of the new equipment. We also recommend complete replacement to allow all vendors to bid the new controls work to create a competitive bidding environment.

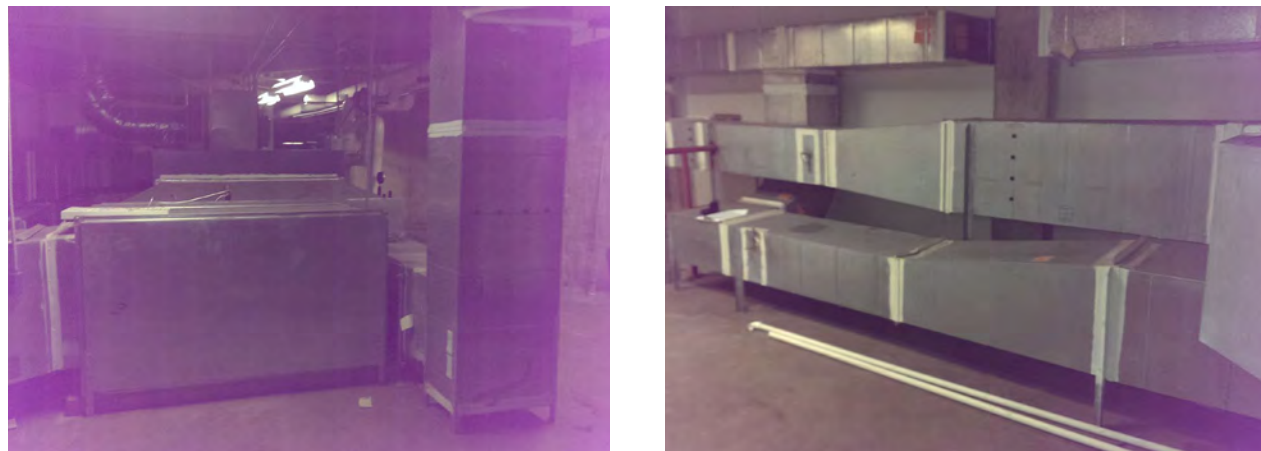
The Baggage Claim / Rental Areas have newer ductwork, but its condition was not observed; however, this ductwork is also approaching the end of its expected service life and should be replaced.

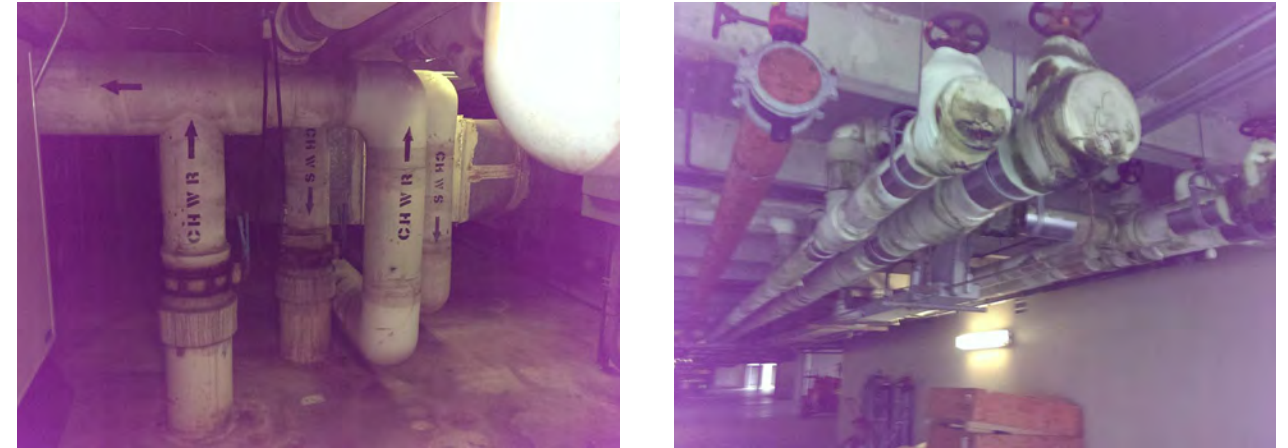
Chilled Water Piping has 30 year expected service life. It is recommended that the chilled water piping be replaced. As a minimum, replace smaller piping (3" and smaller) that is more susceptible to blockage and perform test on samples of the larger pipe sizes to determine their condition before replacing the larger piping sizes. Refer to pictures M-069 & M-070 below.
