MELBOURNE AIRPORT AUTHORITY BOARD MEETING
AGENDA

May 27, 2020 at 8:30 AM
Orlando Melbourne International Airport Terminal

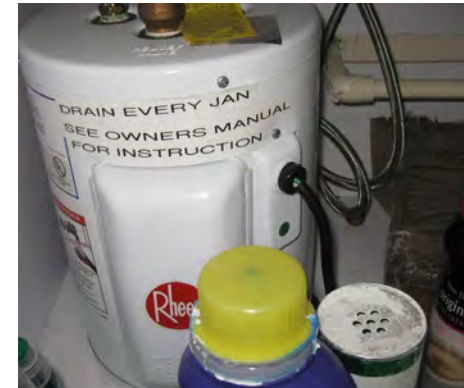
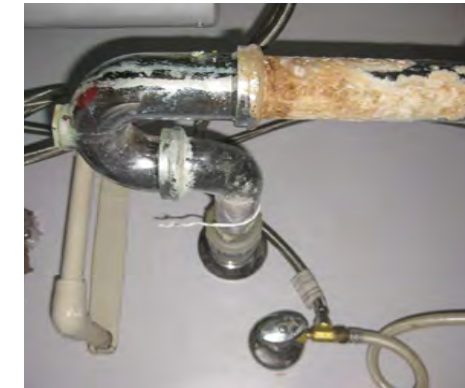
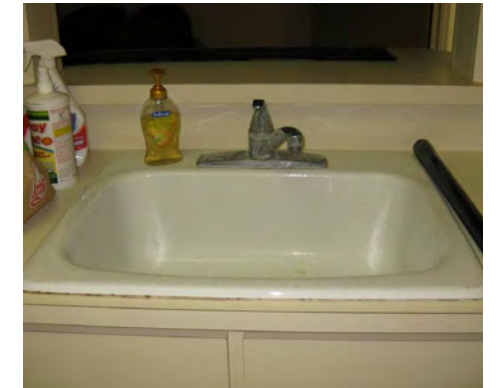
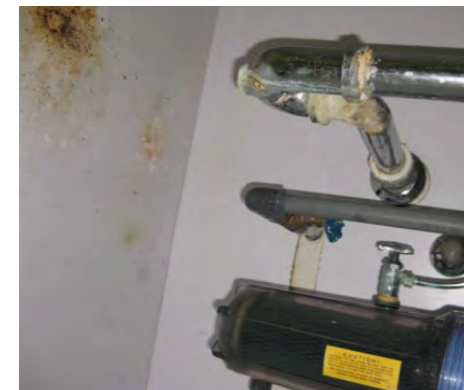
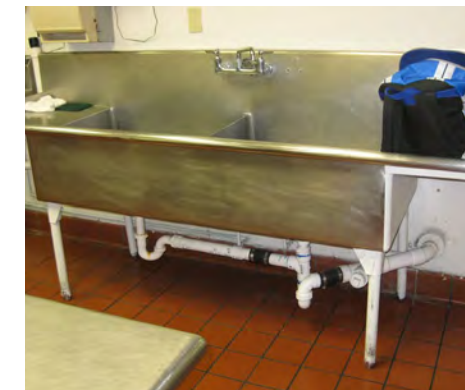
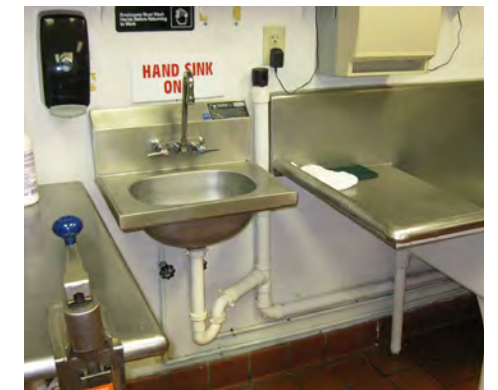
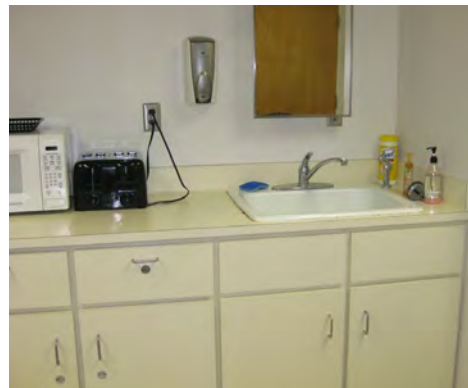
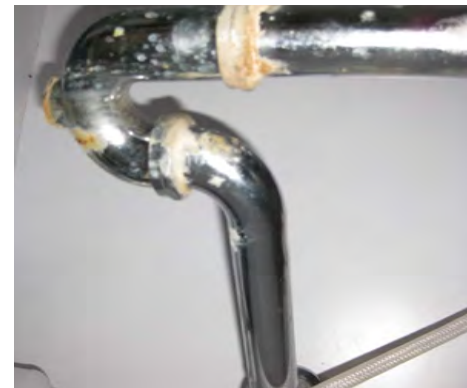
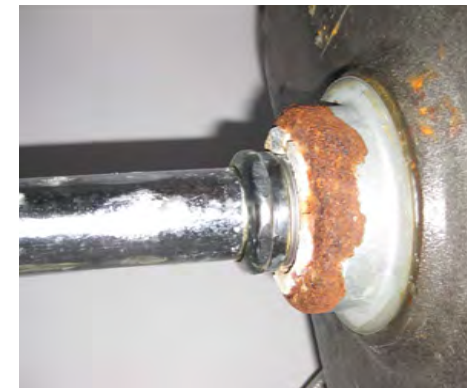
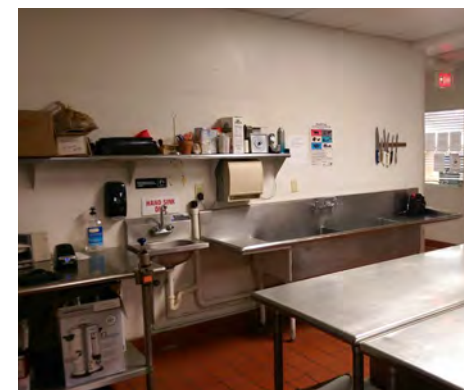
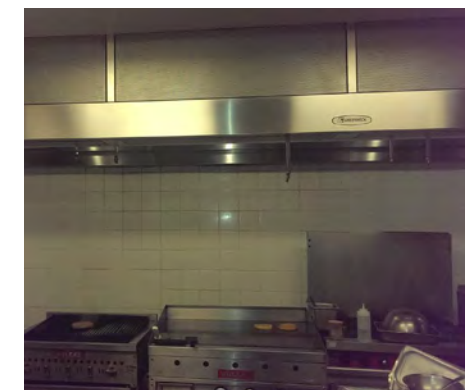
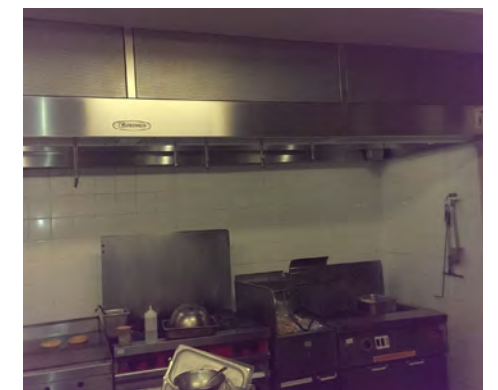
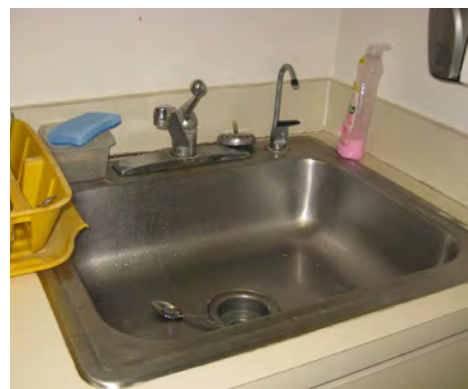
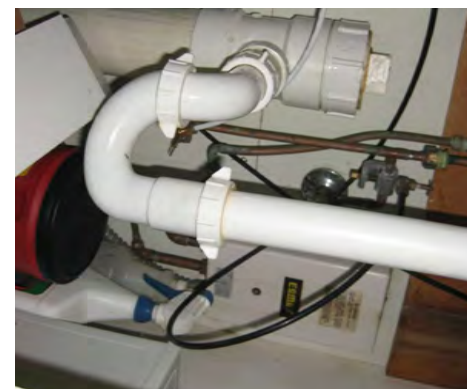
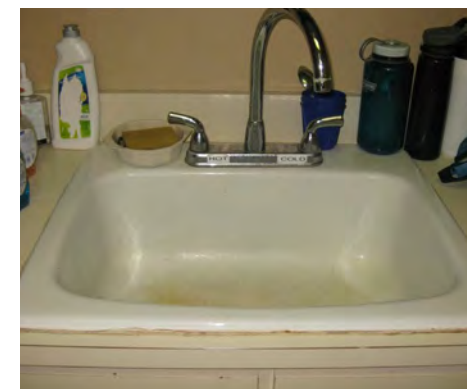
Domestic cold water system serving the Ticketing Area includes cold water being supplied to break room sinks, kitchen and bar equipment, restroom fixtures and outside wall hydrants. The piping dates back to the original 1988 construction and should be approaching the end of its expected service life. Break room sinks appear to be in fair condition. Kitchen, restaurant and bar equipment appear to be in fair condition. Restroom fixtures were replaced in 2000 and appear to be in fair condition, but significant water conservation improvements have been achieved since then. Replacement of these fixtures should be considered.

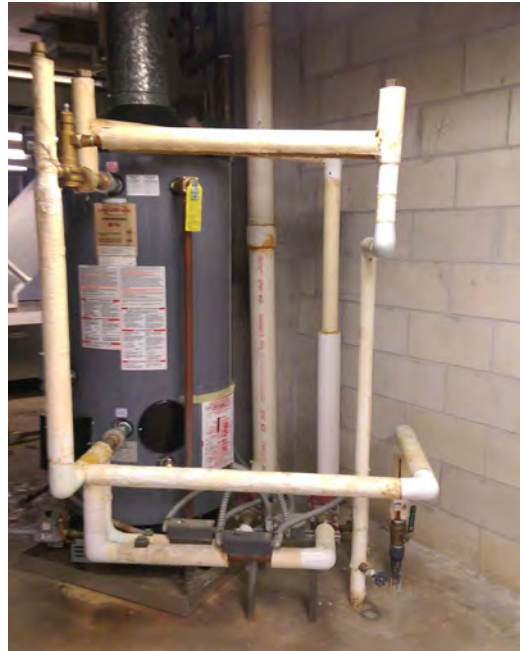
Urinals & Water Closets

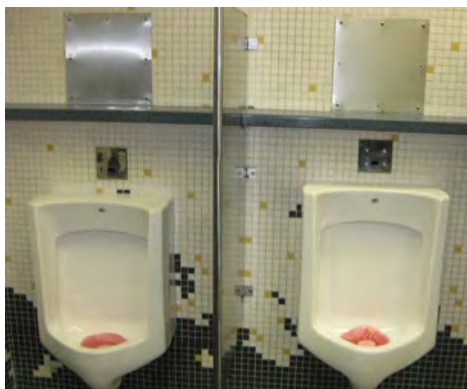
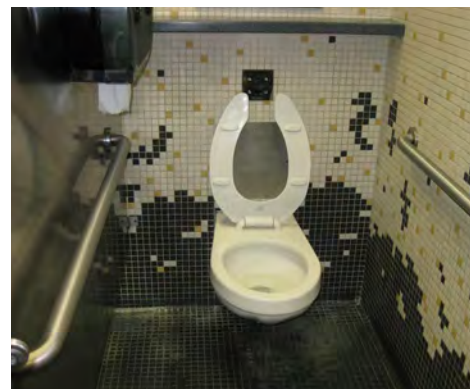
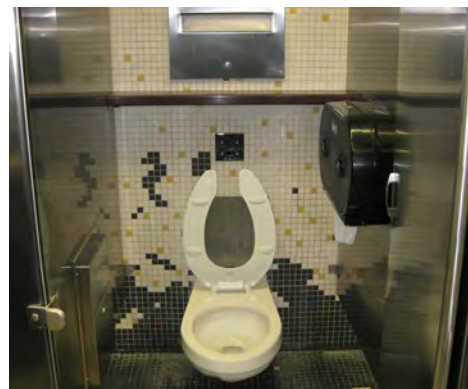
Urinals and Water Closets were replaced in 2000 and appear to be in fair condition, but significant water conservation improvements have been achieved since then. Replacement of these fixtures should be considered.

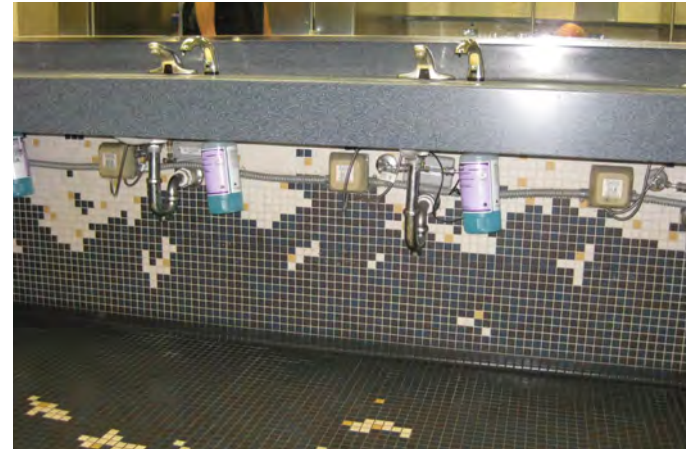
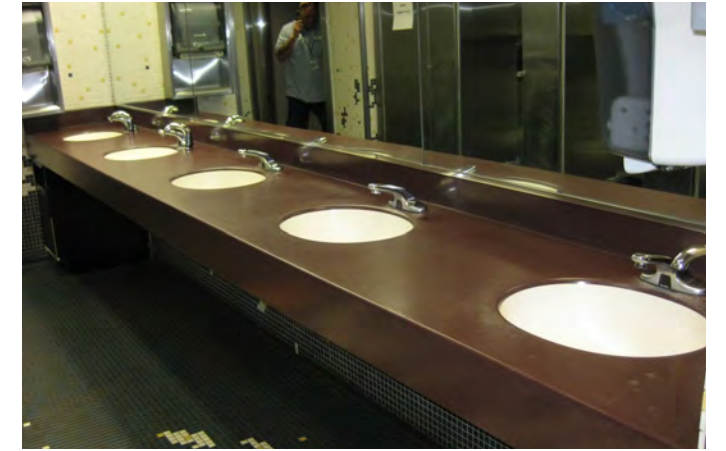
Lavatories and Sinks were replaced in 2000 and appear to be in fair condition, but significant water conservation improvements have been achieved since then. Replacement of these fixtures should be considered.

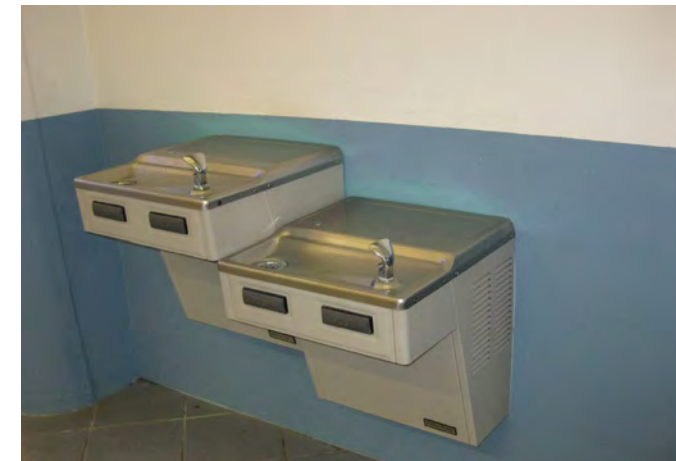
EWC's were replaced in 2000 and are approaching the end of their expected service life and should be replaced.

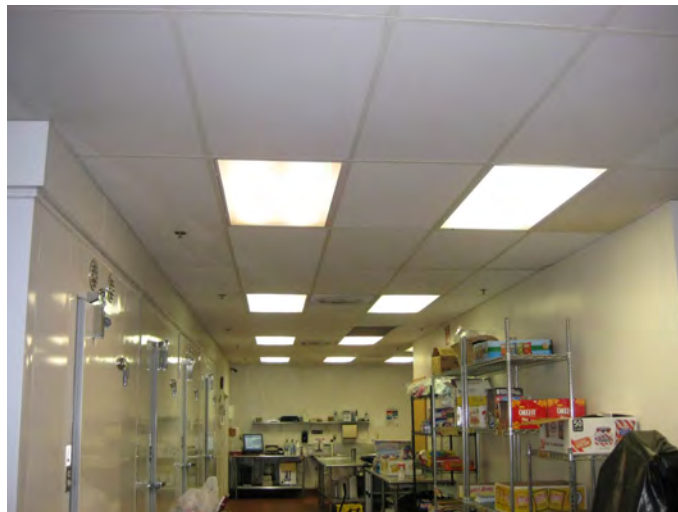
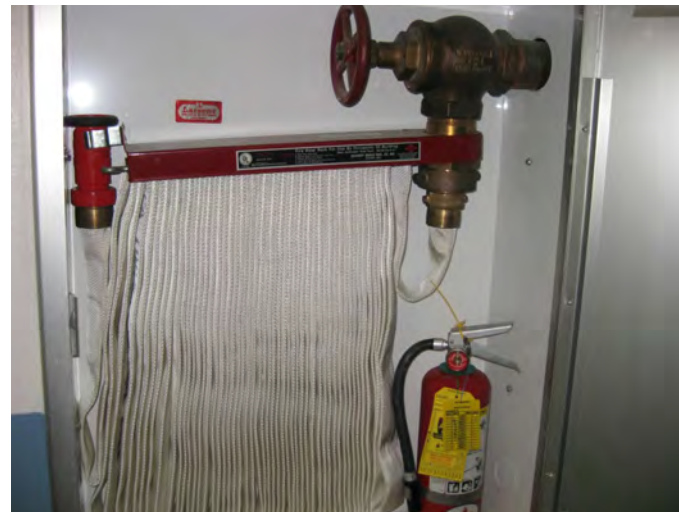
Dry Chemical Suppression

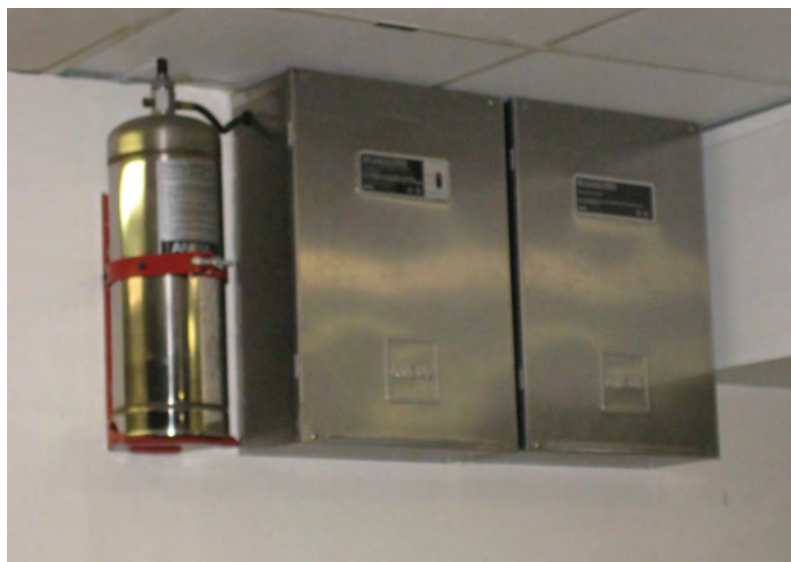
The existing kitchen exhaust hood has its own dry chemical fire suppression system that appears to be in fair condition.

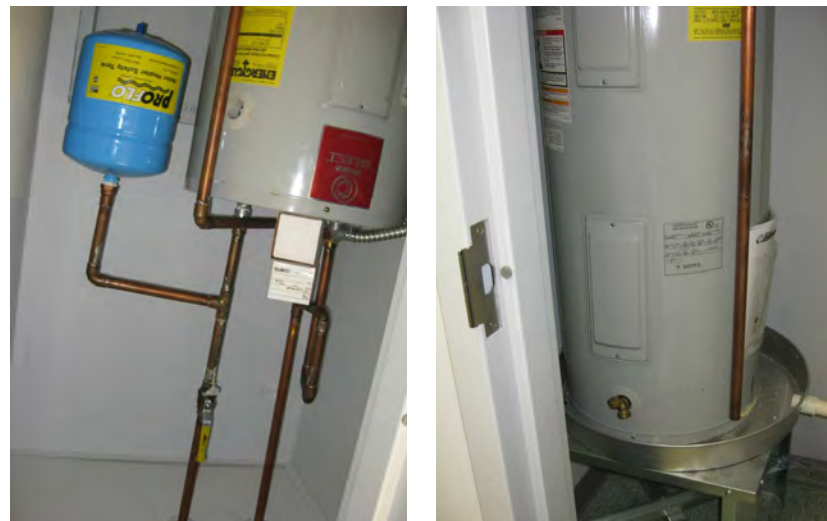
Urinals & Water Closets

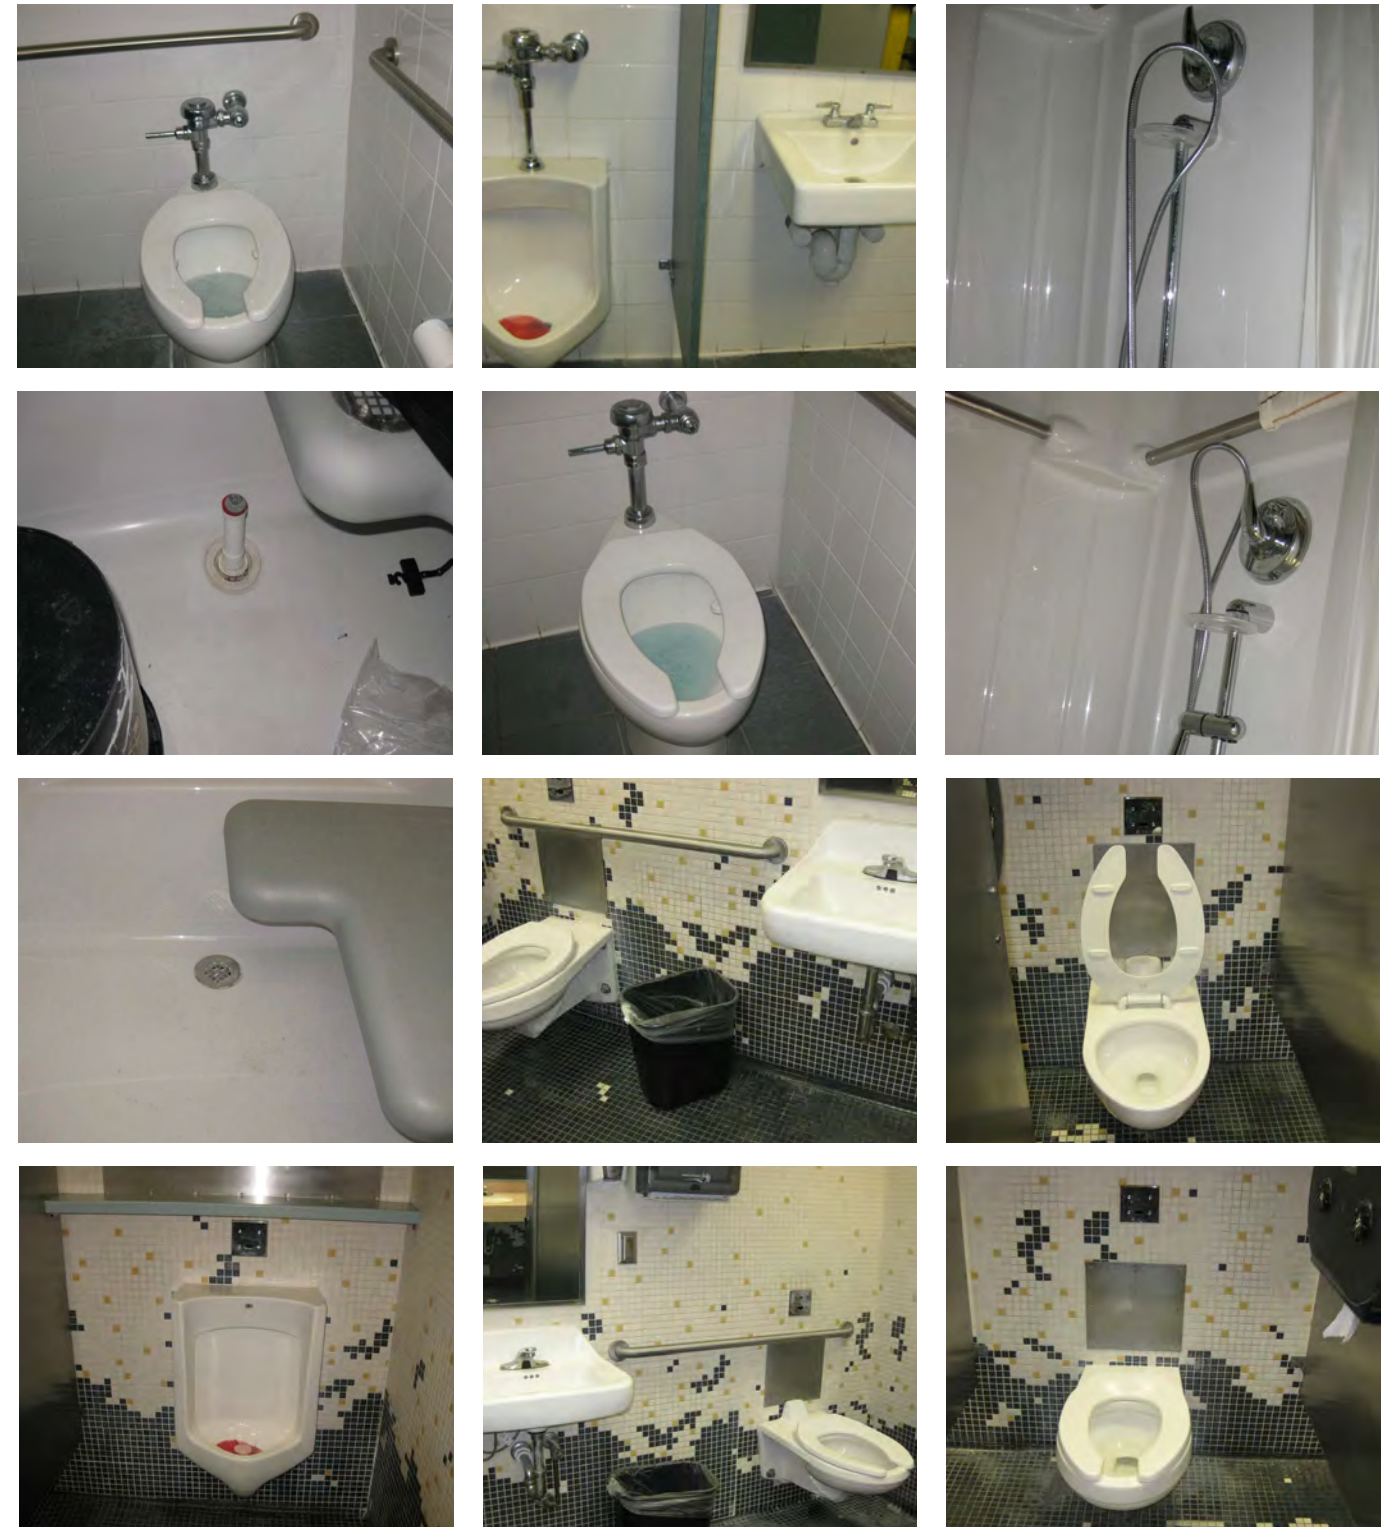
Urinals and Water Closets were replaced in 2000 and appear to be in fair condition, but significant water conservation improvements have been achieved since then. Replacement of these fixtures should be considered.

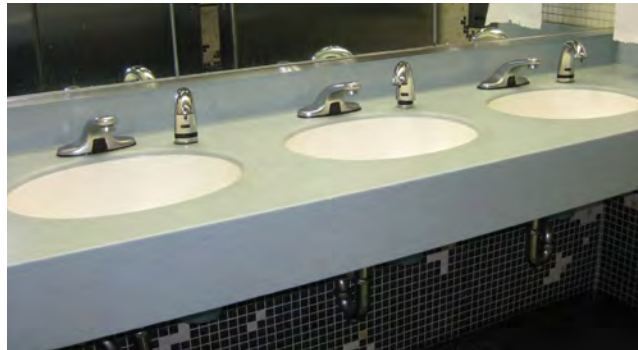
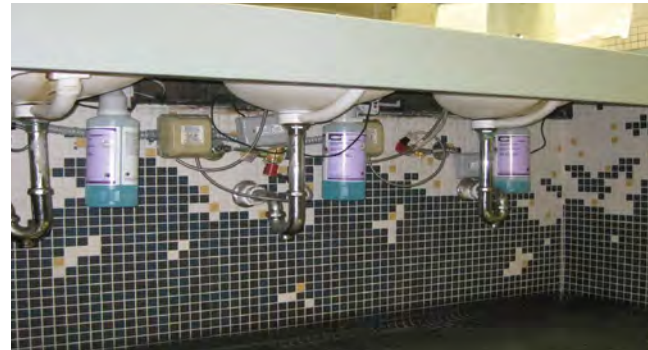
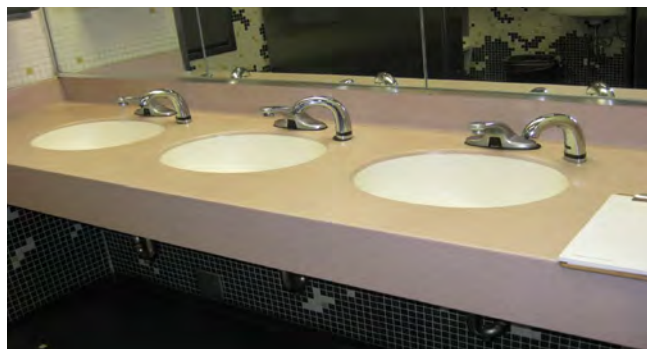
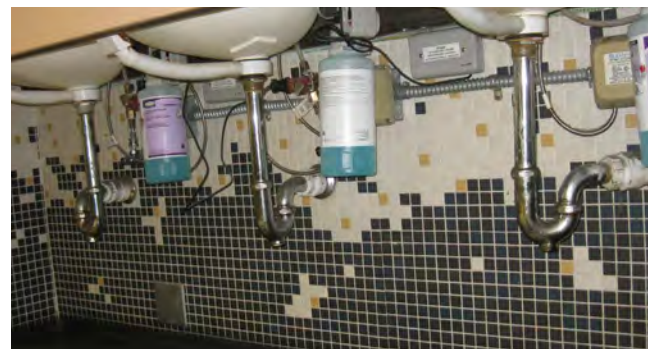
Lavatories and Sinks were replaced in 2000 and appear to be in fair condition, but significant water conservation improvements have been achieved since then. Replacement of these fixtures should be considered.

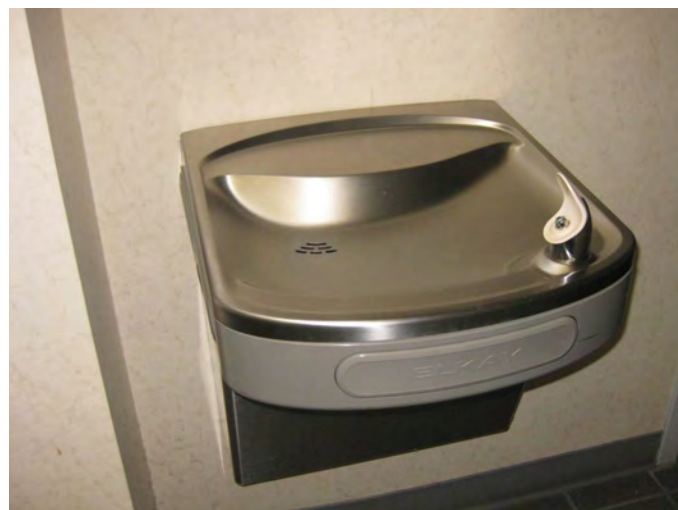
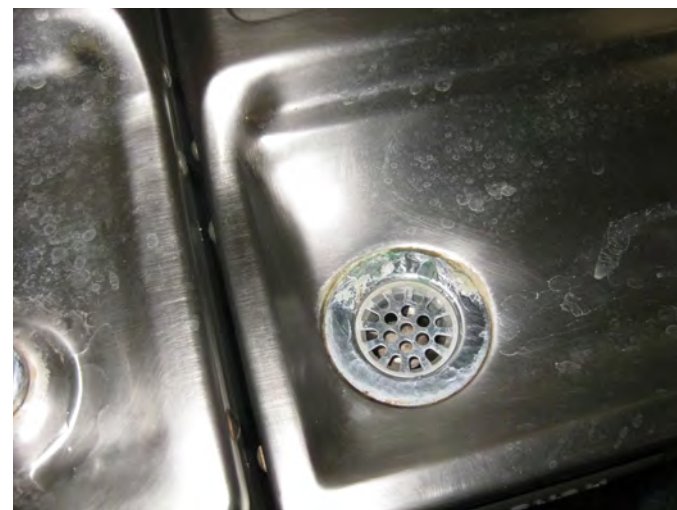
EWC's were replaced in 2000 and are approaching the end of their expected service life and should be replaced.

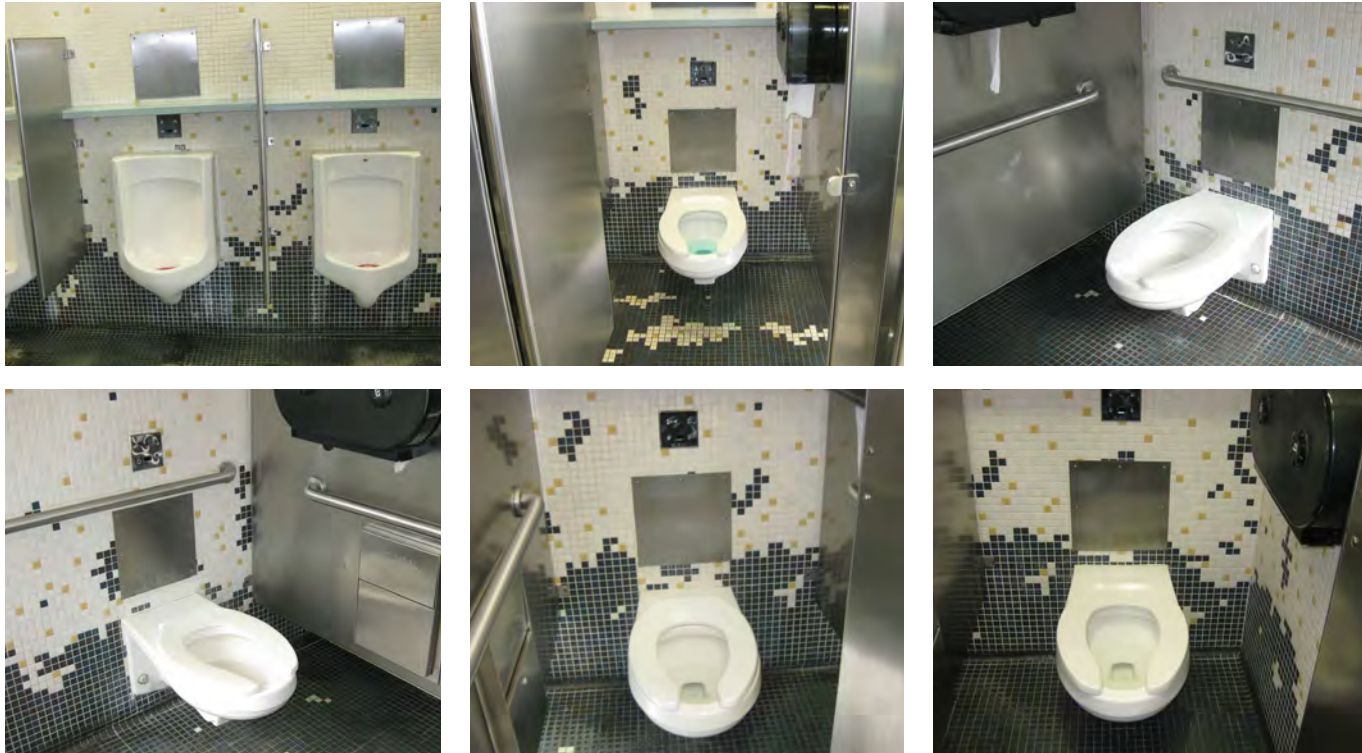
Urinals and Water Closets were replaced in 2000 and appear to be in fair condition, but significant water conservation improvements have been achieved since then. Replacement of these fixtures should be considered.

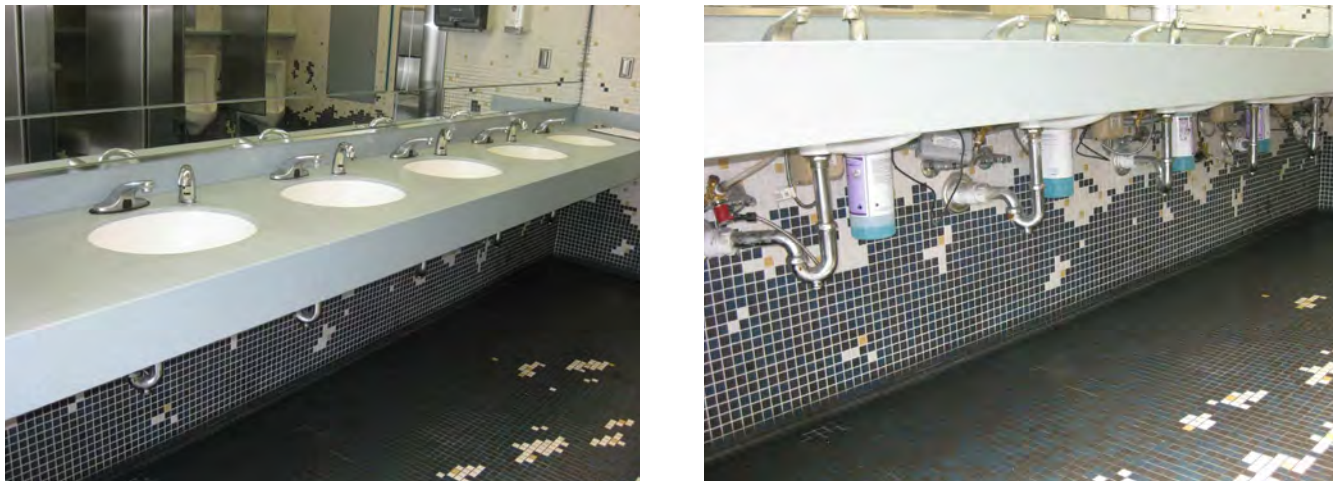
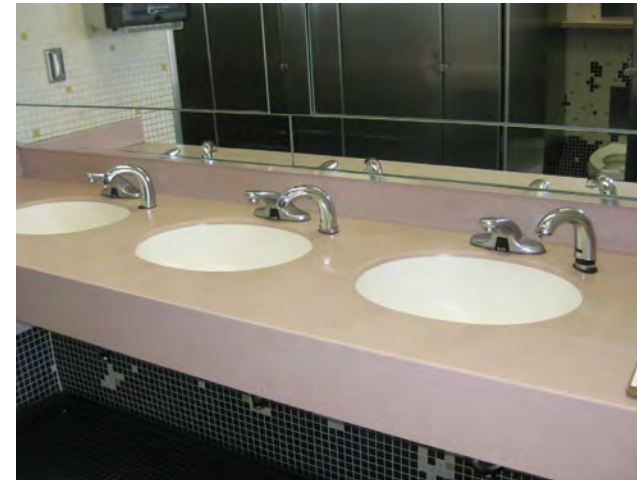
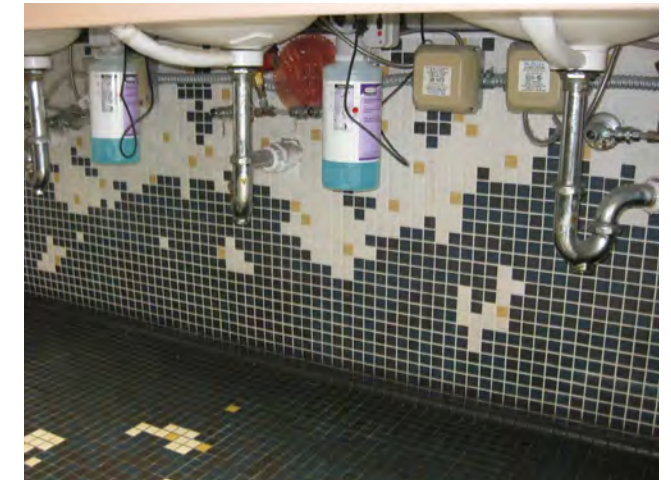
Lavatories and Sinks were replaced in 2000 and appear to be in fair condition, but significant water conservation improvements have been achieved since then. Replacement of these fixtures should be considered.

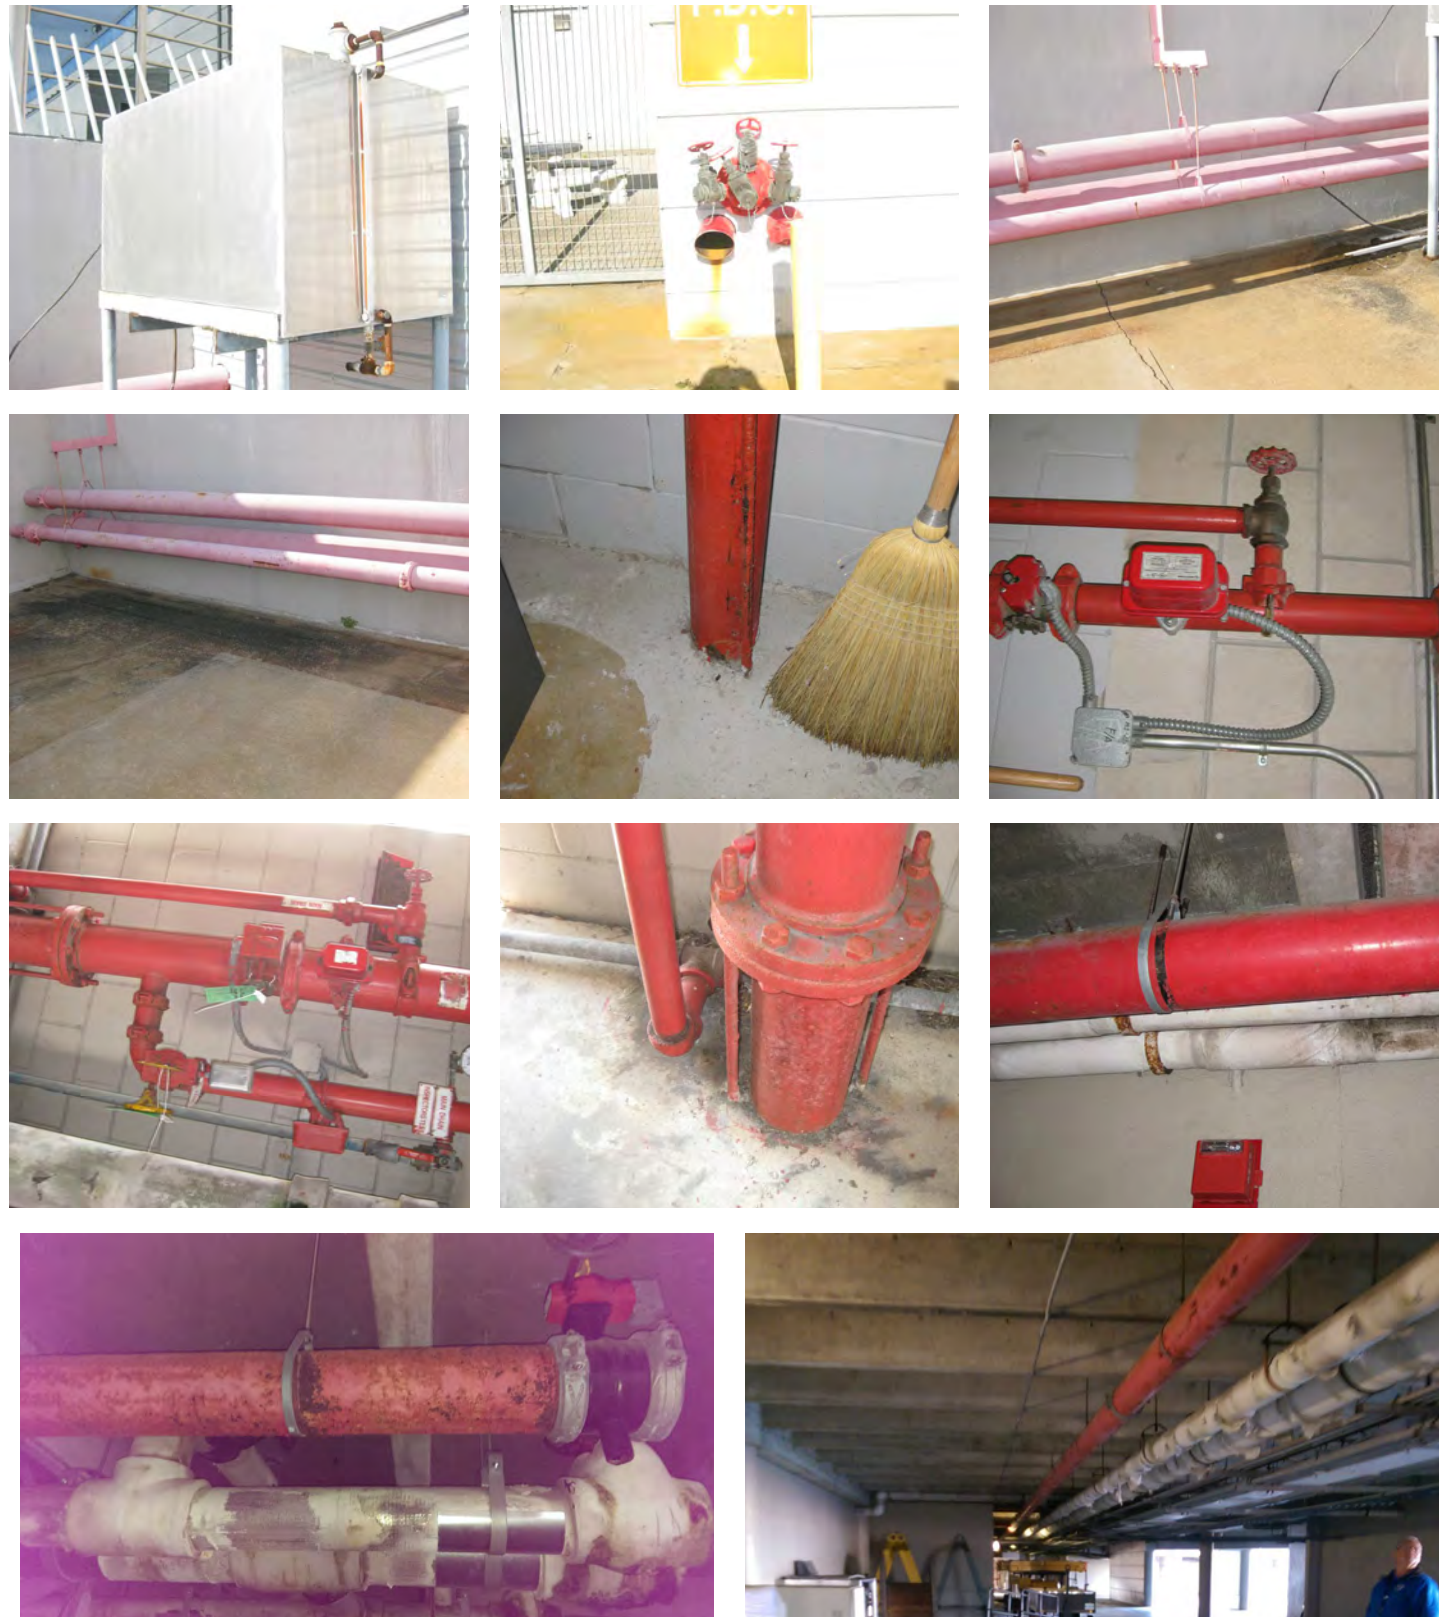
System	Condition	System Description	Useful Life			Quant.	Unit Cost	System Rep. Cost	Remarks
			Yr. Installed	Useful Life(Yrs.)	Remaining Life(Yrs.)				
	G - Good F - Fair P - Poor NA - Not Applicable								
Plumbing									
Domestic Cold Water	F	Piping	1988	30	3				
Domestic Hot Water	F	Piping	1988	30	3				
Urinals and Water Closets	F		2000	20	5				
Lavatories/Sinks	F		2000	20	5				
Faucets	F		2000	20	5				
Electric Water Coolers	F		2000	15	0				
Fire Protection									
Wet/Dry System	P	Piping Exposed Under 2nd Level	1988	30	3				
Wet/Dry System	F	Terminal Wet Sprinkler System	1988	30	3				
Wet/Dry System	F	Terminal Wet Fire Hose System	1988	30	3				
Fire Pump Room	F	Fire Pump System	1988	30	3				
Controls	F		1988	20	0

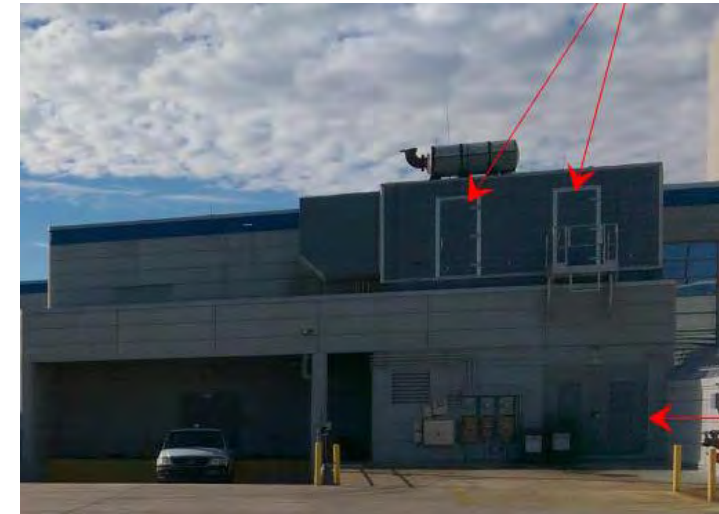
Backup power is provided by an existing 1,250 kW, 480Y/277V, three phase, four wire, enclosed diesel generator located on a platform at the mezzanine level outside of the main building near the main electrical room. The generator is connected to the main switchboard via bus duct and a 4000A/3P circuit breaker (normally open) which is controlled by a Programmable Logic Controller (PLC). The circuit breaker, PLC, and associated controls and indicating lamps are all included as an integral part of the main switchboard assembly. The 4,000 amp circuit breaker appears to be over sized for this application. With a generator full load rating of approximately 1,880 amps (at 80% power factor), the maximum expected breaker at the switchboard should be 2,500 amps.

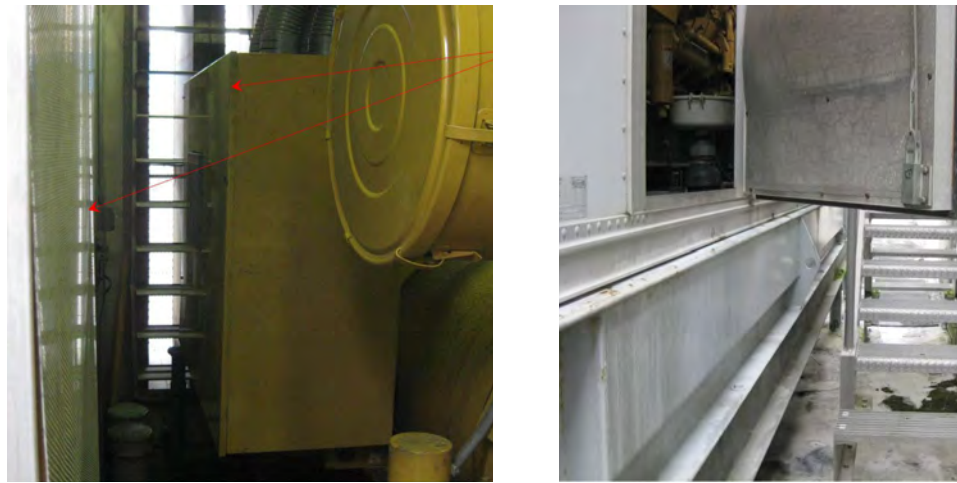
The main electrical switchboard appears to be in very good overall condition but a detailed assessment, including infrared scanning, is recommended. It should be noted that the switchboard manufacturer has expressed concern that replacement circuit breakers for this switchboard are no longer manufactured, which could lead to excessive down time and expense if an existing circuit breaker fails.

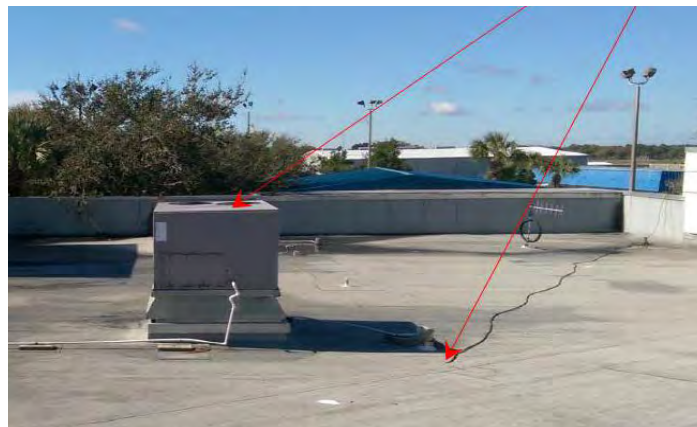
The existing lightning protection appears to be in good overall condition. However, the lightning protection system may have to be replaced and/or re-certified if extensive roof modifications are made. There are a few instances where roof top air conditioning units have been added or replaced and have not been bonded to the lightning protection system as required by NFPA 780. It is recommended that the grounding system around the building be tested to ensure proper ground continuity.

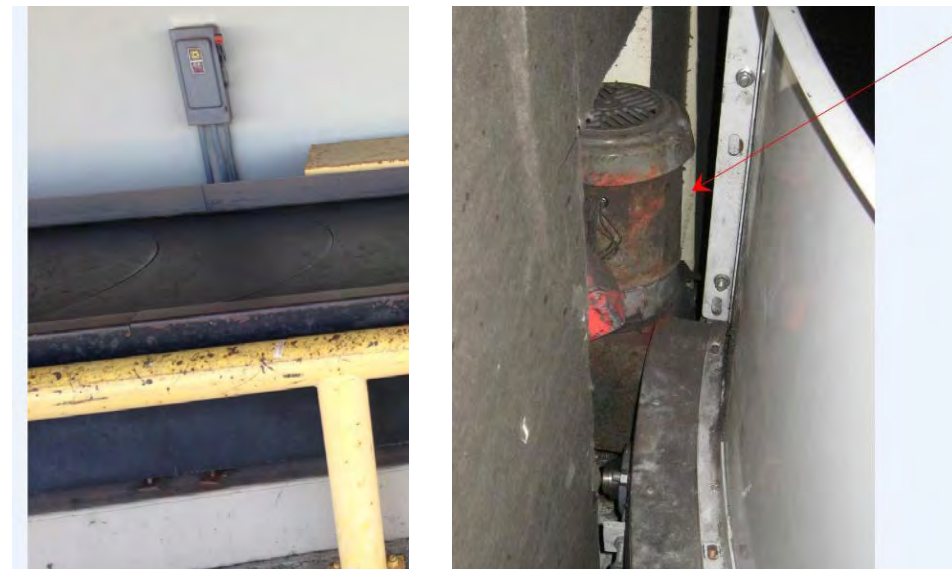
Exterior panelboards and equipment located in loading areas behind the ticketing offices are in poor condition. These panelboards are outdated, are rated for indoor use only (NEMA 1), and are showing signs of excessive rust and corrosion. Replace-

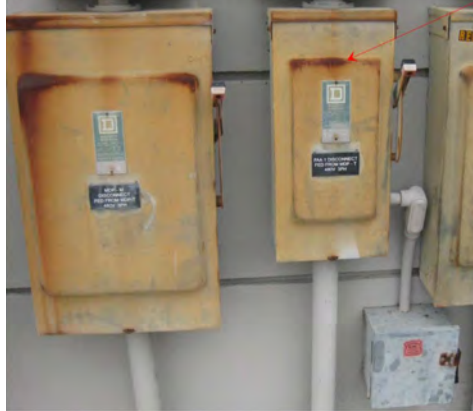
There are multiple instances where electrical disconnect switches for equipment (such as conveyors and fans) are installed in unacceptable locations with inadequate access and working clearance. Additionally, some conveyor motors and other electrical items are installed in locations which do not allow easy access for inspection, replacement, or repair.

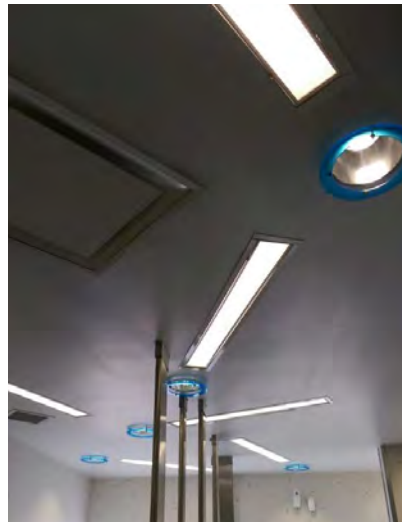
Restroom lighting power densities appear to greatly exceed levels allowed by current applicable codes and standards.

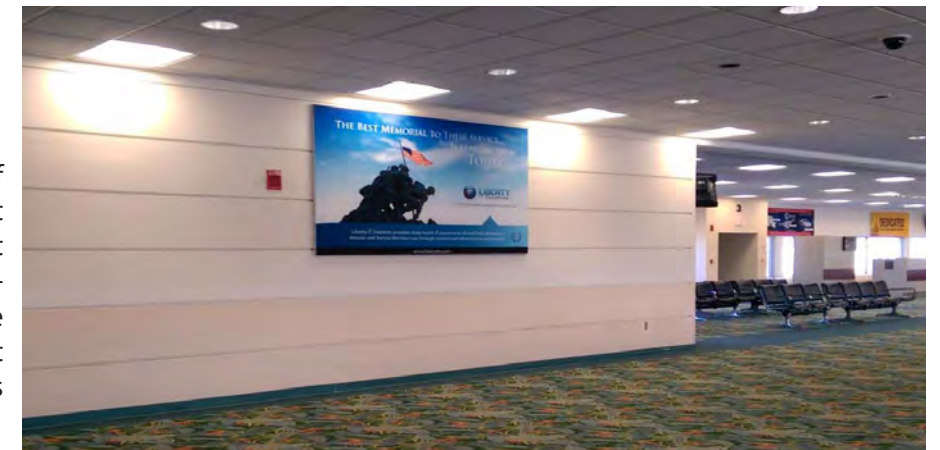
Lighting in the concourse primarily consists of 42 watt round recessed compact fluorescent down lights in main areas with 2' x 2' compact fluorescent indirect lay-in fixtures in waiting areas. These fixtures are typically in good shape and light levels appear to be adequate but power density is likely high and likely exceeds current code allowable levels.

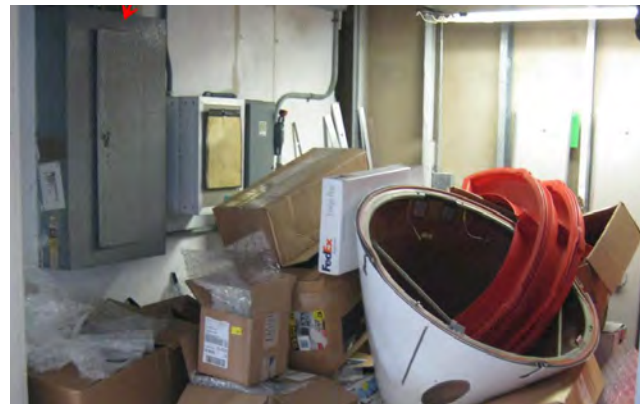
PANELBOARDS, ELECTRICAL EQUIPMENT, & DEVICES

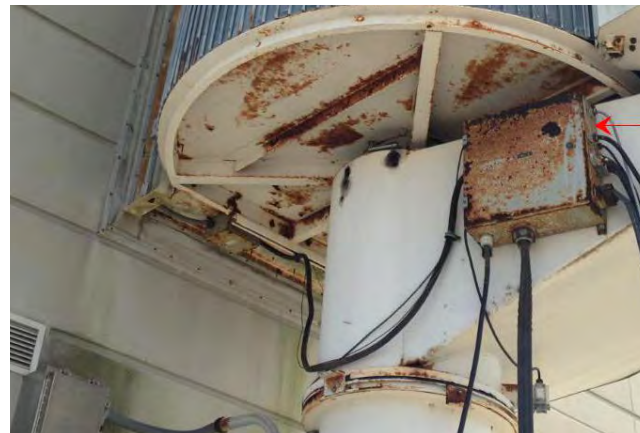
The majority of feeder and branch circuit conduits serving the concourse and support areas are installed in an overhead conduit rack system run beneath the concourse in areas exposed to the outdoor elements. These conduits are primarily EMT (Electrical Metallic Tubing) type with set screw couplings, which are not suitable for use in outdoor environments. These conduits are in very poor condition, with excessive rust and corrosion showing in many places. Some conduits have been completely compromised, and associated conductors are no longer protected. Extensive replacement is recommended.

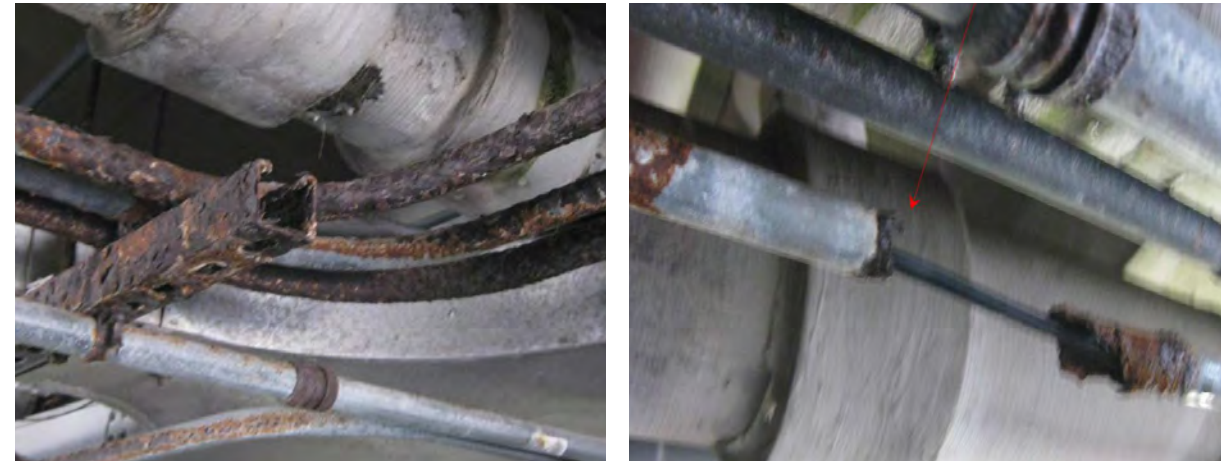
Outdoor receptacles located underneath the concourse and on the concourse exterior appear to be GFCI type, weatherproof, and in good condition. Any exceptions should be replaced.

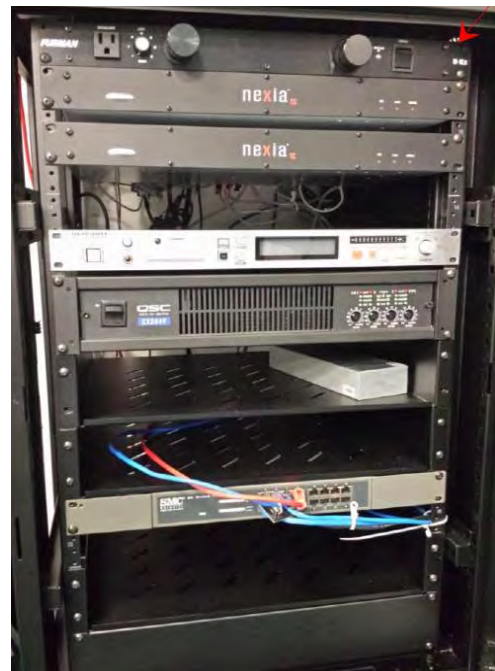
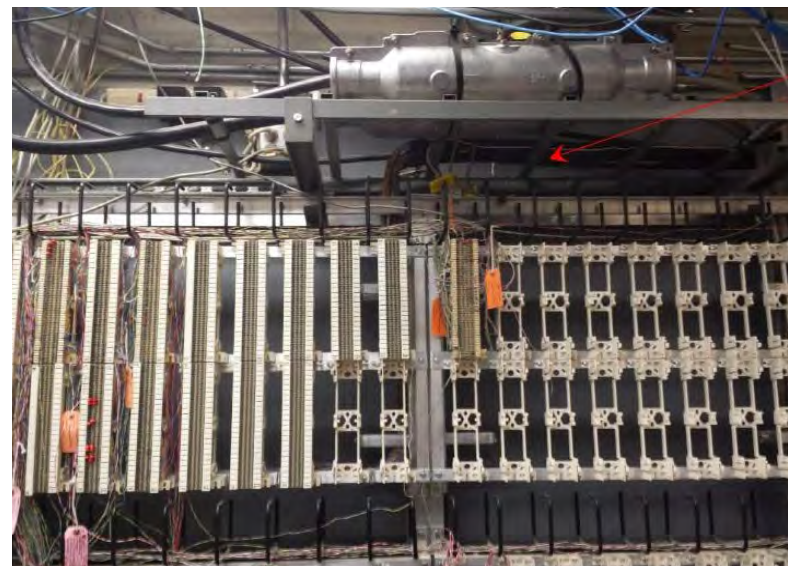
Telecommunications rooms

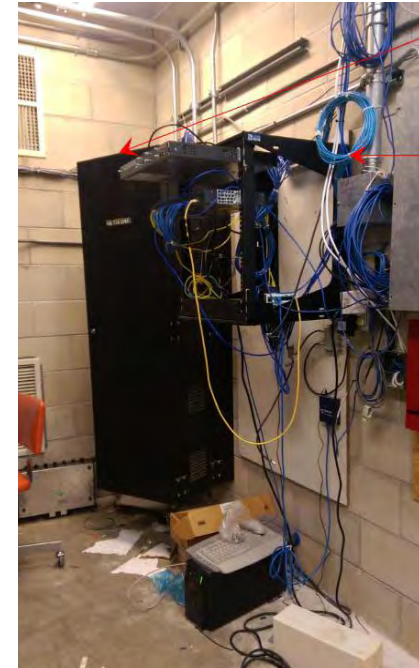
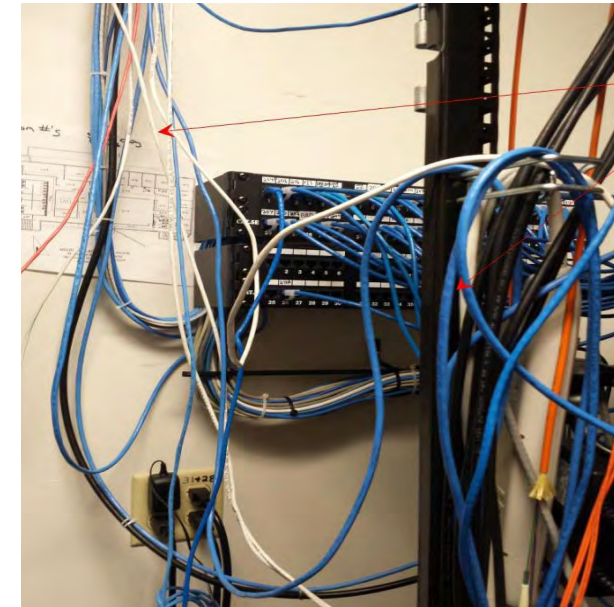
Telecommunications user infrastructure

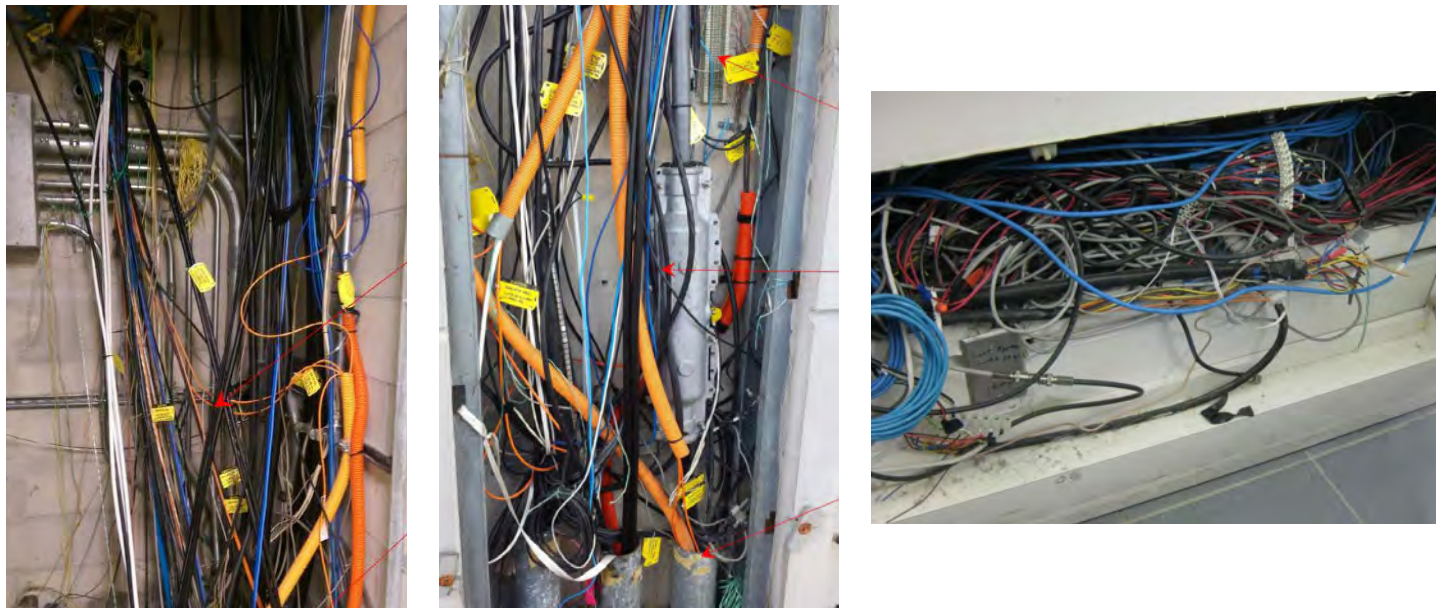
The majority of communications cabling serving the concourse and support areas are installed in an overhead cable tray system run beneath the concourse in areas exposed to the outdoor elements. An assessment should be made to determine whether cable types are properly segregated as required by codes and whether the cable tray system is suitable for continued use in an outdoor environment.

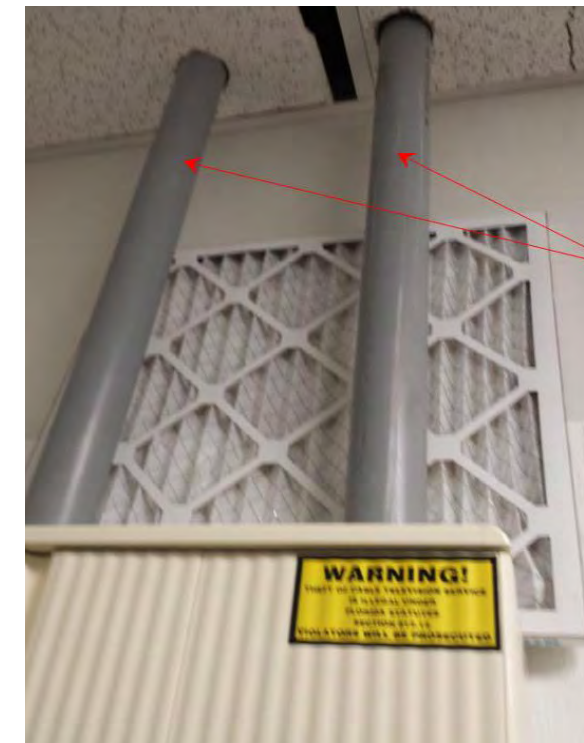
BRPH Project No. C07071.001.00
TICKETING AREA Date: 3/10/15 Square Footage: Footprint
 Taken By: AHS/CDS Year Built: Various stages of Renovation
