MELBOURNE AIRPORT AUTHORITY BOARD MEETING
AGENDA

May 27, 2020 at 8:30 AM
Orlando Melbourne International Airport Terminal

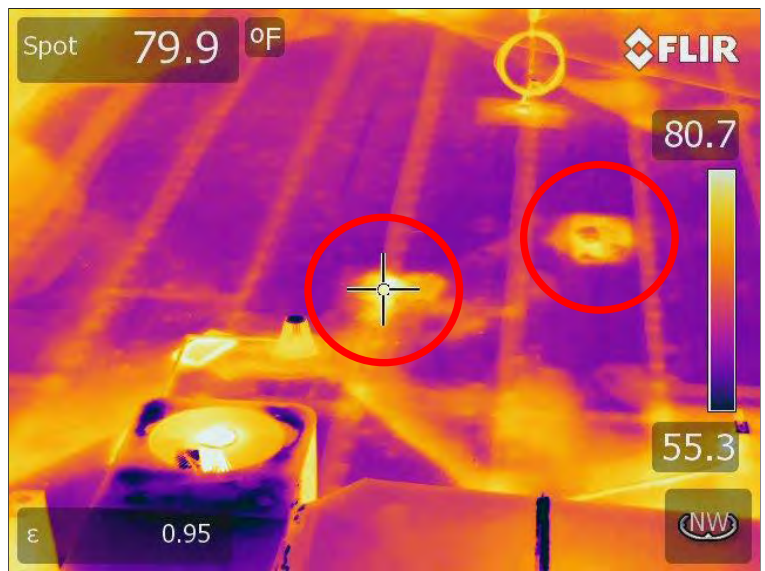
Thermogram 1: Light shaded areas indicate areas of potential trapped moisture under granular capsheet.

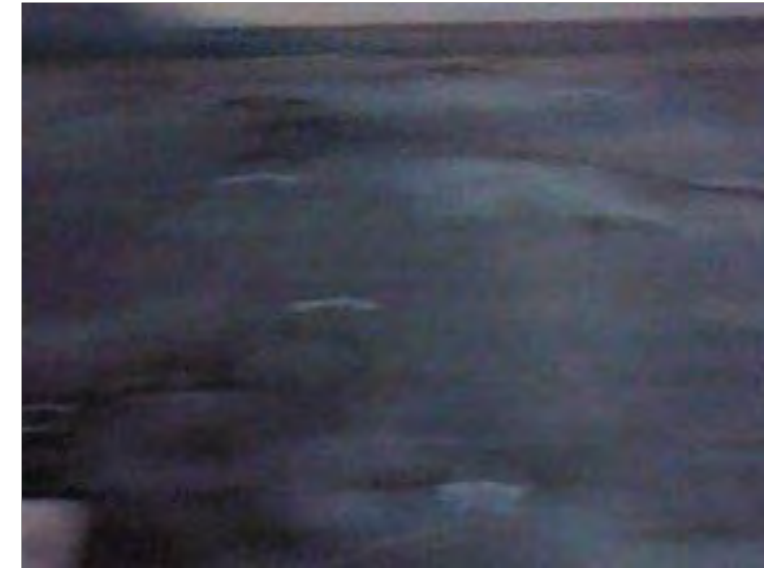
Photo 2: Close up of Roof #10 at Thermogram locations #1 – #3.

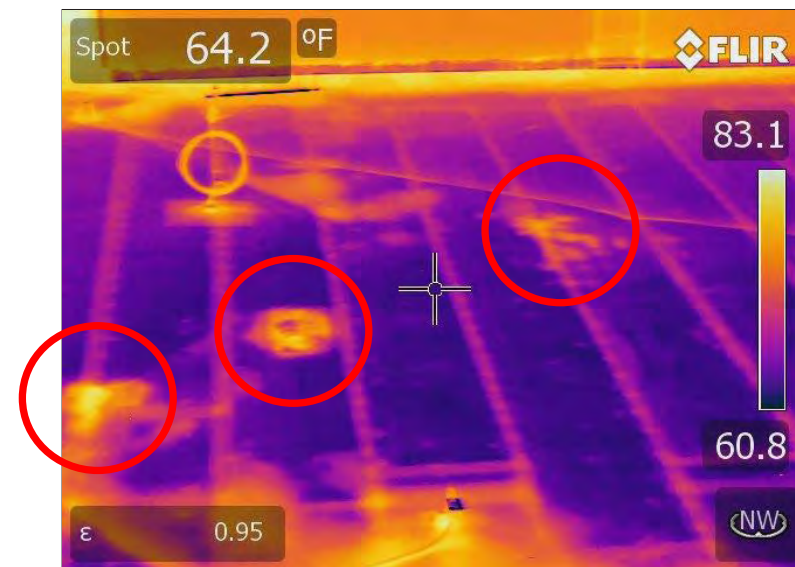
Thermogram 2: Light shaded areas indicate areas of potential trapped moisture under granular capsheet.

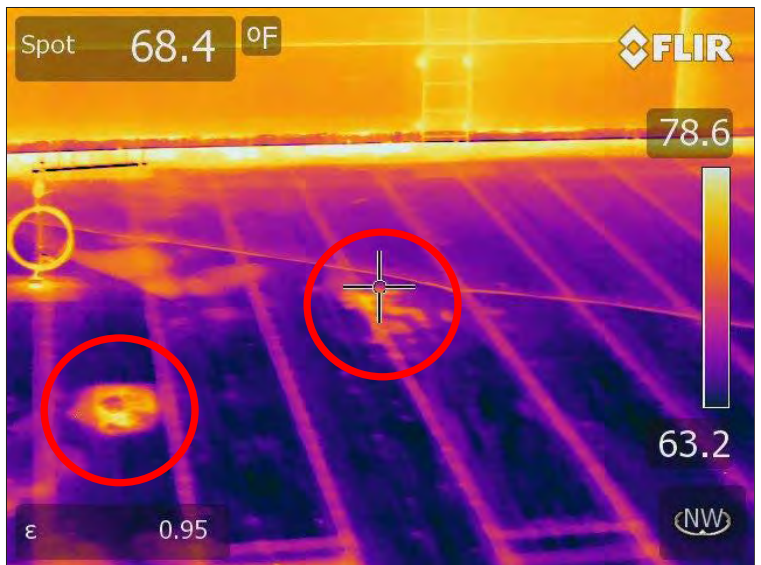
Thermogram 3: Light shaded areas indicate areas of potential trapped moisture under granular capsheet.

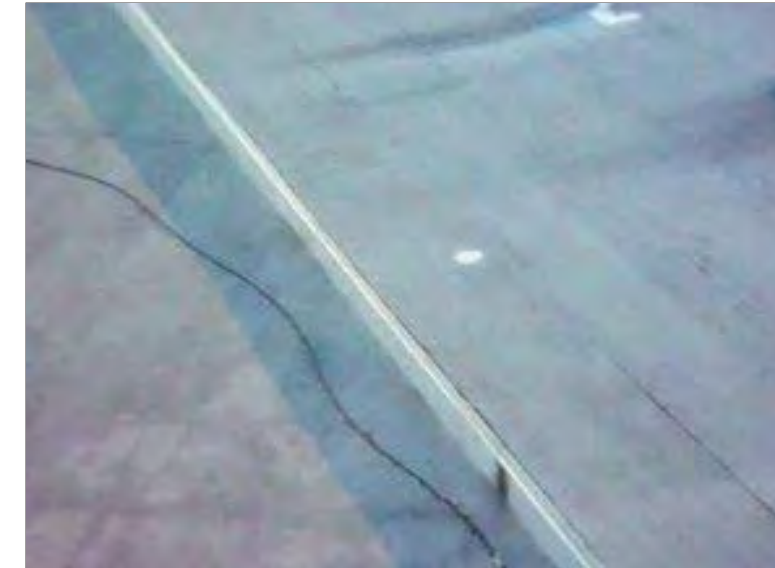
Photo 4: Overview of Thermogram #4 location at Roof #10.

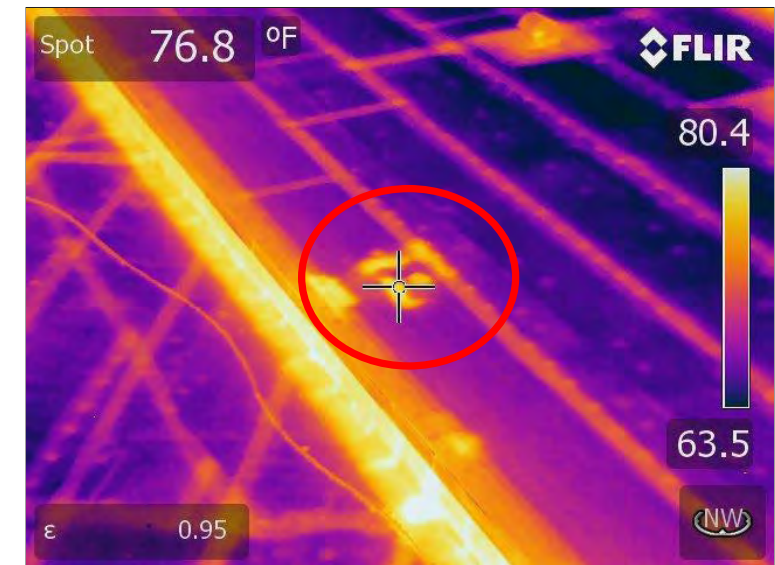
Thermogram 4: Light shaded areas indicate areas of potential trapped moisture under granular capsheet. Note – light lines display areas of roof transition and overlap which represent areas of heat escaping from the roof system.

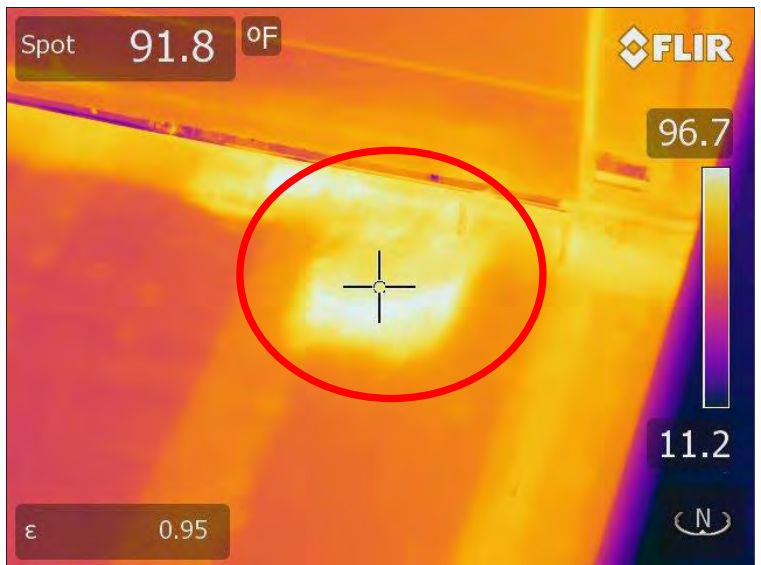
Thermogram 5: Light shaded areas indicate areas of potential trapped moisture under granular capsheet.

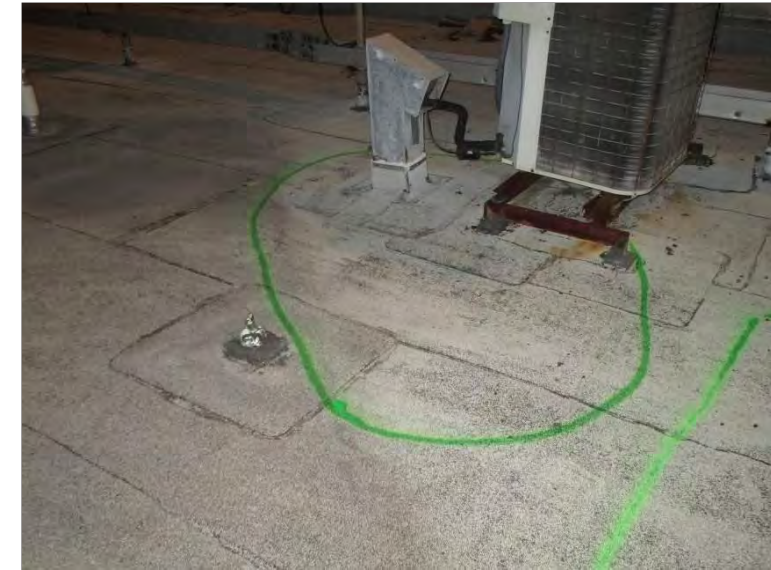
Photo 6: Overview of Thermogram #6 location at Roof #14.

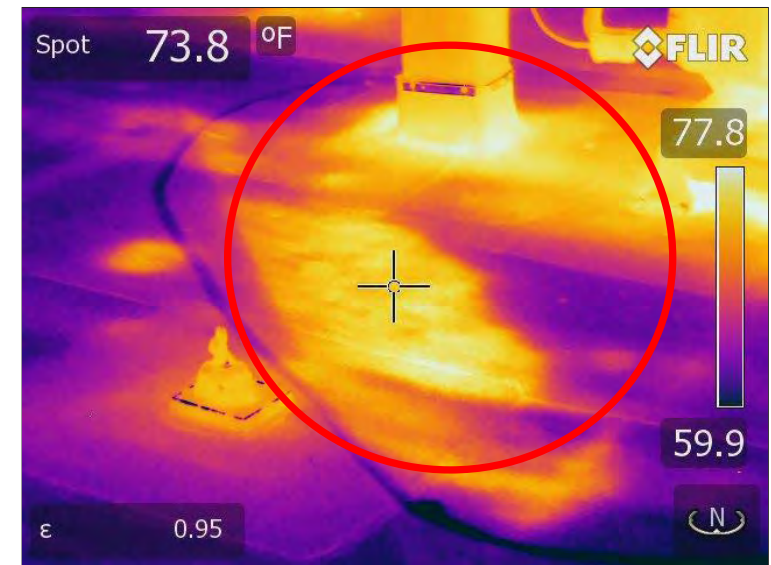
Thermogram 6: Light shaded areas indicate areas of potential trapped moisture under granular capsheet.

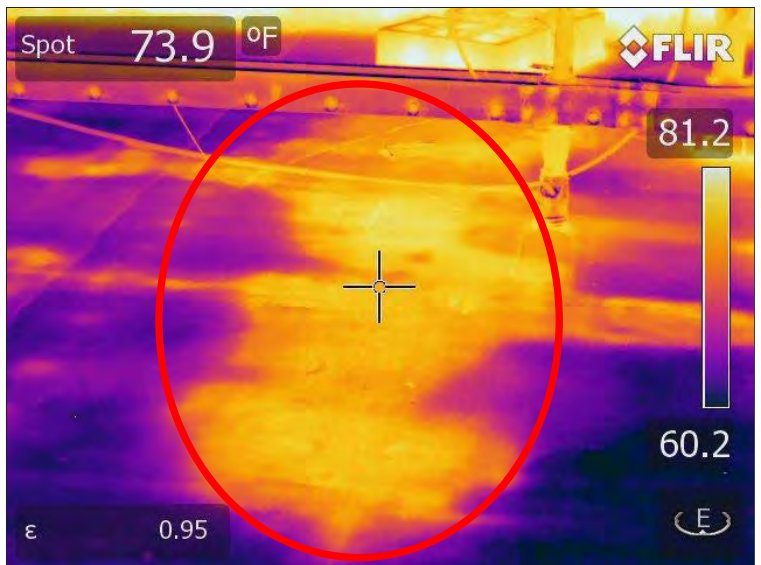
Thermogram 7: Light shaded areas indicate areas of potential trapped moisture under granular capsheet.

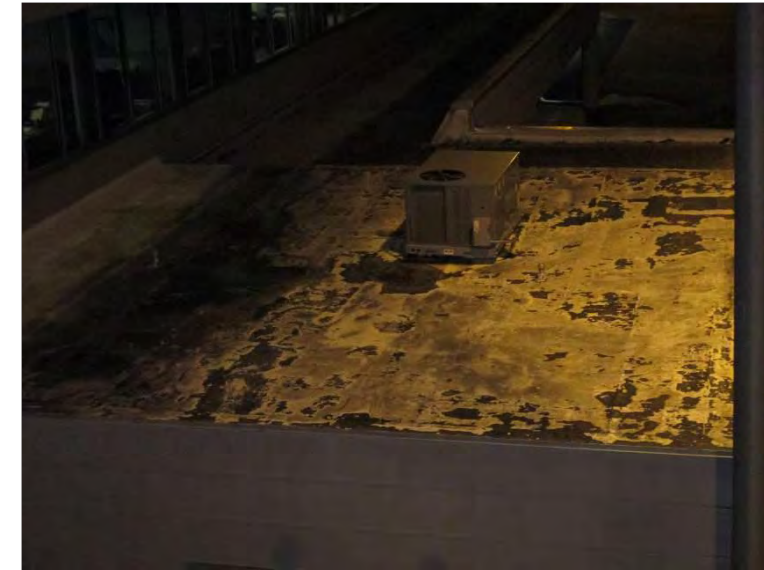
Photo 8: Overview of Thermogram #8 location at Roof #7.

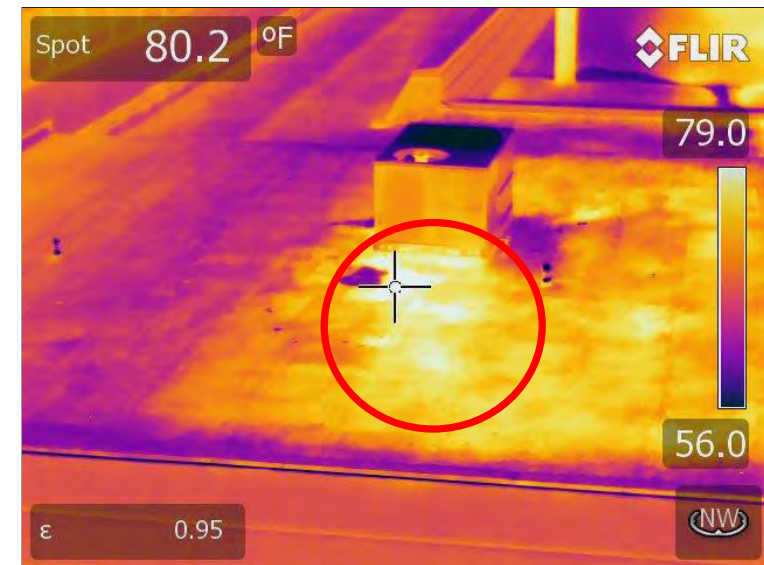
Thermogram 8: Light shaded areas indicate areas of potential trapped moisture under granular capsheet.

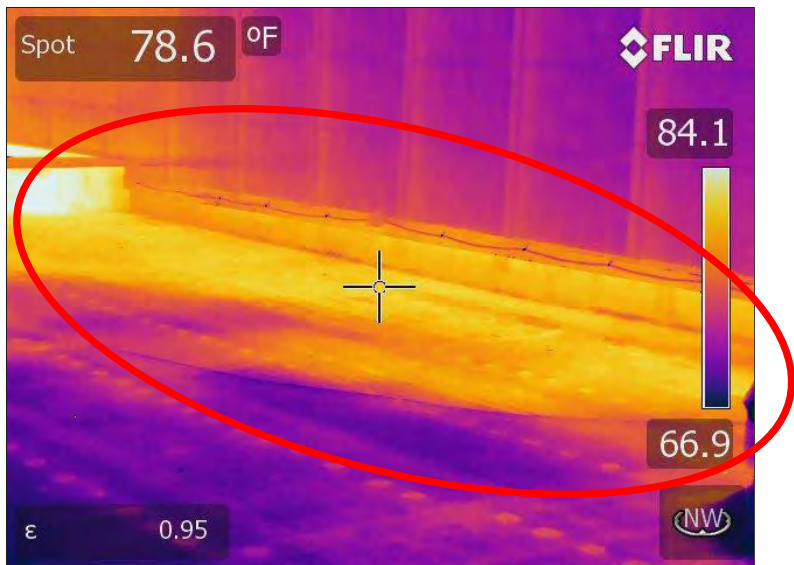
Thermogram 9: Light shaded areas indicate areas of potential trapped moisture under granular capsheet.

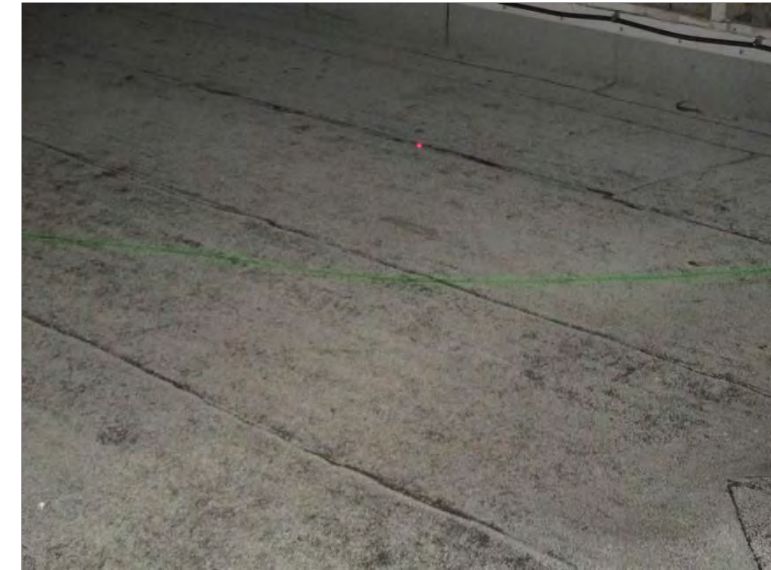
Photo 10: Overview of Thermogram #10 location at Roof #16.

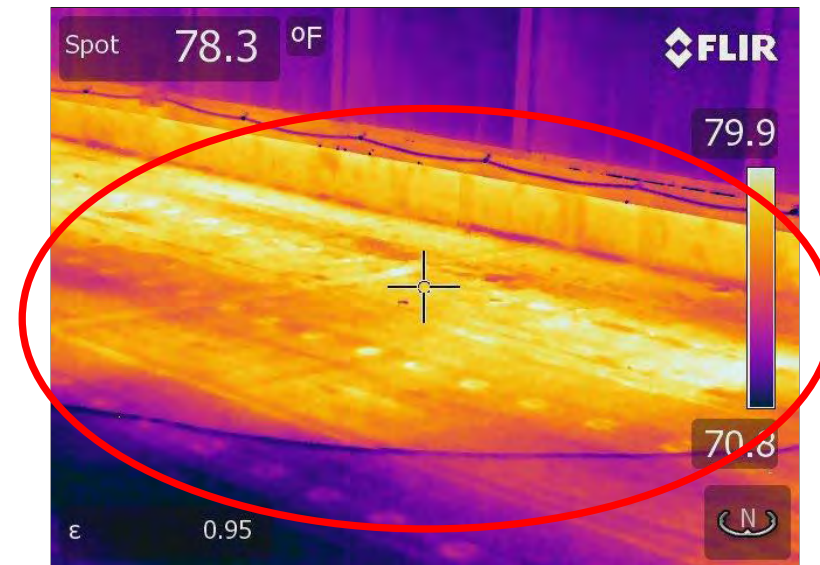
Thermogram 10: Light shaded areas indicate areas of potential trapped moisture under granular capsheet.

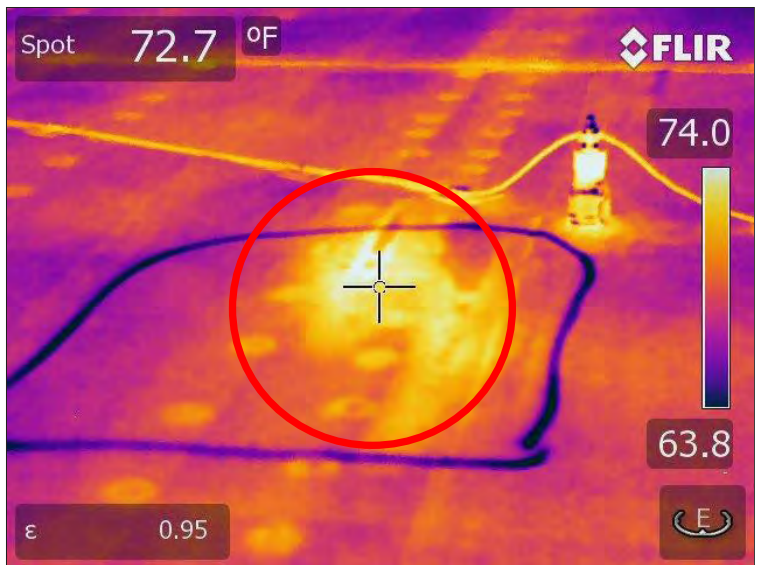
Thermogram 11: Light shaded areas indicate areas of potential trapped moisture under granular capsheet.

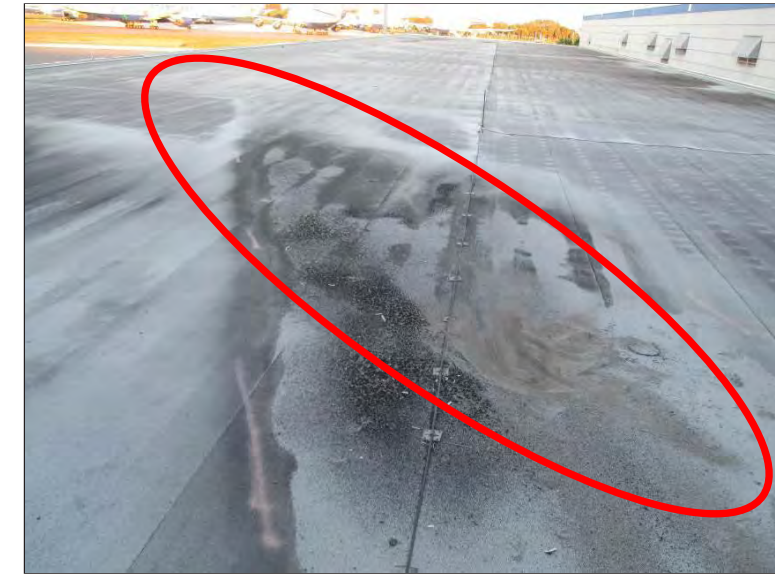
Photo 12: Overview of Thermogram #12 location at Roof #18.

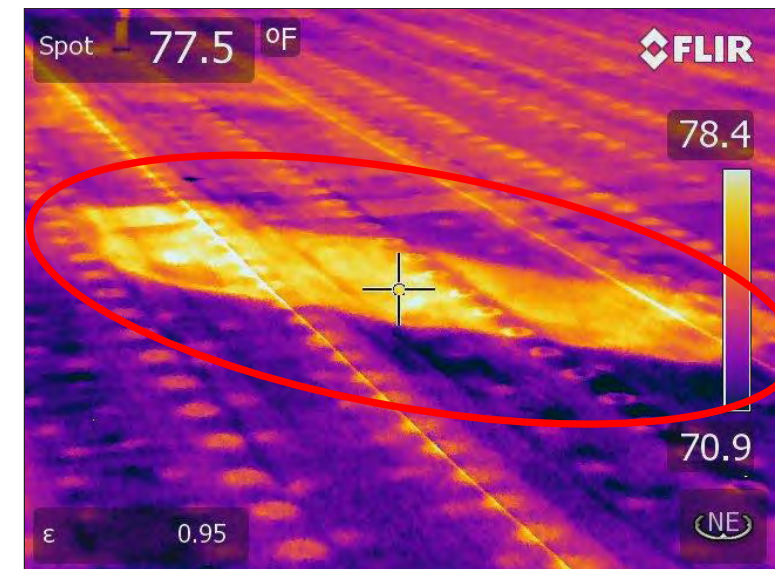
Thermogram 12: Light shaded areas indicate areas of potential trapped moisture under granular capsheet.

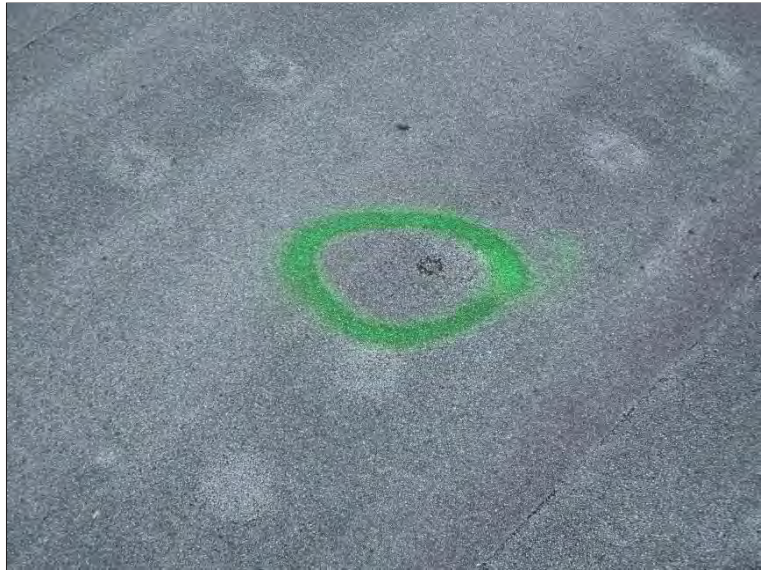
Photo 13: Overview of Thermogram #13 location at Roof #18.

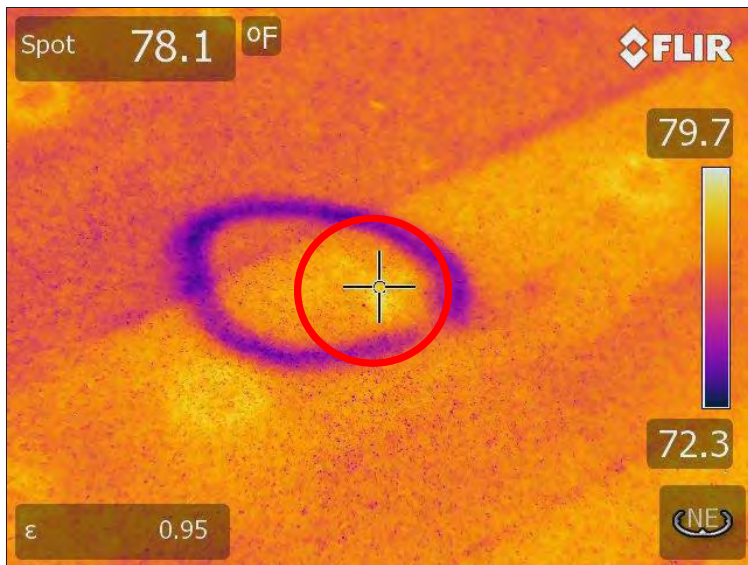
Thermogram 13: Light shaded areas indicate areas of potential trapped moisture under granular capsheet.

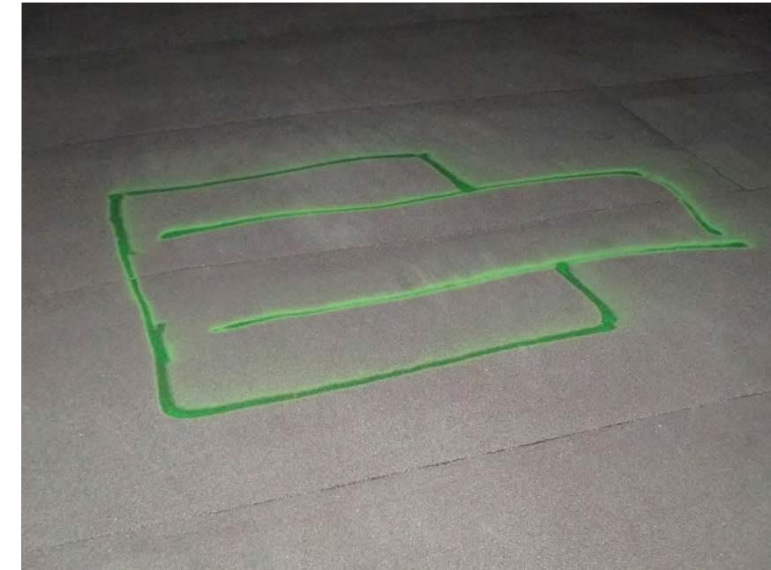
Photo 14: Overview of Thermogram #14 location at Roof #19.

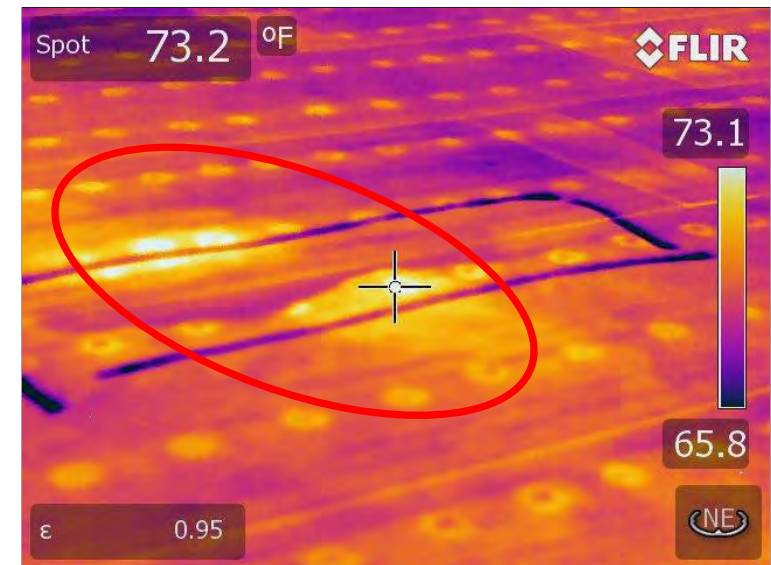
Thermogram 14: Light shaded areas indicate areas of potential trapped moisture under granular capsheet.

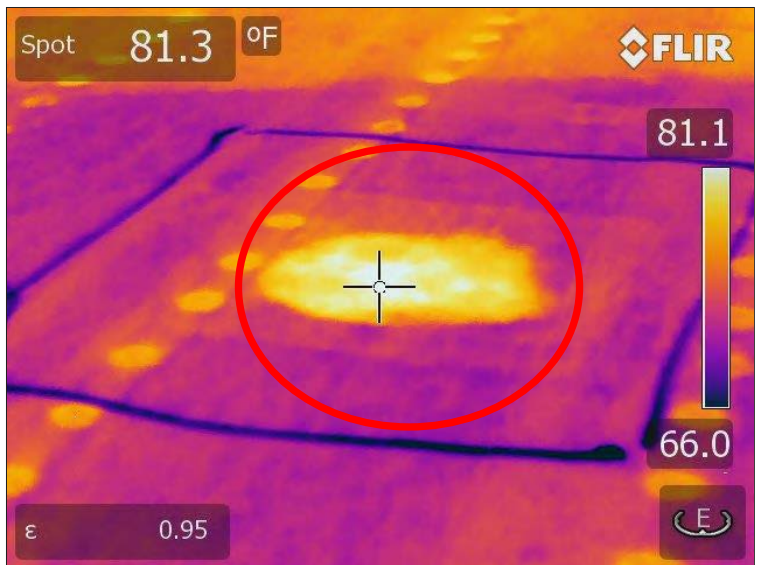
Thermogram 15: Light shaded areas indicate areas of potential trapped moisture under granular capsheet.

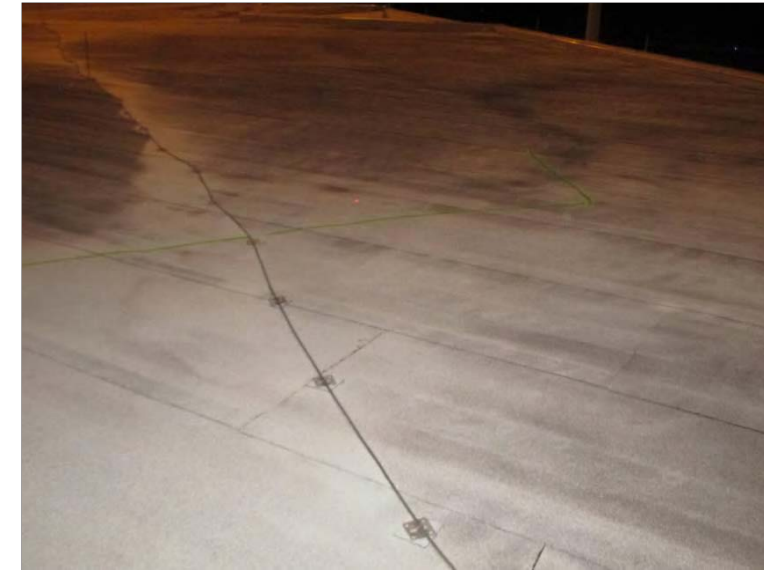
Photo 16: Overview of Thermogram #16 location at Roof #25.

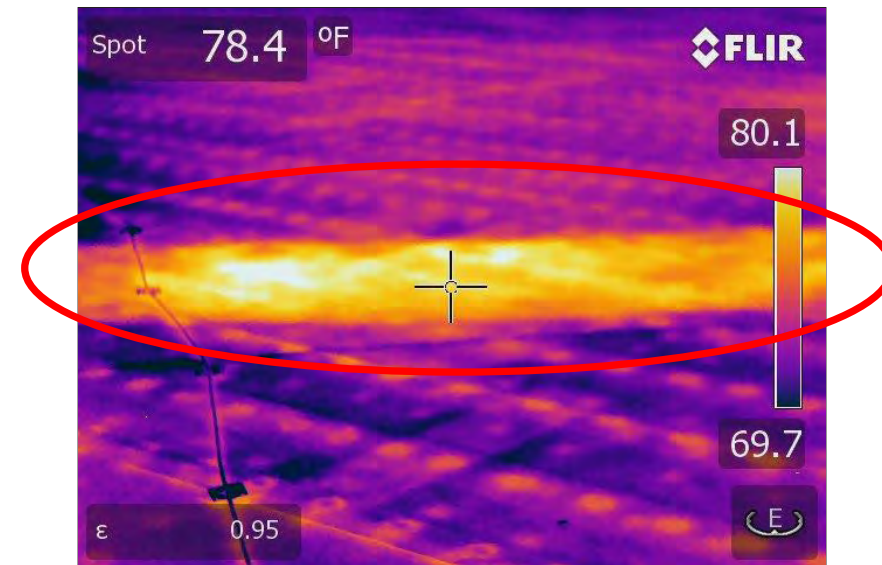
Thermogram 16: Light shaded areas indicate areas of potential trapped moisture under granular capsheet.

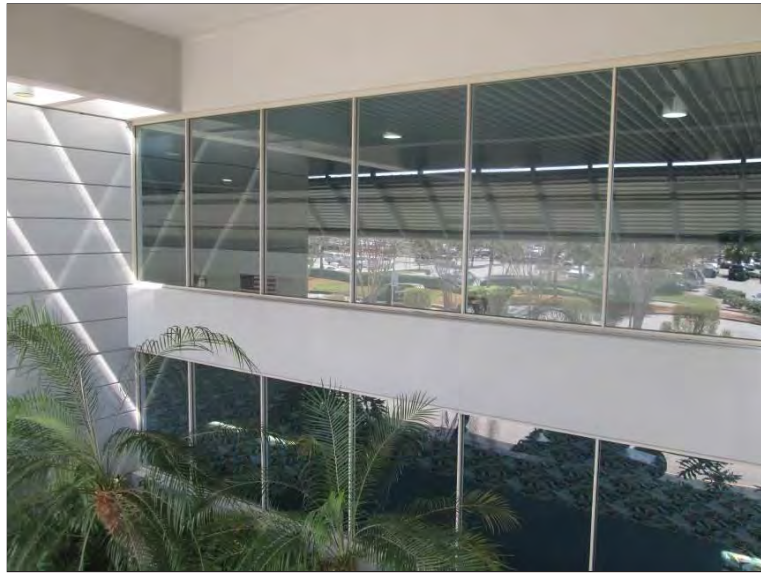
Photo 1: Window assemblies in the ticketing area throughout the south elevation where PSI performed a visual curtainwall and glazed openings survey to document current condition and note observed deficiencies.

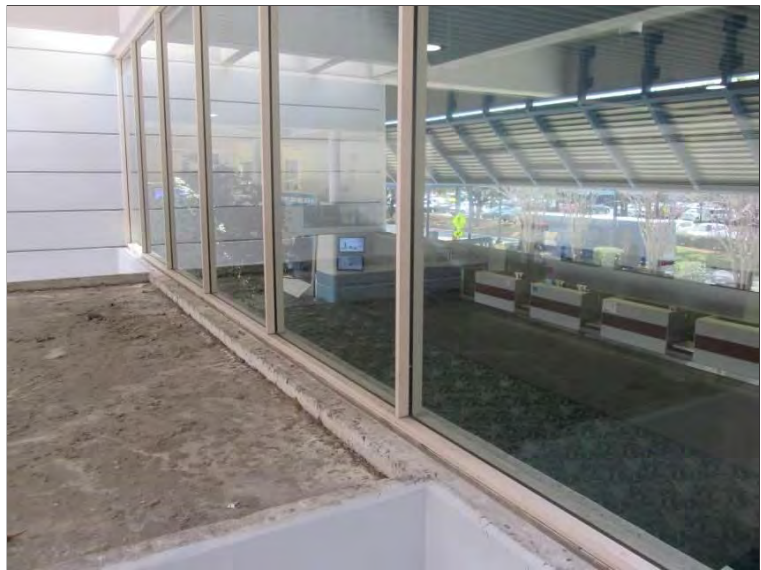
Photo 2: The aluminum framed curtainwall systems in the Ticketing area are single pane tempered safety glass manufactured by RC.

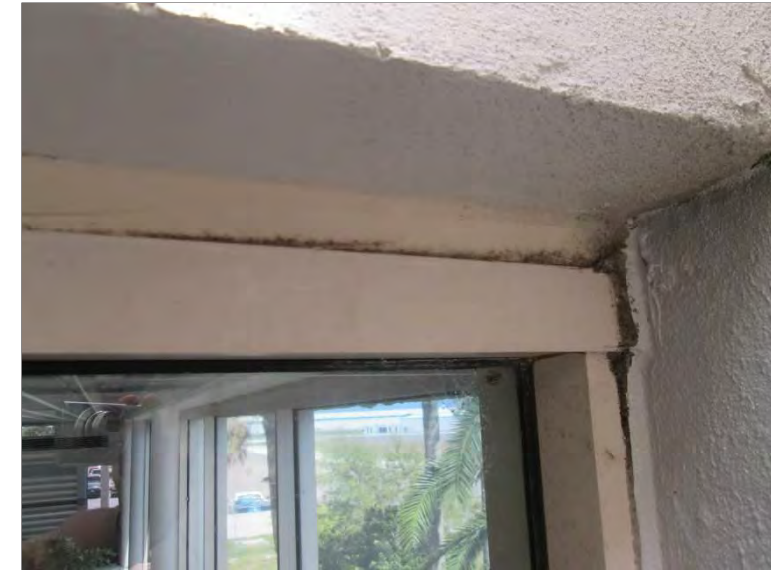
Photo 3: Deteriorated flexible sealant was observed at all exterior perimeters at the frame to wall transitions due to age and exposure to the elements.

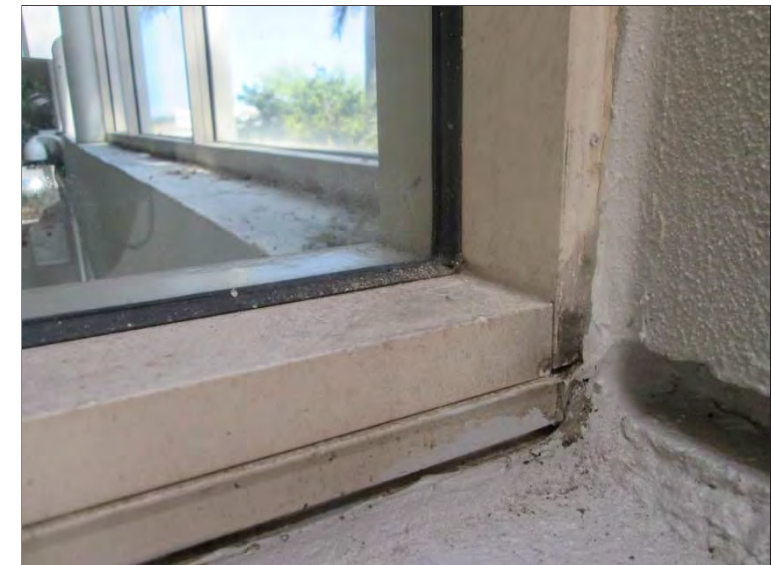
Photo 4: Deteriorated flexible sealant was observed at all exterior perimeters at the frame to wall transitions due to age and exposure to the elements.

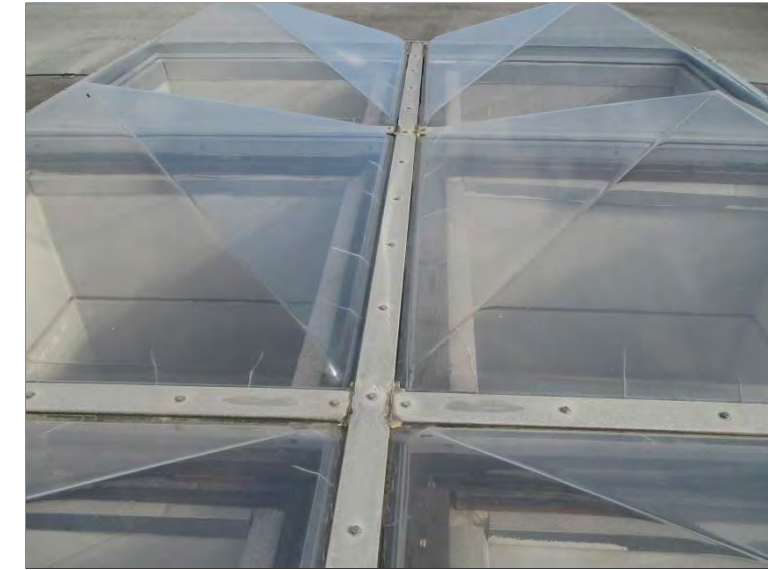
Photo 11: Skylights in the Ticketing area where PSI performed a visual survey to document current condition and note observed deficiencies.

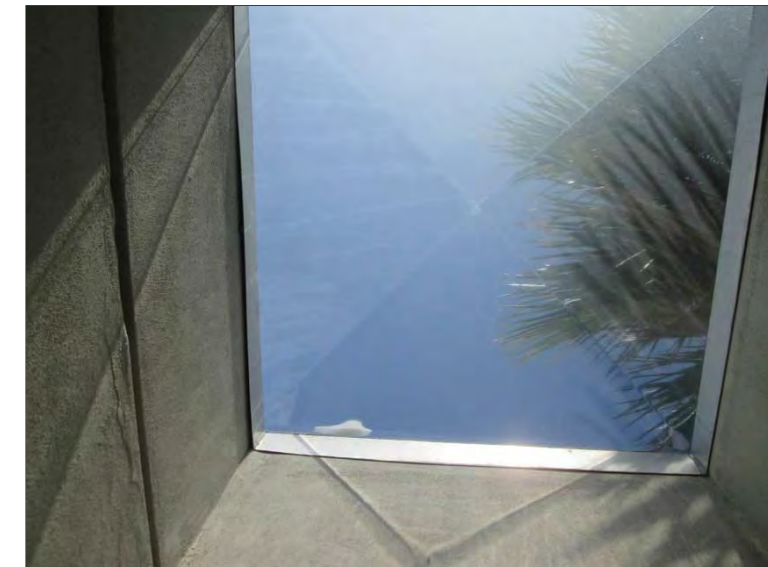
Photo 12: Skylights in the Ticketing area were constructed of a Lexan type plastic material with aluminum framing. The skylight measured approximately 4'7" x 4'7" in size.

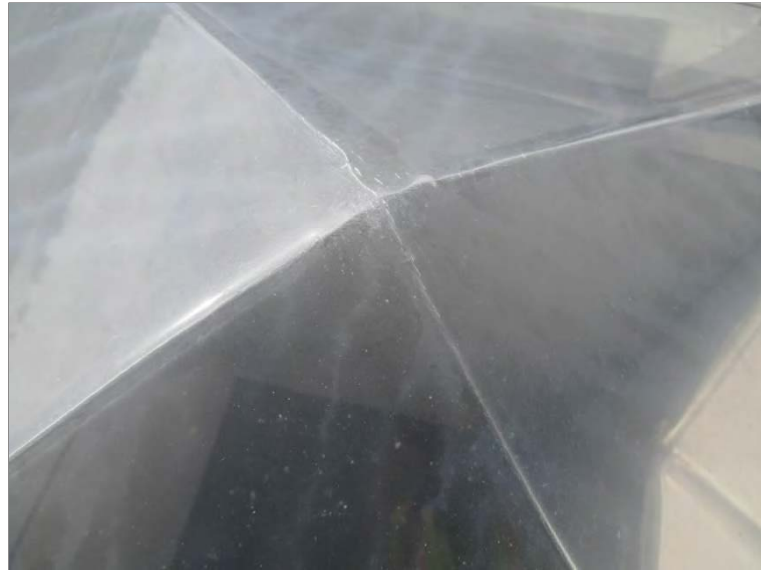
Photo 13: Example of a skylight observed to be in fair condition.

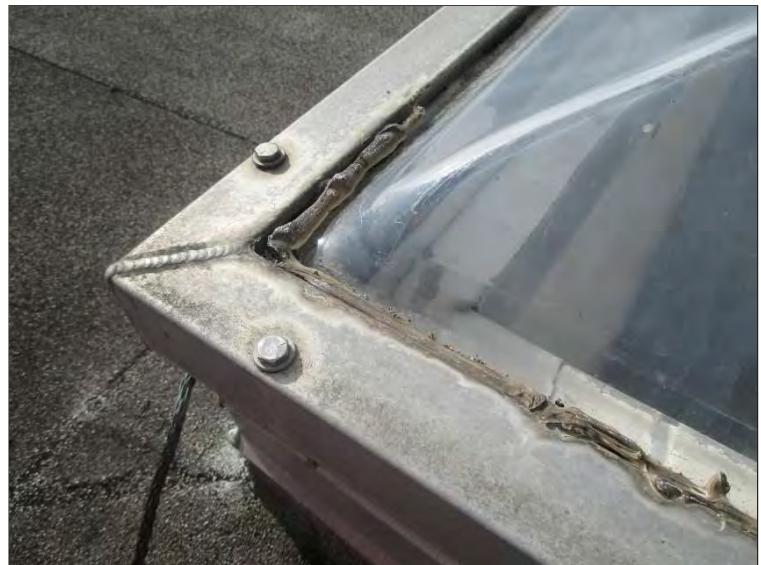
Photo 14: Deteriorated flexible sealant was observed at all perimeter panels to exterior frame transitions due to age and exposure to the elements in the Ticketing area.

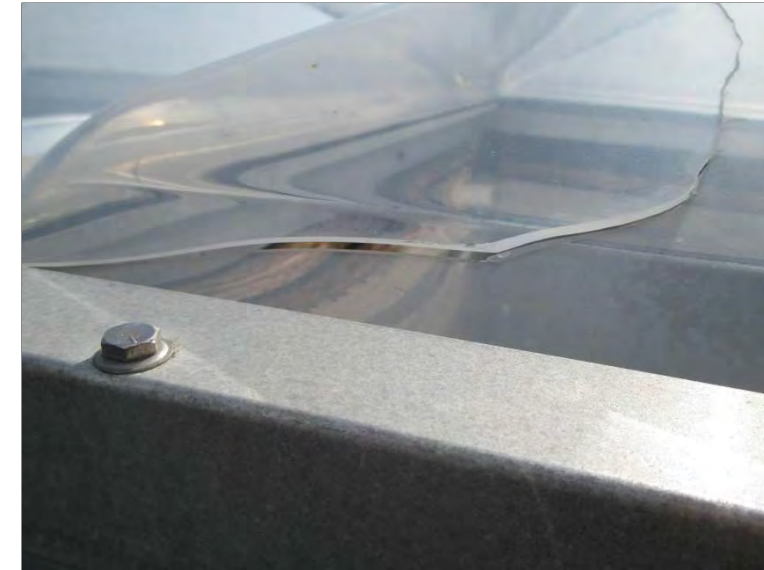
Photo 15: Cracking observed at skylight location in the Ticketing area.

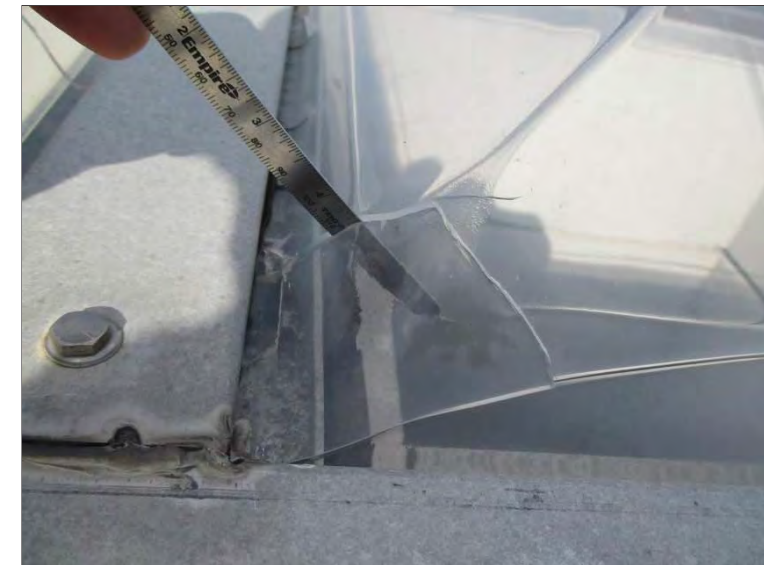
Photo 16: Cracking observed at skylight location in the Ticketing area.

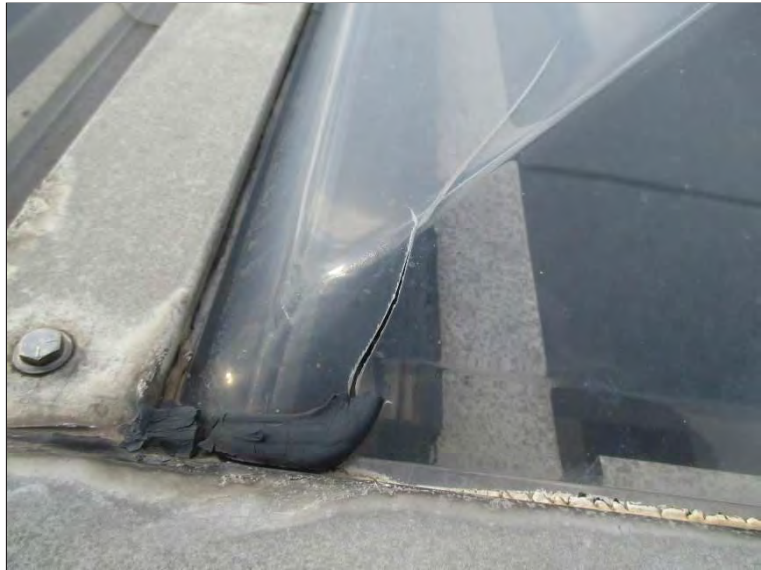
Photo 17: Cracking observed at skylight location in the Ticketing area.

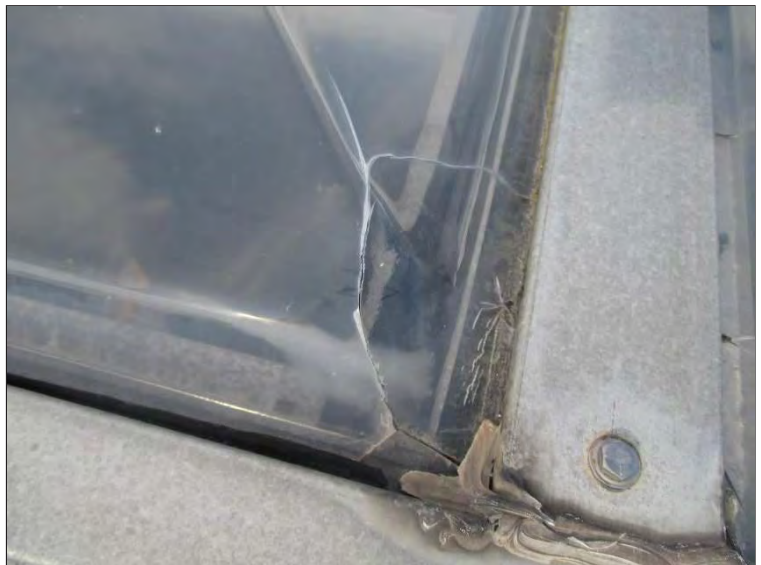
Photo 18: Cracking observed at skylight location in the Ticketing area.

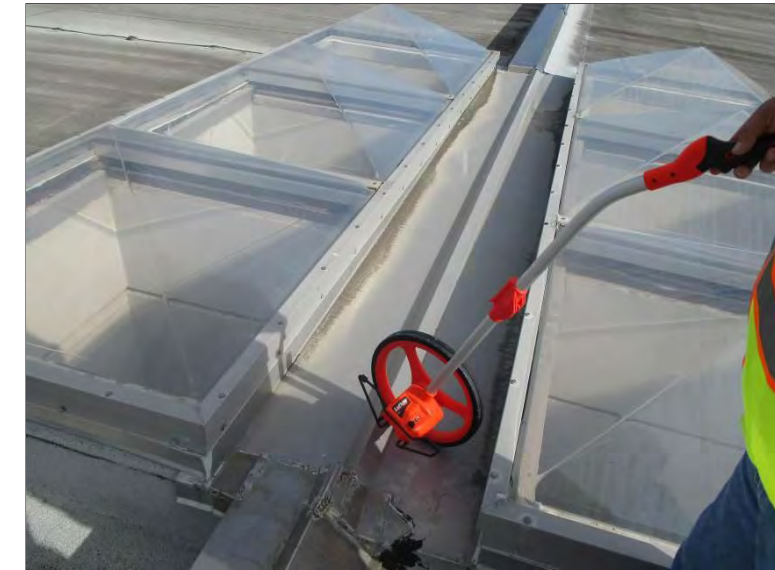
Photo 19: Skylights at the expansion joint on the roof separating the Ticketing and Atrium areas.

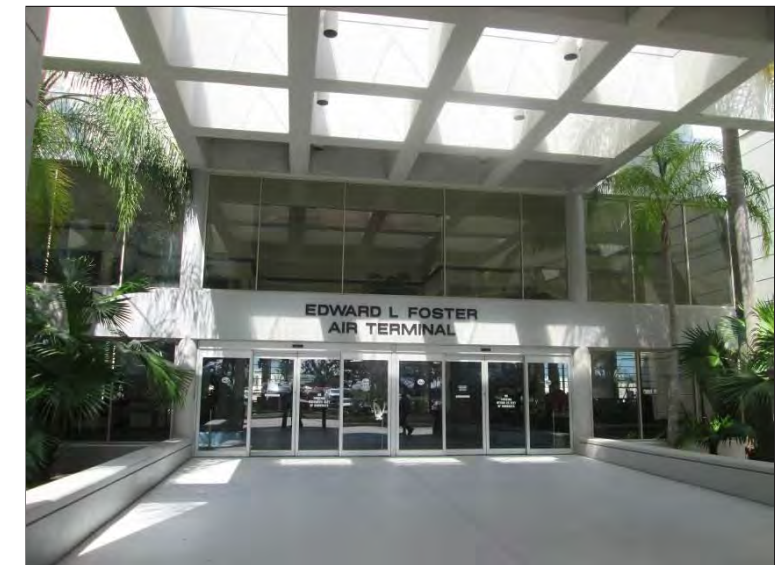
Photo 20: Window assemblies in the Atrium area throughout the south elevation where PSI performed a visual curtainwall and glazed openings survey to document current condition and note observed deficiencies.

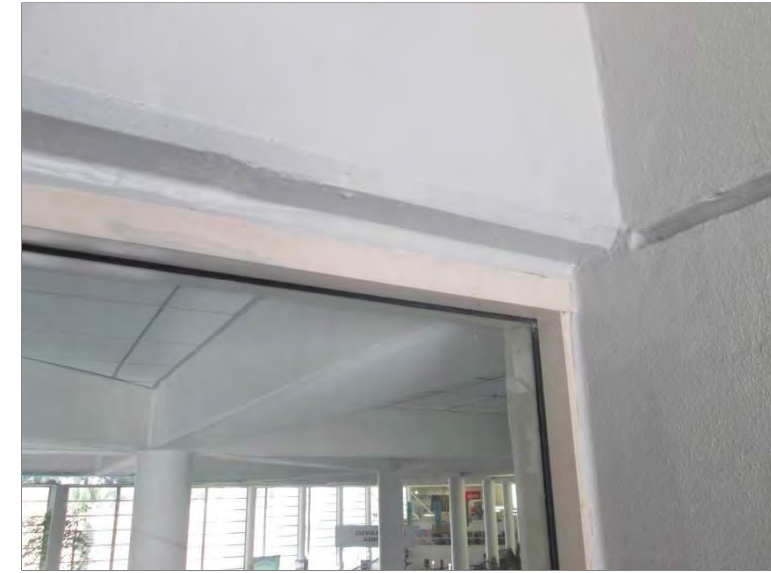
Photo 23: Deteriorated flexible sealant was observed at all exterior perimeters at the frame to wall transitions due to age and exposure to the elements in the Atrium area.

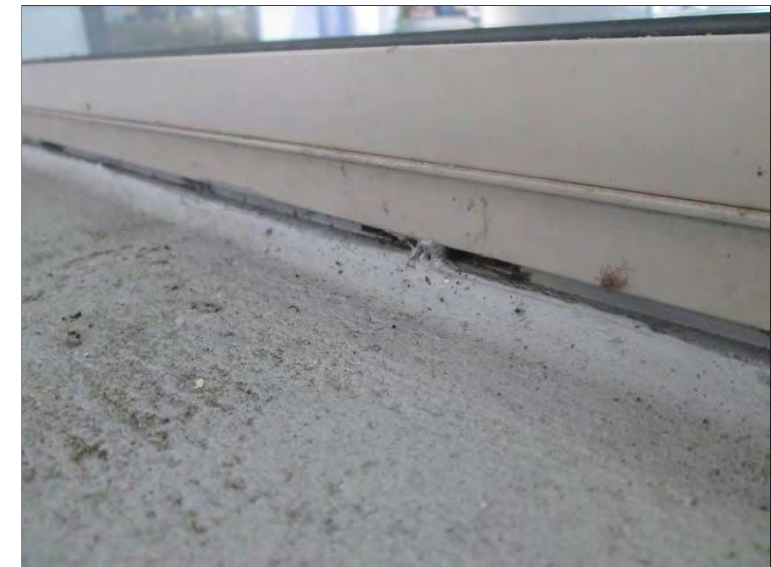
Photo 24: Deteriorated flexible sealant was observed at all exterior perimeters at the frame to wall transitions due to age and exposure to the elements in the Atrium area.

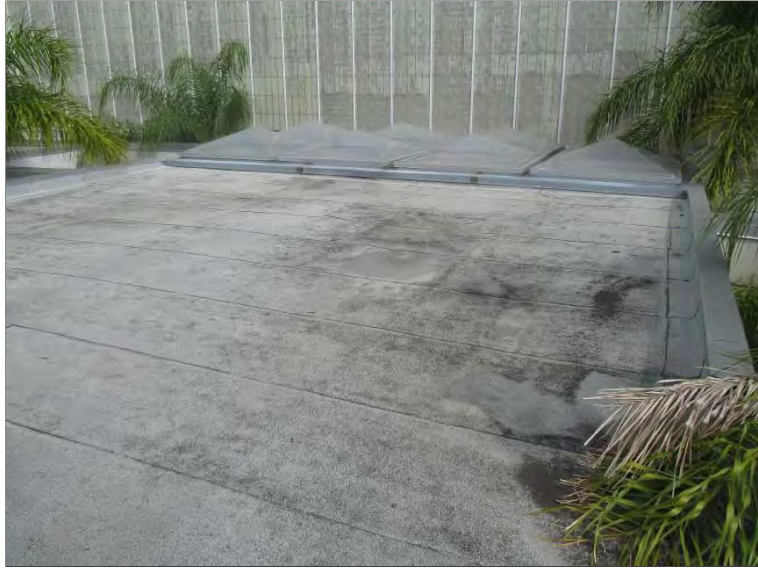
Photo 29: Skylights in the center of the Atrium area where PSI performed visual survey to document current condition and note observed deficiencies.

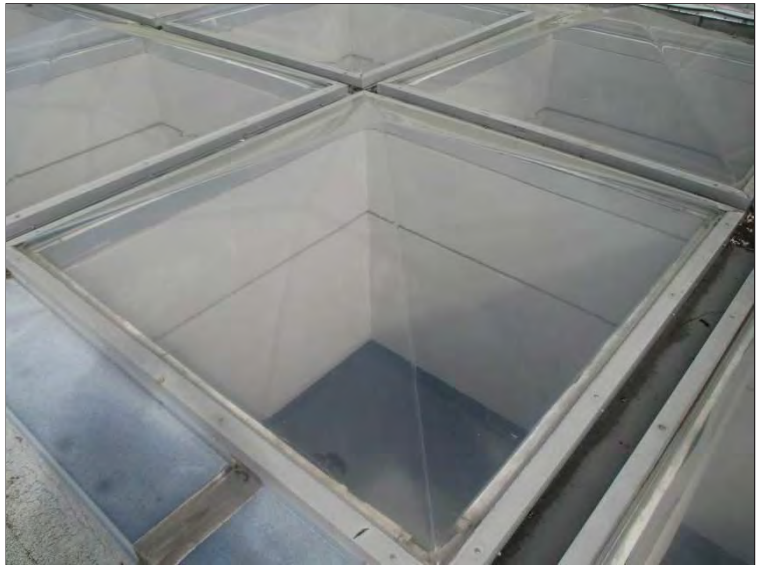
Photo 30: Skylights are constructed of a Lexan type plastic material with aluminum framing. The skylights in the center measured approximately 6'8" x 6'8" in size. Deteriorated flexible sealant was observed at all perimeters due to age and exposure to the elements.

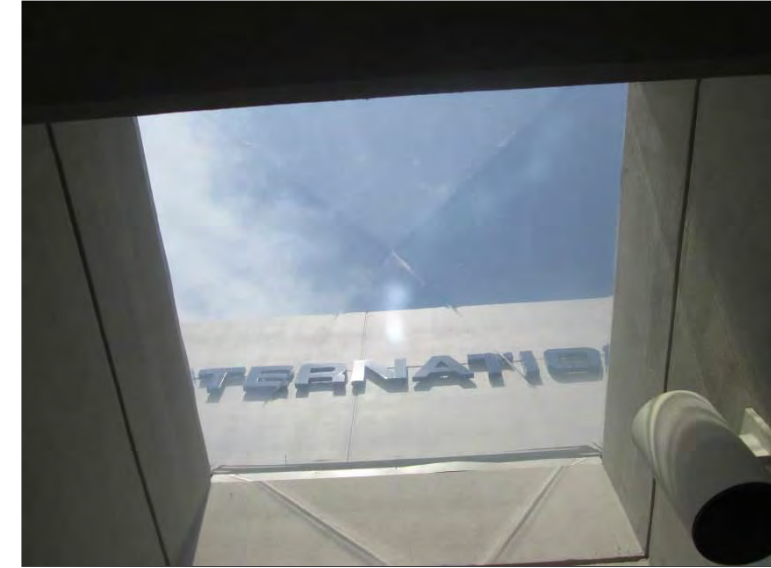
Photo 31: Example of a skylight observed to be in good condition in the Atrium area.

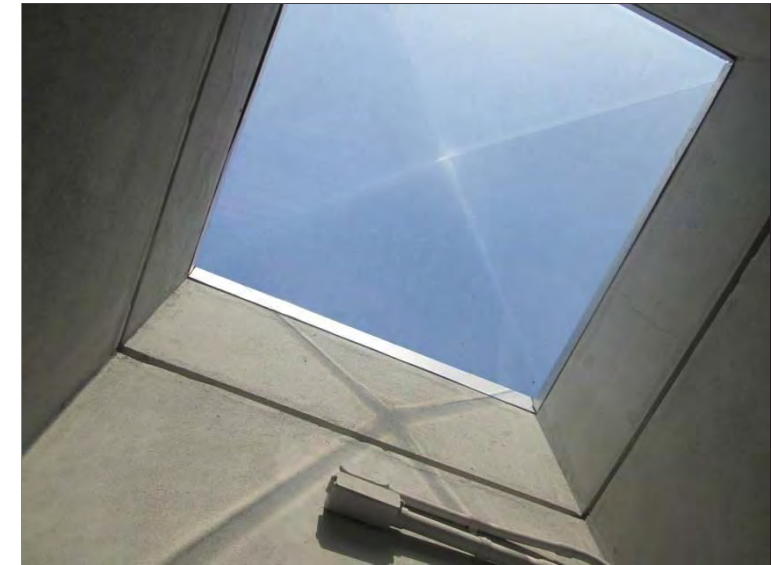
Photo 32: Example of a skylight observed to be in good condition in the Atrium area.

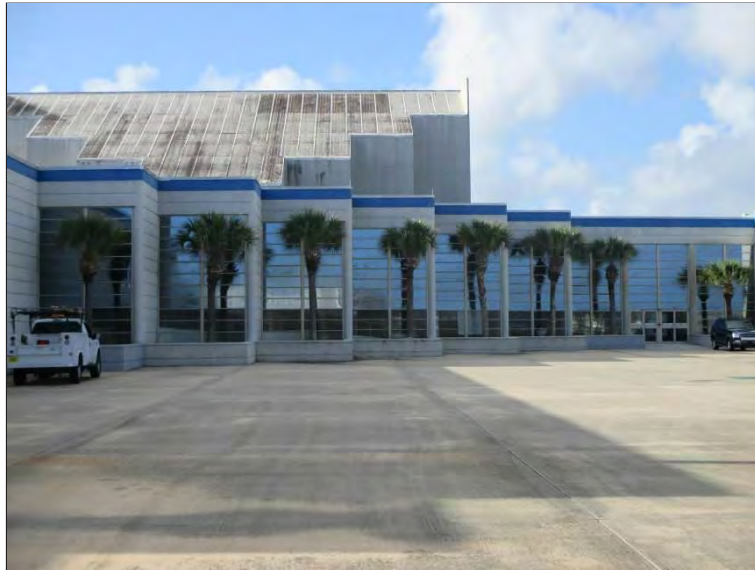
Photo 33: Window assemblies on the north elevation of the Atrium area where PSI performed a visual curtainwall and glazed openings survey to document current condition and note observed deficiencies.

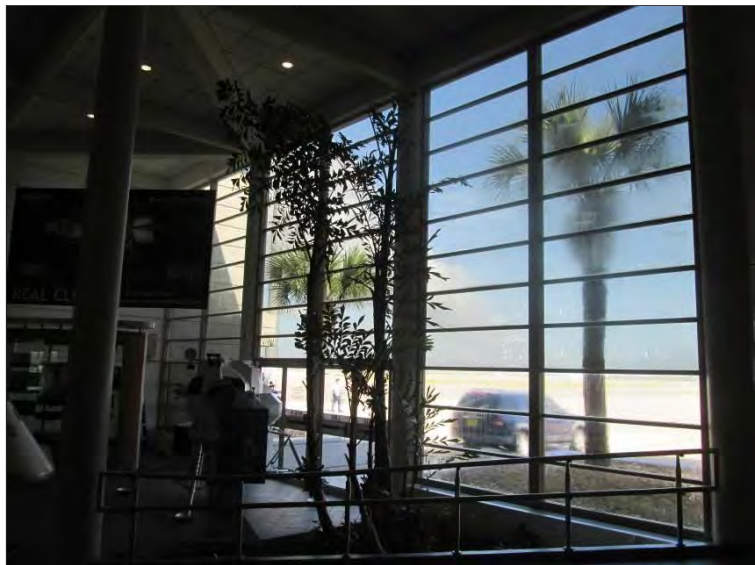
Photo 34: Interior view of window assemblies on the northwest elevation of the Atrium area where PSI performed a visual curtainwall and glazed openings survey to document current condition and note observed deficiencies.

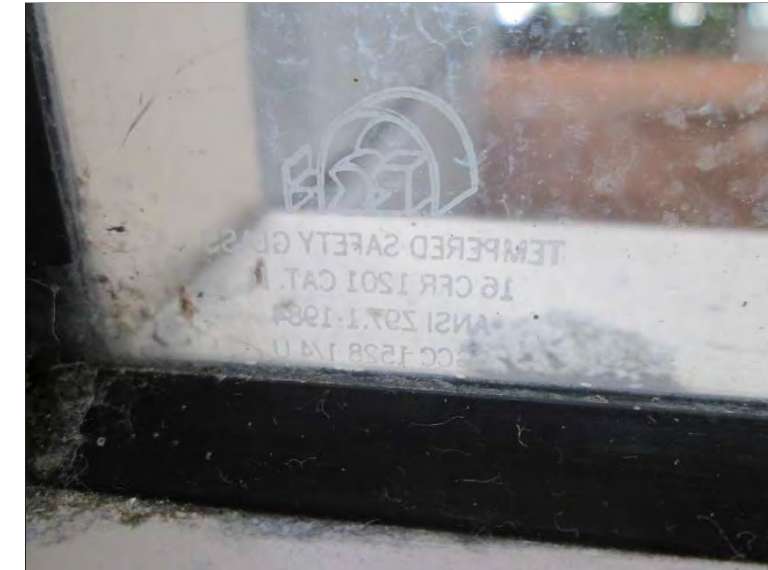
Photo 35: The aluminum framed curtainwall systems in the Atrium area are single pane tempered safety glass manufactured by RC.

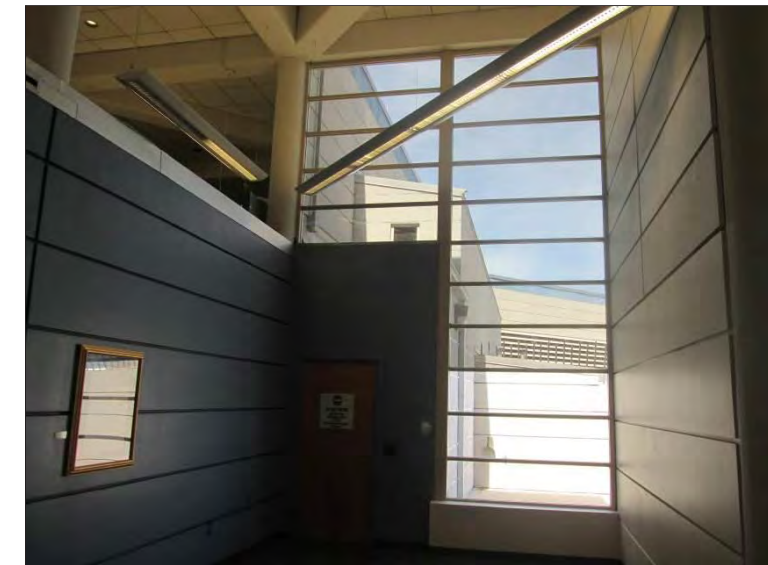
Photo 36: Interior view of window assemblies on the northeast elevation of the Atrium area where PSI performed a visual curtainwall and glazed openings survey to document current condition and note observed deficiencies.
