MELBOURNE AIRPORT AUTHORITY BOARD MEETING
AGENDA

May 27, 2020 at 8:30 AM
Orlando Melbourne International Airport Terminal

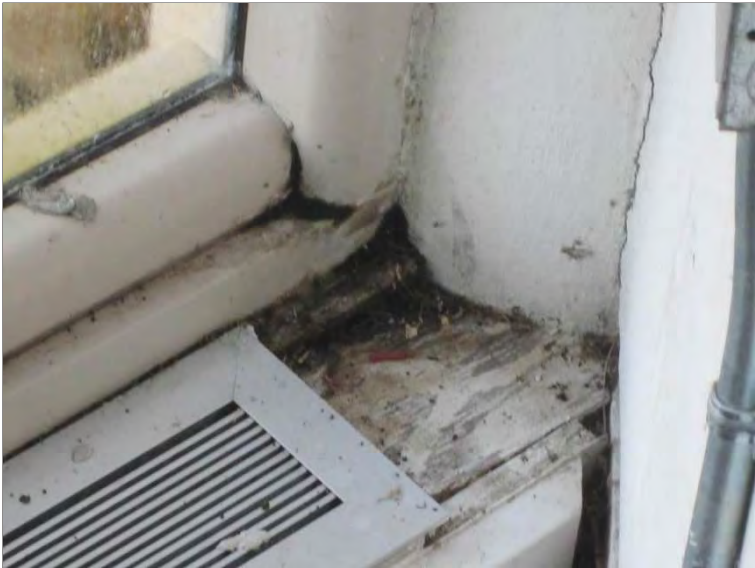
Photo 37: Observed area containing evidence of water intrusion in the bay of vertical panels approximately 77" x 21" in size closest to the concourse on the northwest elevation at the lower right hand corner in the Atrium area.

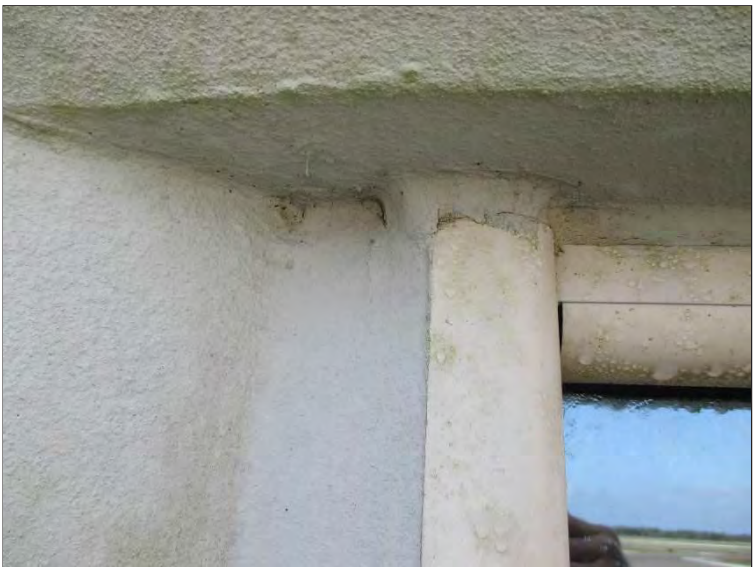
Photo 38: Deteriorated flexible sealant was observed at all perimeters at the frame to exterior wall transitions due to age and exposure to the elements in the Atrium area.

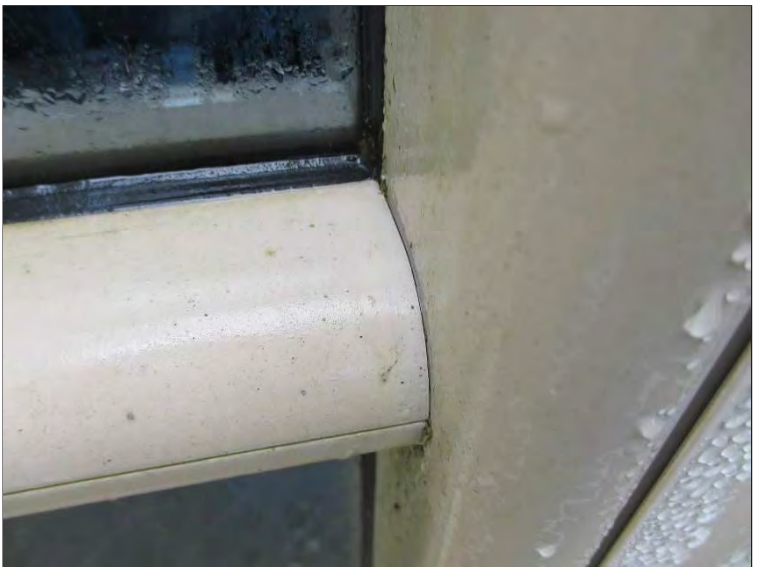
Photo 44: Missing flexible sealant on the exterior of the rounded aluminum framing applied to at the horizontal to vertical transitions in the Atrium area.

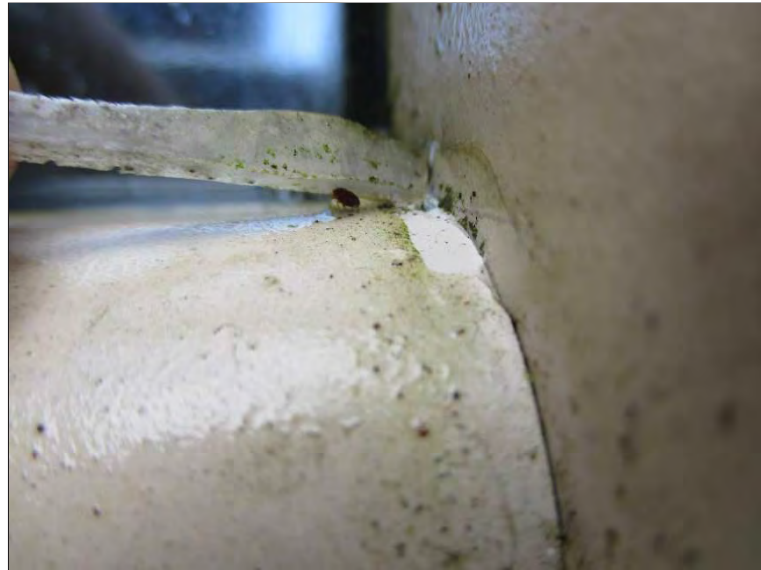
Photo 45: Deteriorated or pulling away flexible sealant on the exterior of the rounded aluminum framing applied to at the horizontal to vertical transitions in the Atrium area.

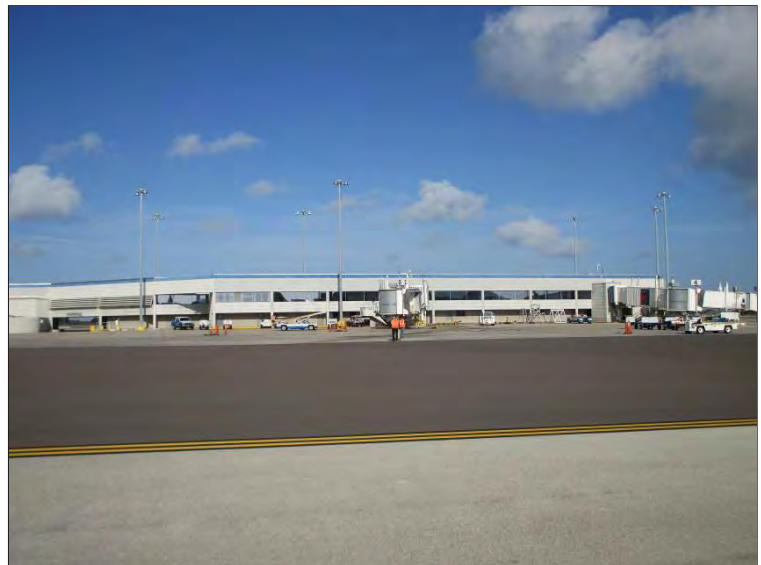
Photo 46: Window assemblies in the Concourse area throughout the east elevation where PSI performed a visual curtainwall and glazed openings survey to document current condition and note observed deficiencies.

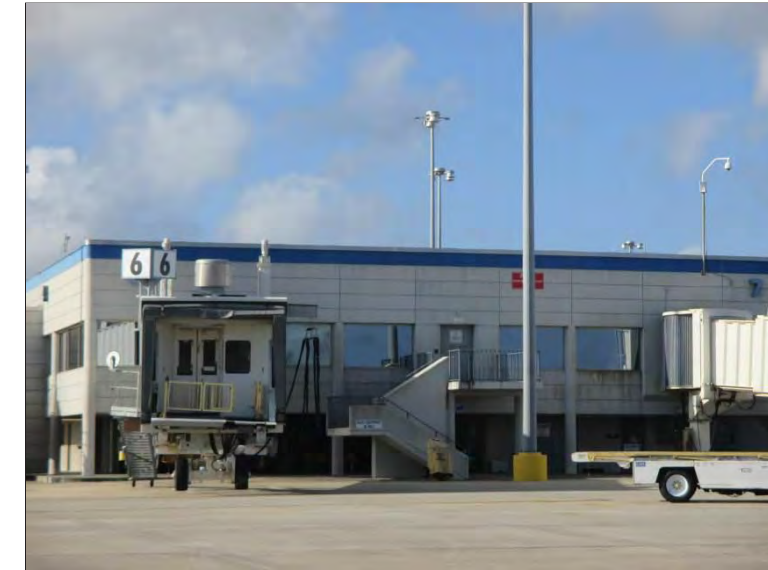
Photo 47: Window assemblies in the Concourse area throughout the north elevation where PSI performed a visual curtainwall and glazed openings survey to document current condition and note observed deficiencies.

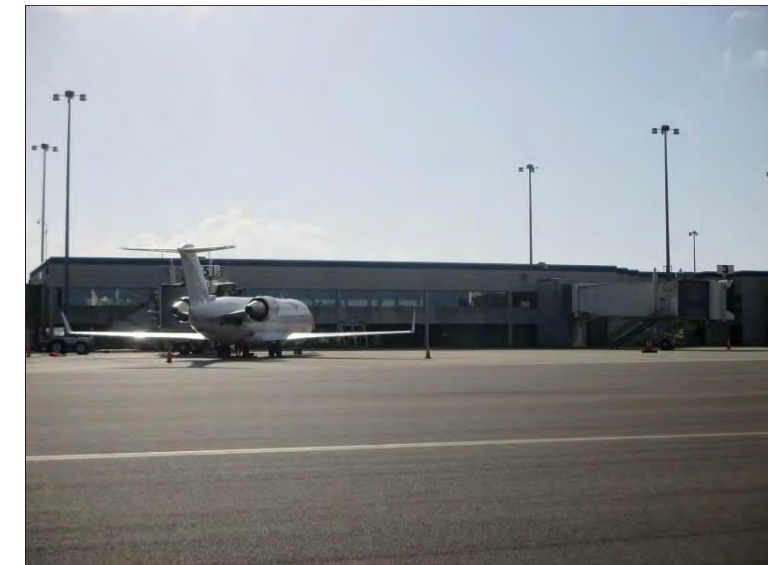
Photo 48: Window assemblies in the Concourse area throughout the west elevation where PSI performed a visual curtainwall and glazed openings survey to document current condition and note observed deficiencies.

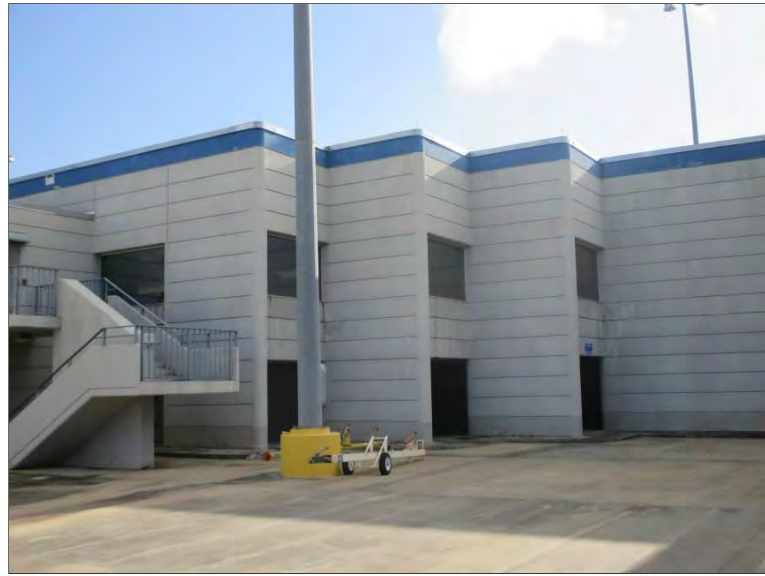
Photo 49: Window assemblies in the Concourse area throughout the west elevation where PSI performed a visual curtainwall and glazed openings survey to document current condition and note observed deficiencies.

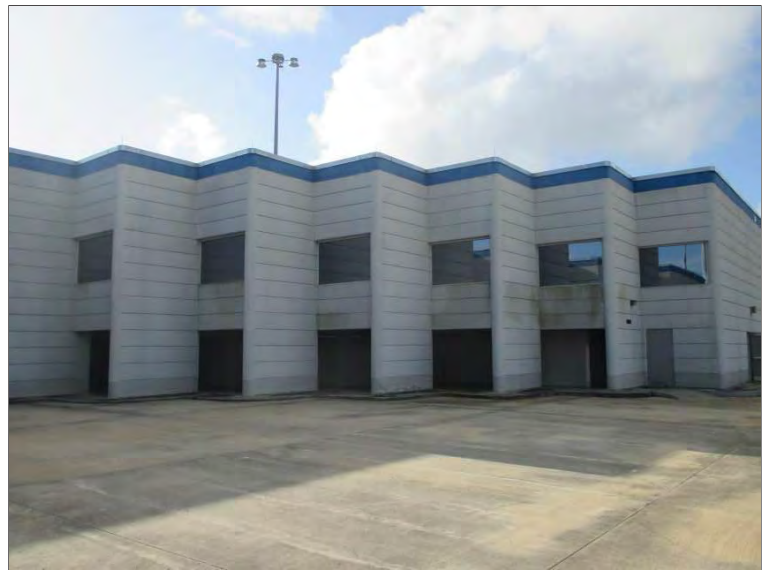
Photo 50: Window assemblies in the Concourse area throughout the west elevation where PSI performed a visual curtainwall and glazed openings survey to document current condition and note observed deficiencies.

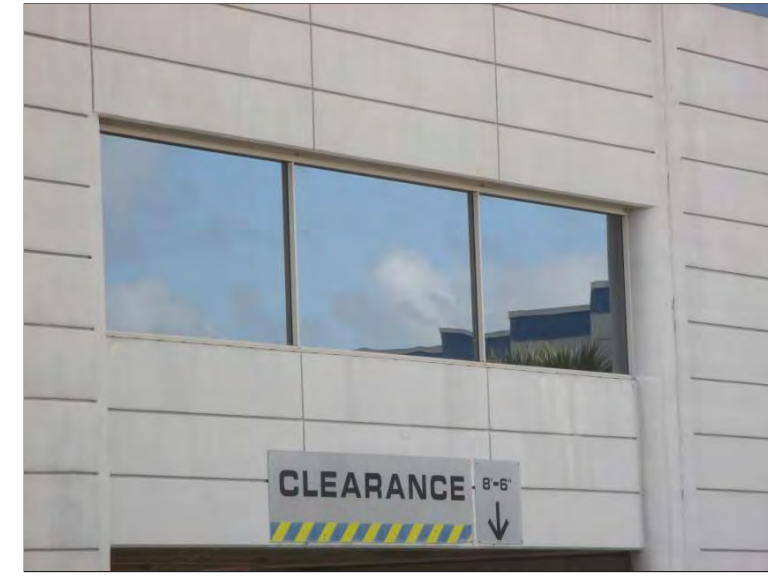
Photo 51: Window assemblies in the Concourse area throughout the west elevation where PSI performed a visual curtainwall and glazed openings survey to document current condition and note observed deficiencies.

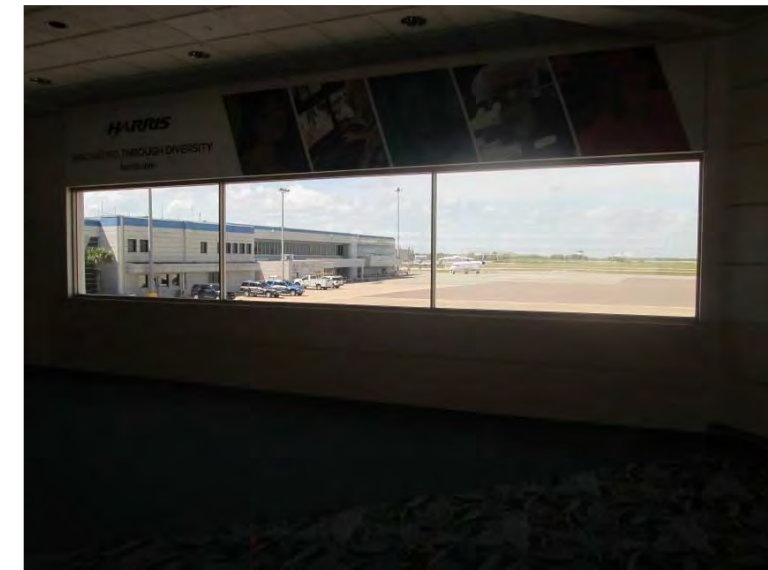
Photo 52: Interior view of window assemblies in the Concourse area throughout the west elevation where PSI performed a visual curtainwall and glazed openings survey to document current condition and note observed deficiencies.

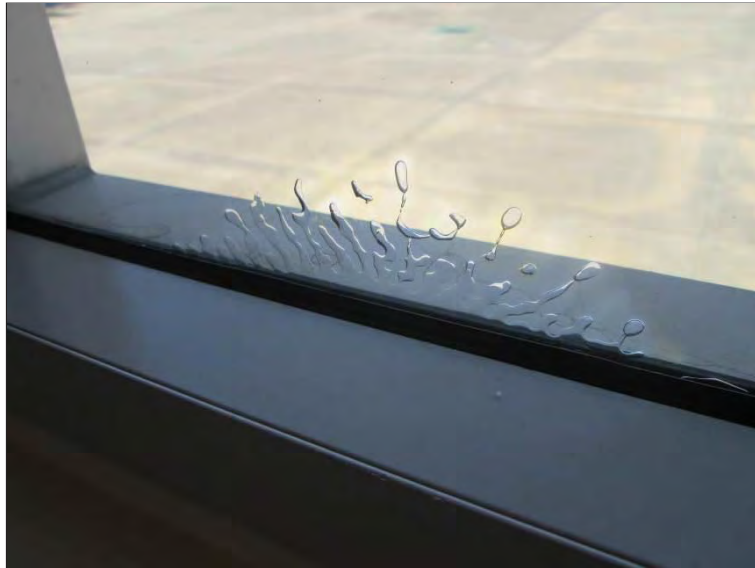
Photo 53: Delamination observed within the single pane tempered safety glass throughout the Concourse area.

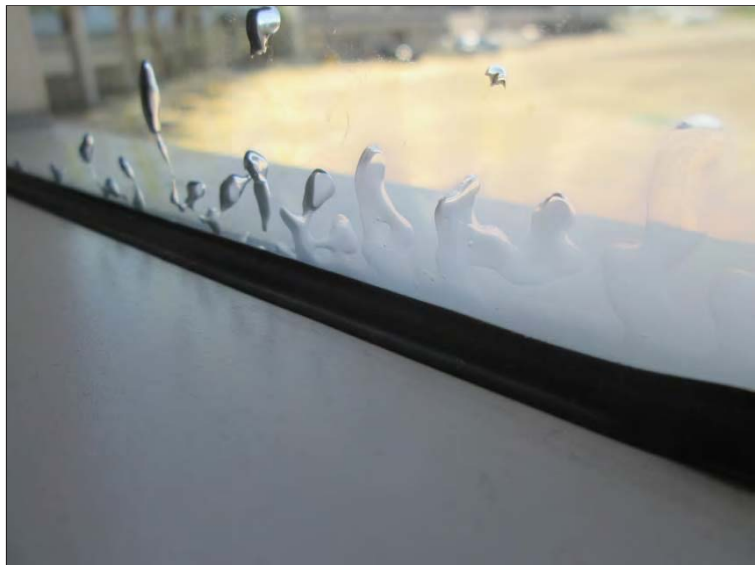
Photo 54: Delamination observed within the single pane tempered safety glass throughout the Concourse area.

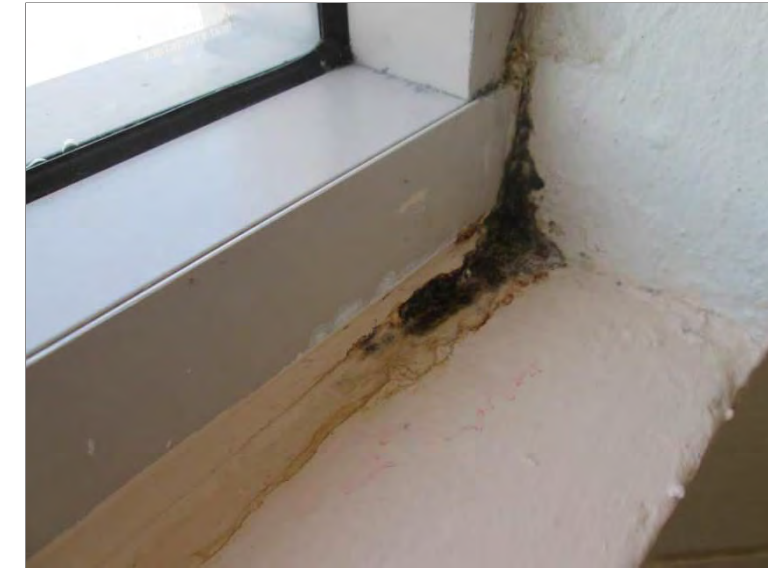
Photo 55: Observed area containing evidence of water intrusion in the bay of three windows on the west elevation of the Concourse area closest to the Atrium area at the lower right hand corner where the aluminum framing transitions to the interior gypsum wallboard.

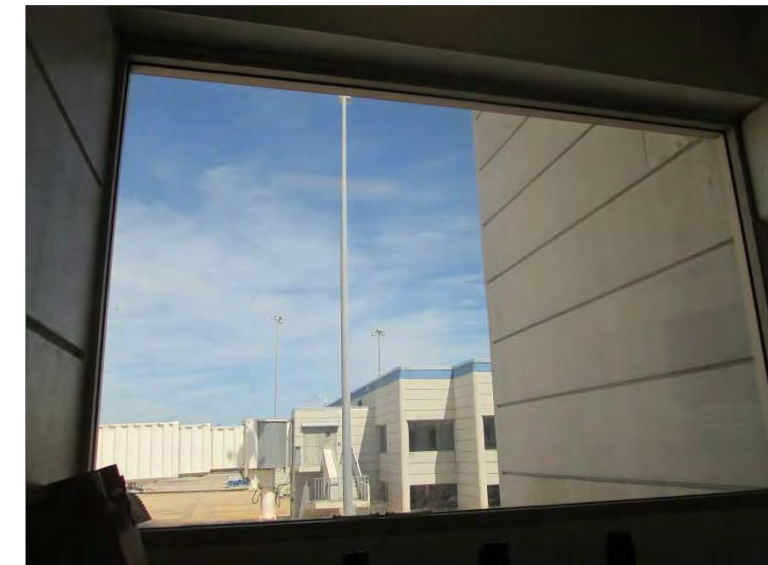
Photo 56: Delamination observed within the single pane tempered safety glass throughout the Concourse area.

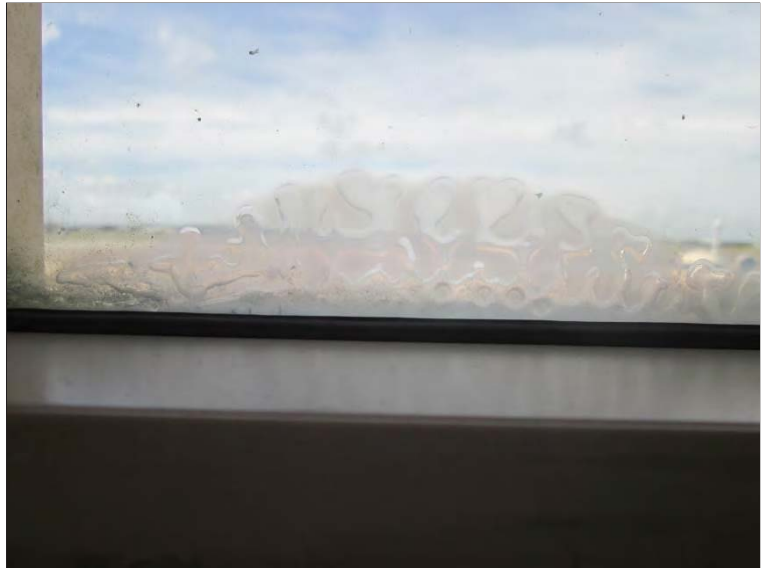
Photo 57: Delamination observed within the single pane tempered safety glass throughout the Concourse area.

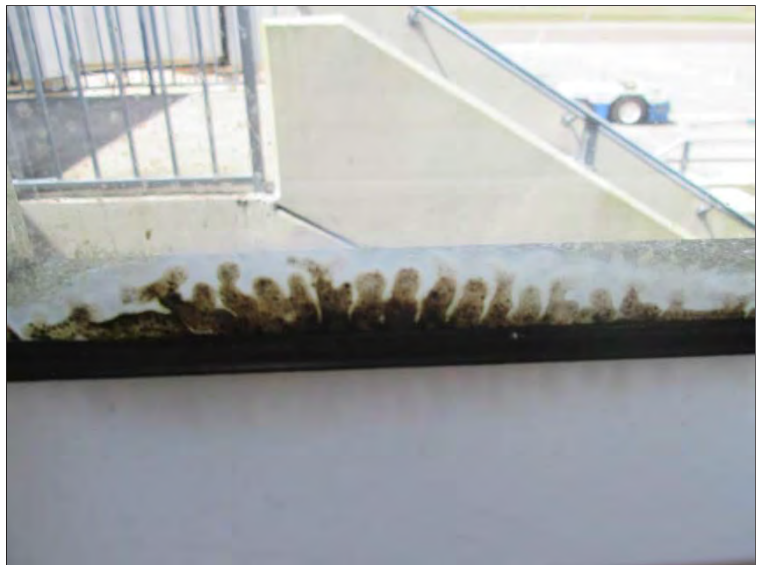
Photo 58: Delamination observed within the single pane tempered safety glass throughout the Concourse area.

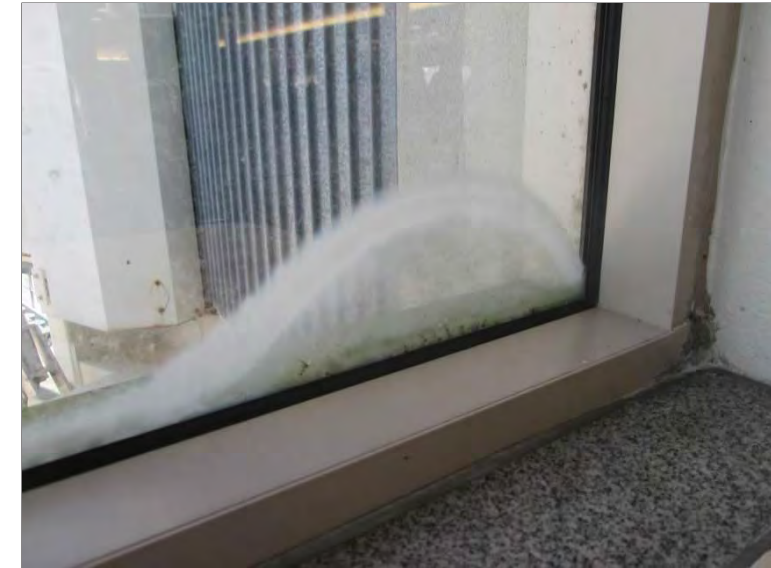
Photo 59: Delamination observed within the single pane tempered safety glass throughout the Concourse area.

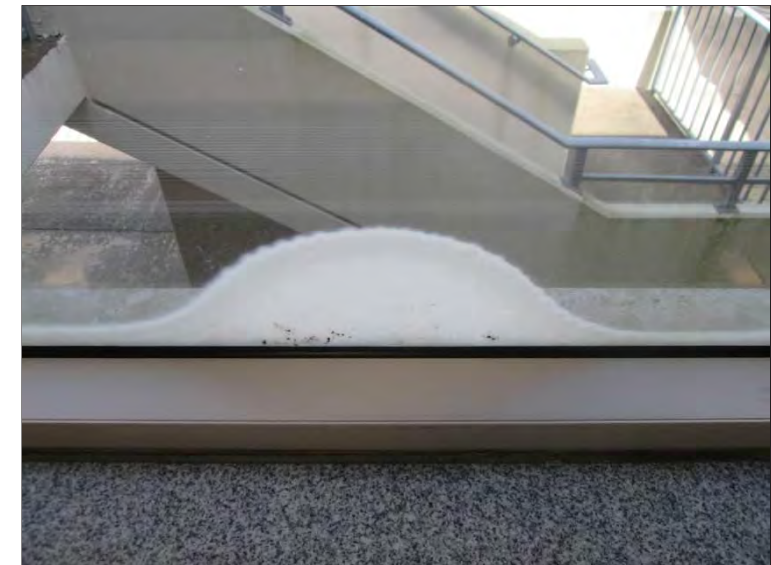
Photo 60: Delamination observed within the single pane tempered safety glass throughout the Concourse area.

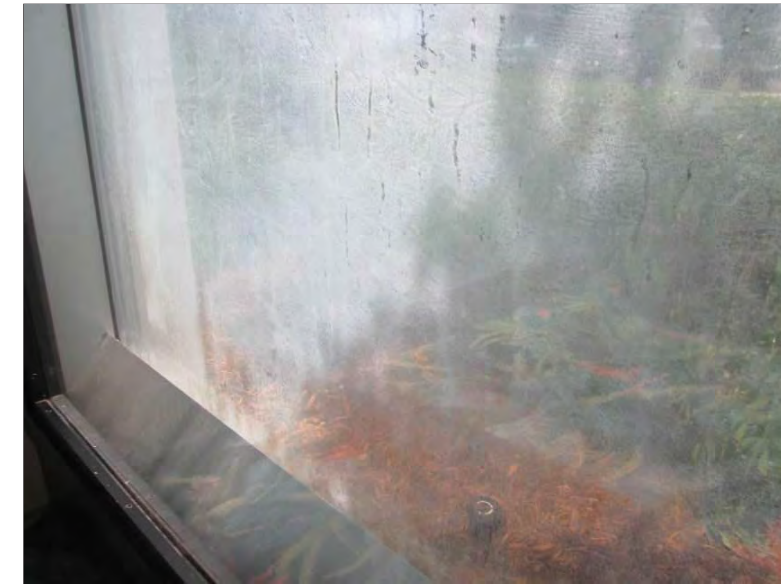
Photo 63: Observed sprinkler head directly outside the window assembly that appears to be directed at the window causing the discoloration.

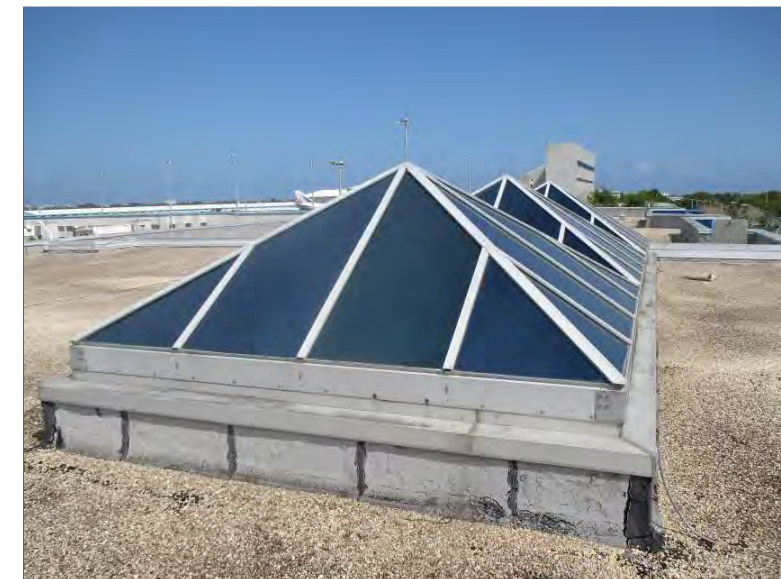
Photo 64: Skylights in the international terminal/baggage claim area. Skylights appeared to be constructed of single pane glass set in structural steel framing. The skylights measured approximately 12' x 13' in size and were in a group of three (totaling 37' x 13').

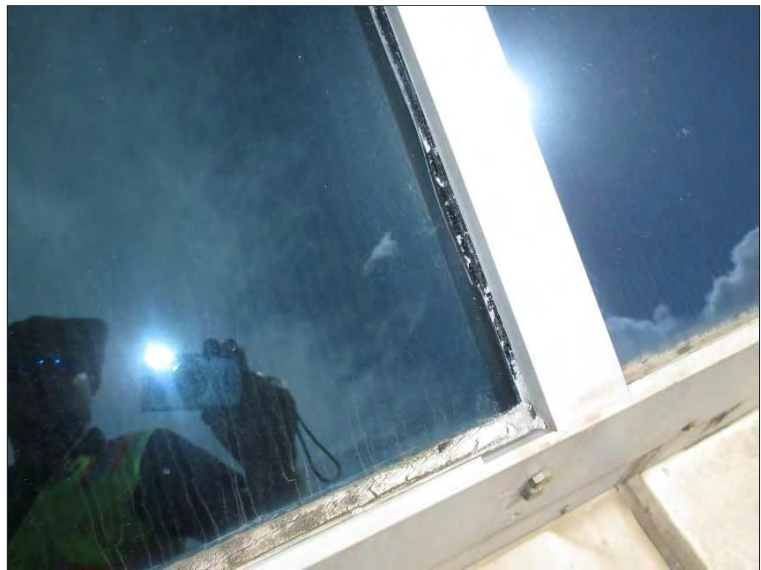
Photo 66: The sealant associated with the piece of glass that was replaced on the west perimeter if the skylight system was observed to be deteriorating and needs to be replaced.

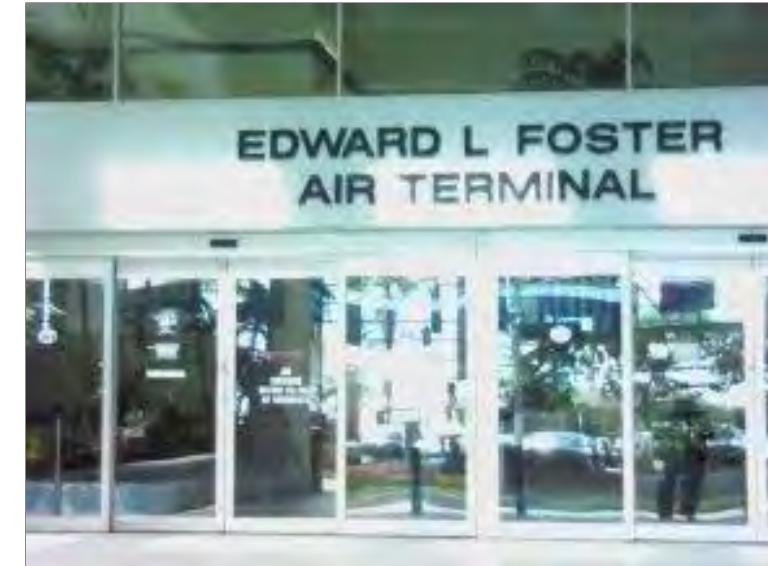
Photo 67: Digital image of the main entrances to the Atrium area.

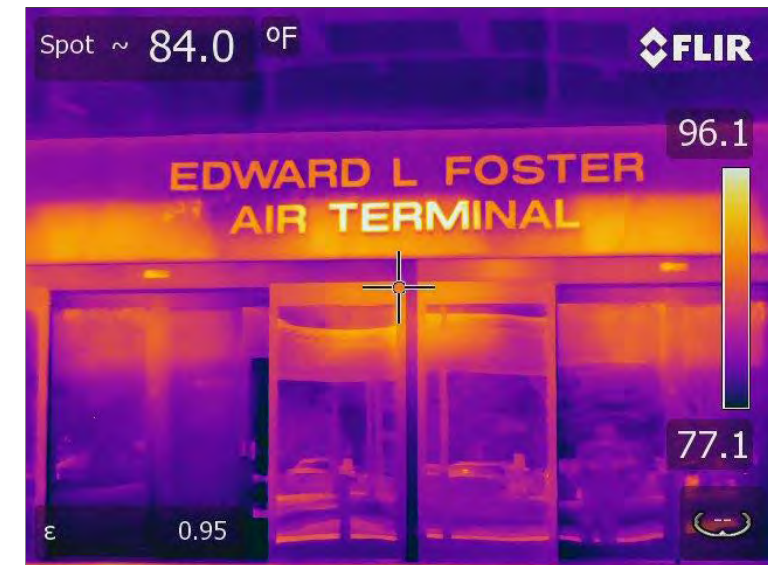
Photo 68: Thermal image of the main entrances to the Atrium area. No thermal differences were present indicative of moisture intrusion.

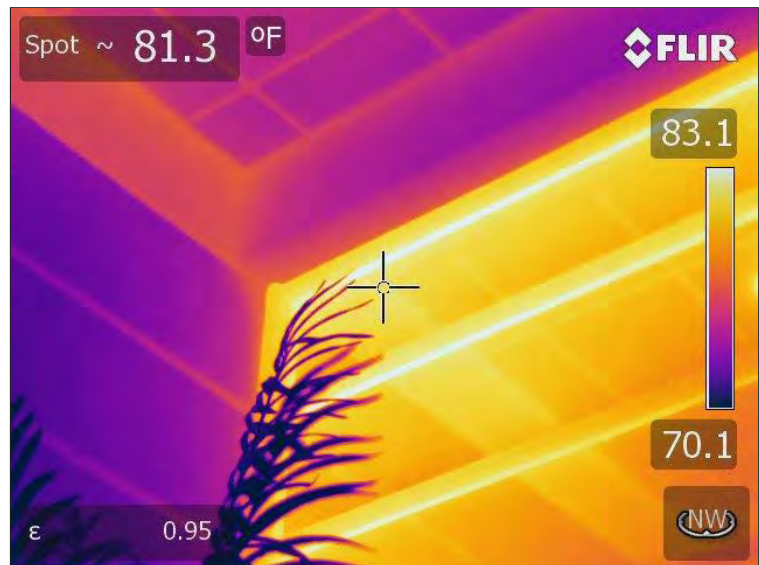
Photo 70: Thermal image of the curtainwall systems on the north elevation of the Atrium area. No thermal differences were present indicative of moisture intrusion.

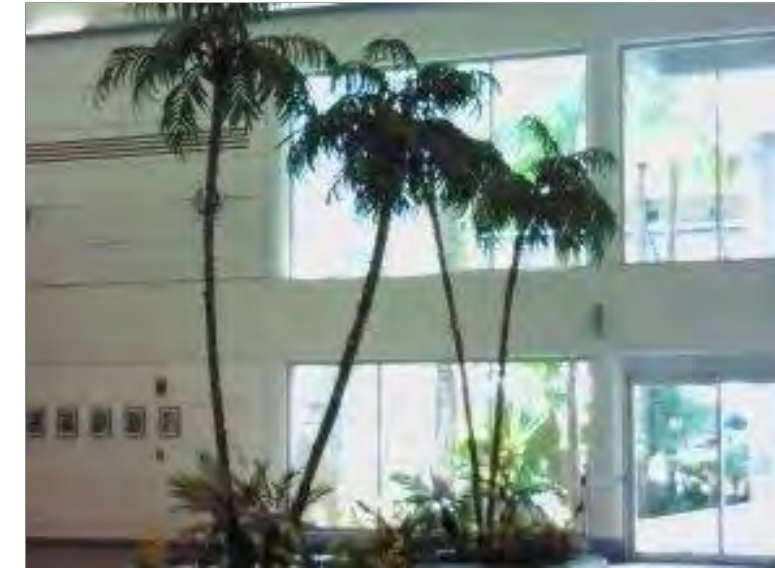
Photo 71: Digital image of the curtainwall systems on the south elevation of the Atrium area.

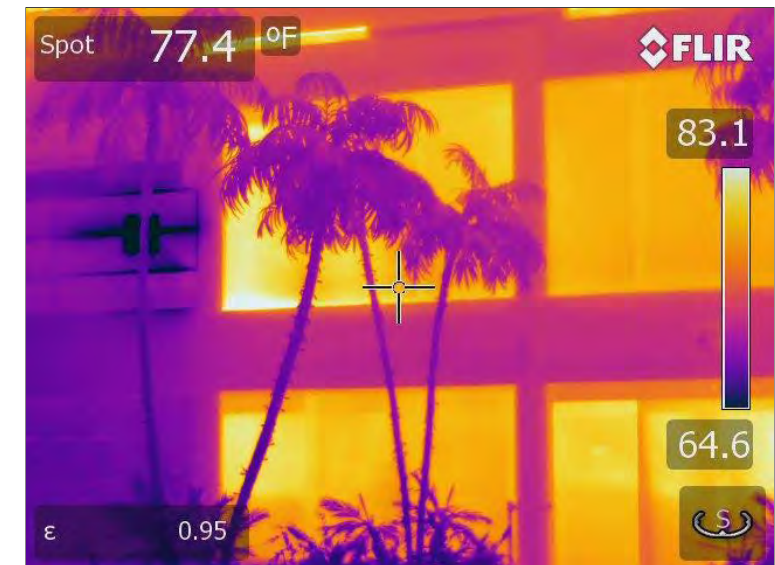
Photo 72: Thermal image of the curtainwall systems on the south elevation of the Atrium area. No thermal differences were present indicative of moisture intrusion.

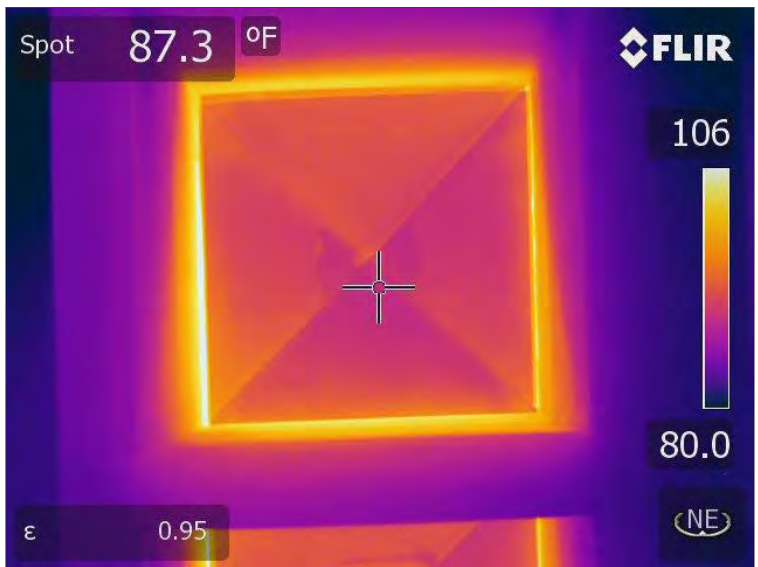
Photo 74: Thermal image of the skylights associated with the Ticketing area. No thermal differences were present indicative of moisture intrusion.

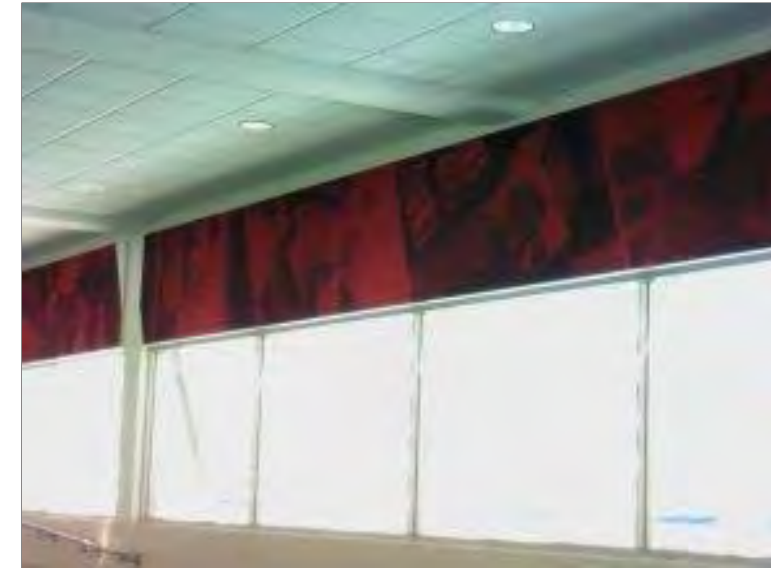
Photo 75: Digital image of the curtainwall systems throughout the Concourse area.

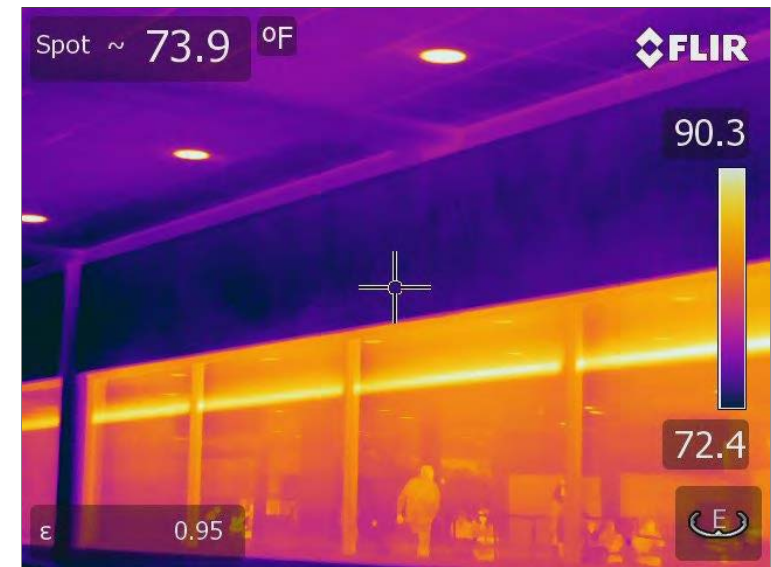
Photo 76: Thermal image of the curtainwall systems throughout the Concourse area. No thermal differences were present indicative of moisture intrusion.

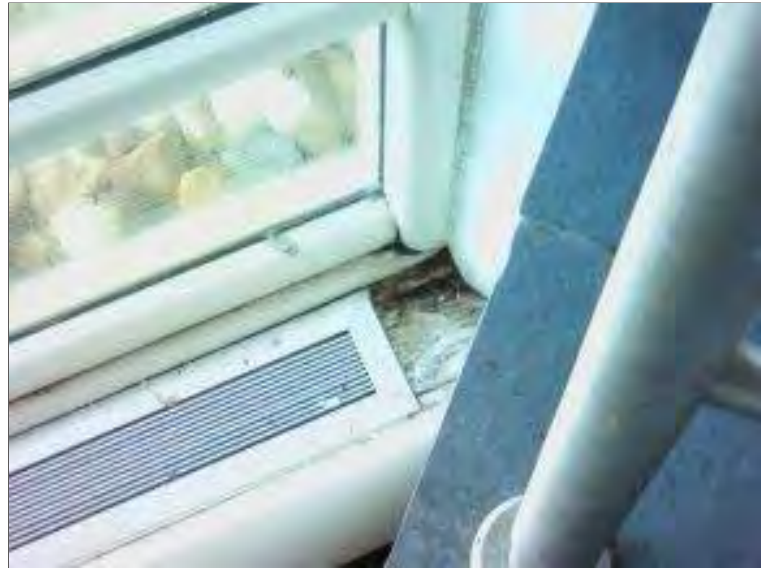
Photo 77: Digital image of the curtainwall systems on the northwest elevation in the Atrium area where evidence of moisture and water intrusion was observed at the last panel on the right side of the 1st bay east of the Concourse.

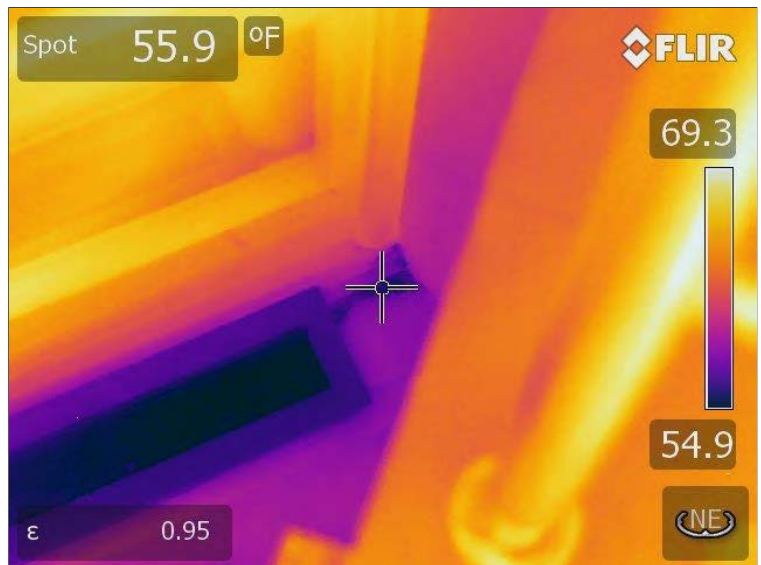
Photo 78: Thermal image of the curtainwall systems on the northwest elevation in the Atrium area where evidence of moisture and water intrusion was observed at the last panel on the right side of the 1st bay east of the Concourse.

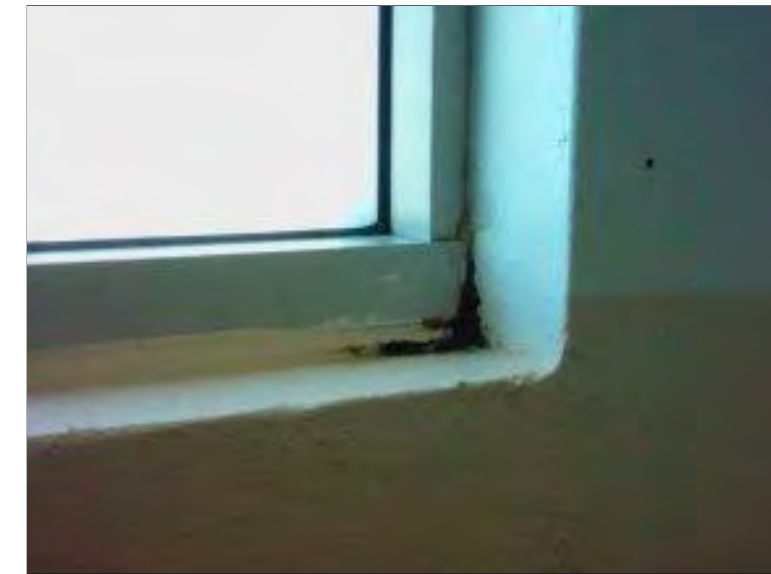
Photo 79: Digital image of the curtainwall systems on the west elevation in the Concourse area where evidence of moisture and water intrusion was observed at the set of three aluminum framed curtainwall systems leading to the Atrium at the lower right corner of the north panel at the frame to interior gypsum wallboard transition.

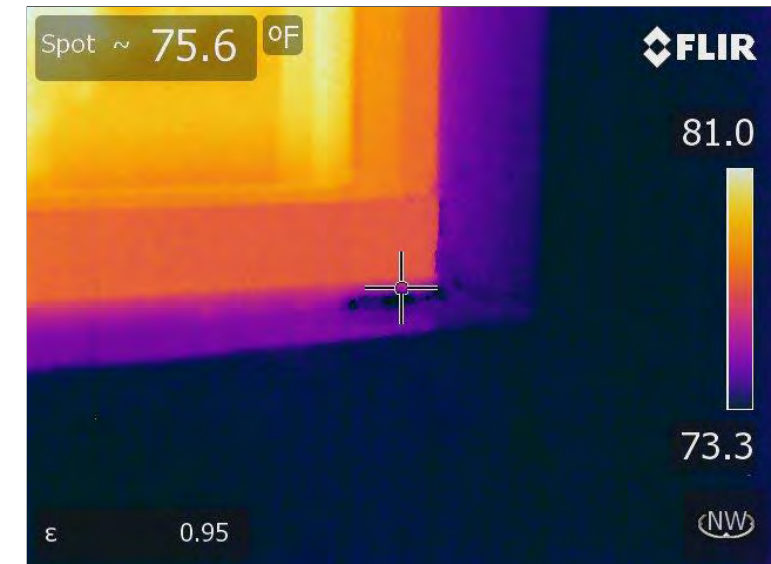
Photo 80: Thermal image of the curtainwall systems on the west elevation in the Concourse area where evidence of moisture and water intrusion was observed at the set of three aluminum framed curtainwall systems leading to the Atrium at the lower right corner of the north panel at the frame to interior gypsum wallboard transition.

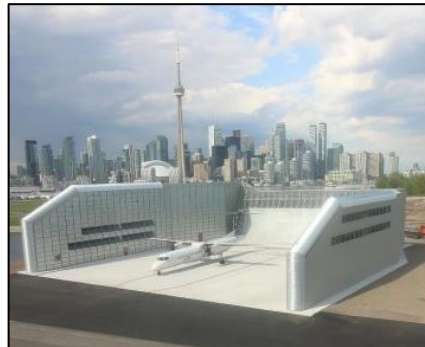
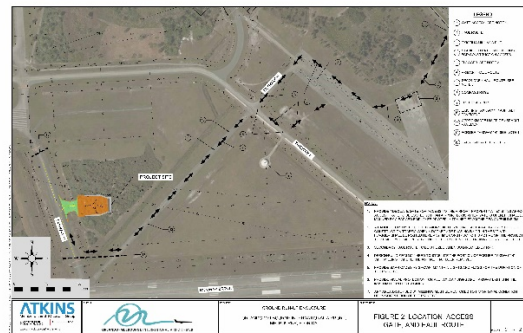
Passenger Boarding Bridges 7 and 4 Replacement:

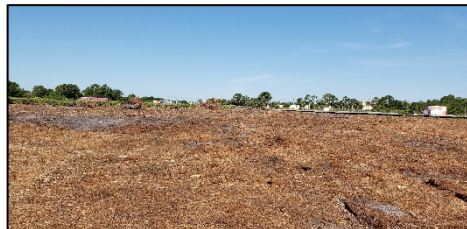
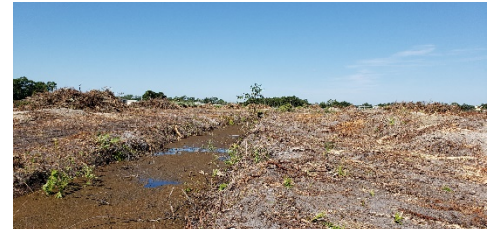
Northrop Grumman Building 219 Metal Roof Replacement:
